Characterization of Water Quality in a Hydrothermally Altered and Historically Mined Watershed, Warden Gulch, Colorado

Erik Oerter
Colorado Geological Survey
Colorado Department of Natural Resources

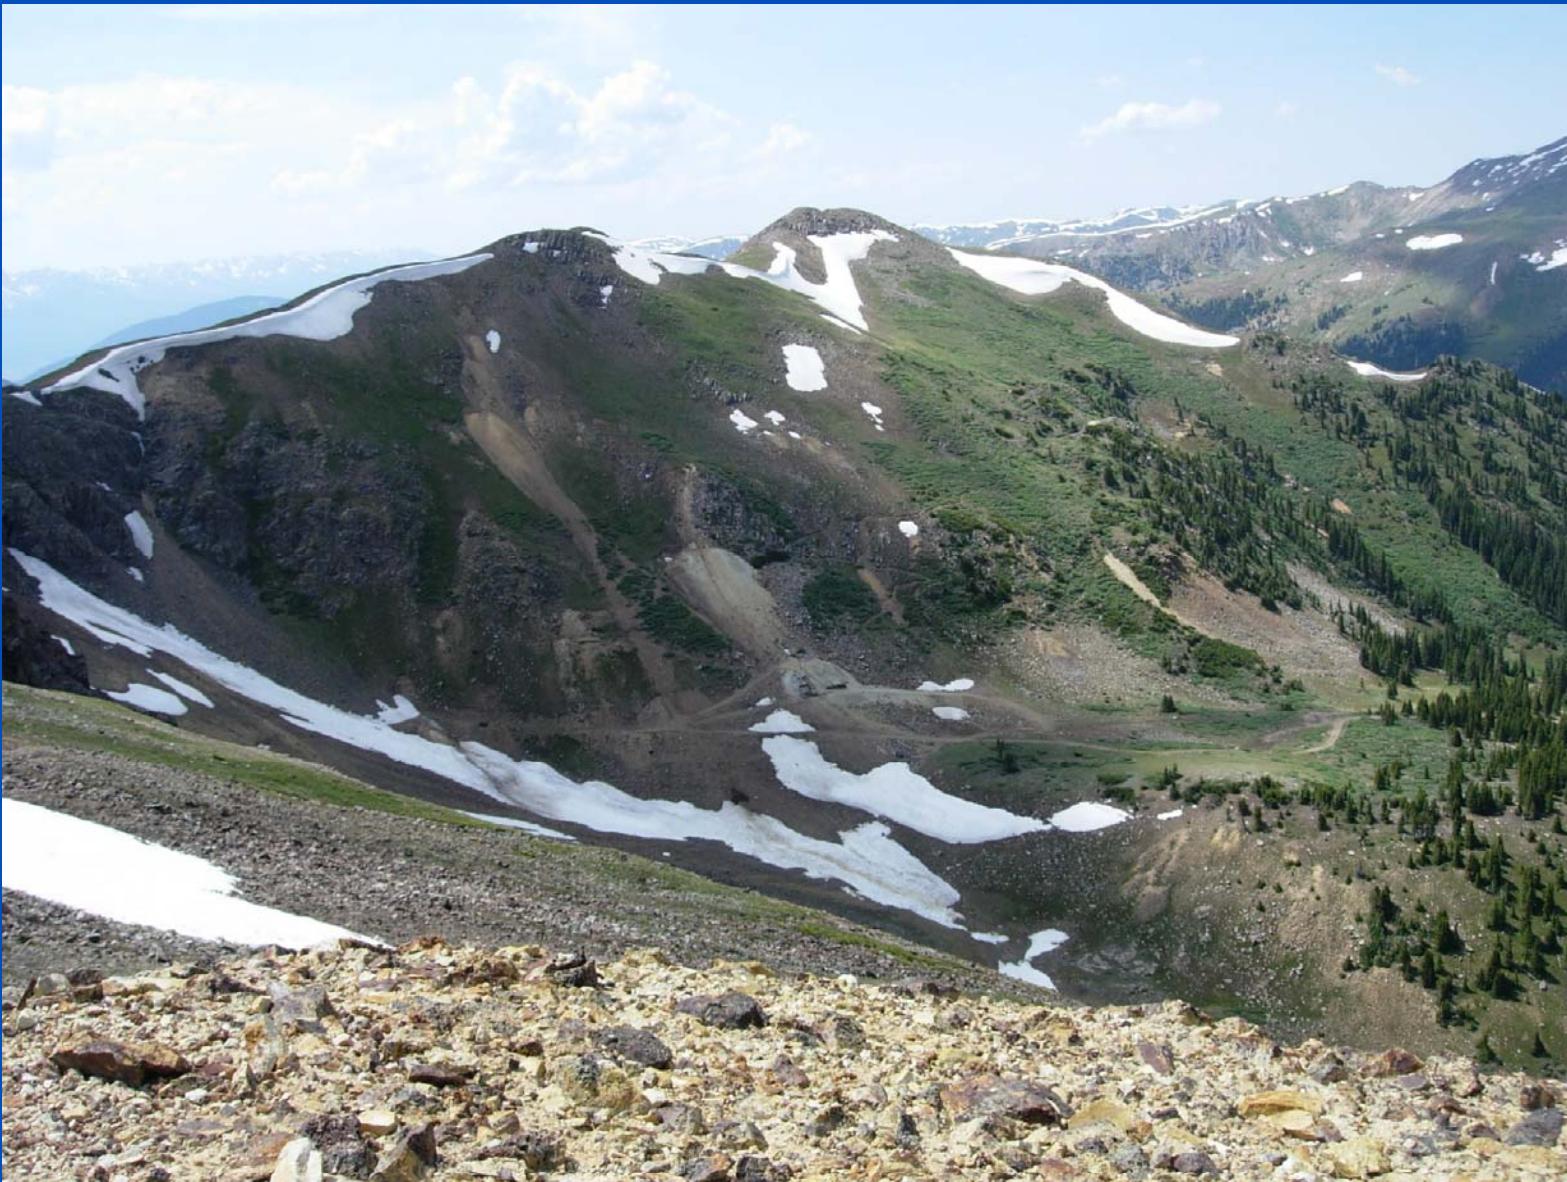
View of Collier Mountain from the Continental Divide, looking to the northwest
Allen Emory Mine group workings visible

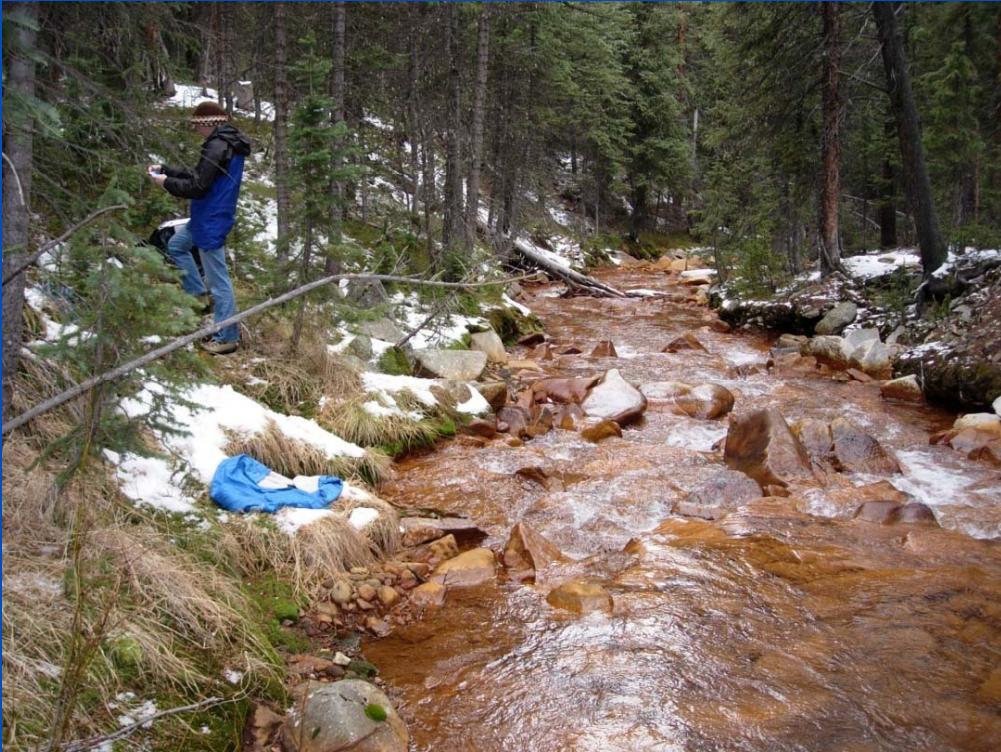
Warden Gulch during October 2004 sampling event

- Low Flow ~230 gpm (0.5 cfs)

Note red staining on streambed

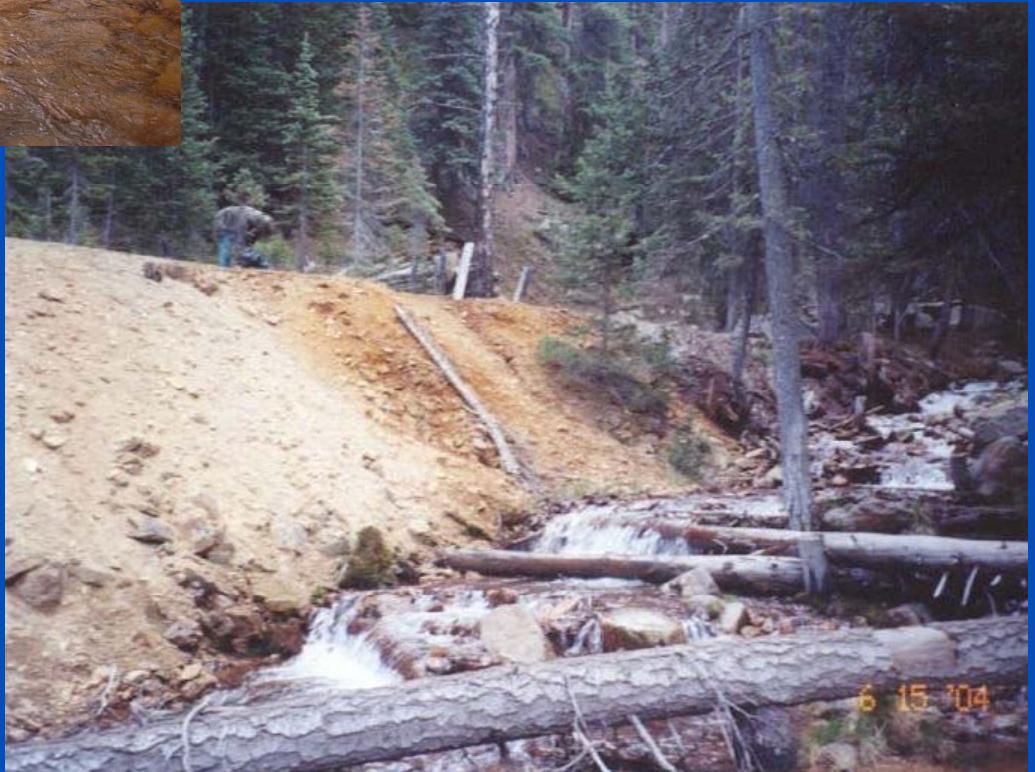
Waste rock dump directly adjacent to Warden Gulch

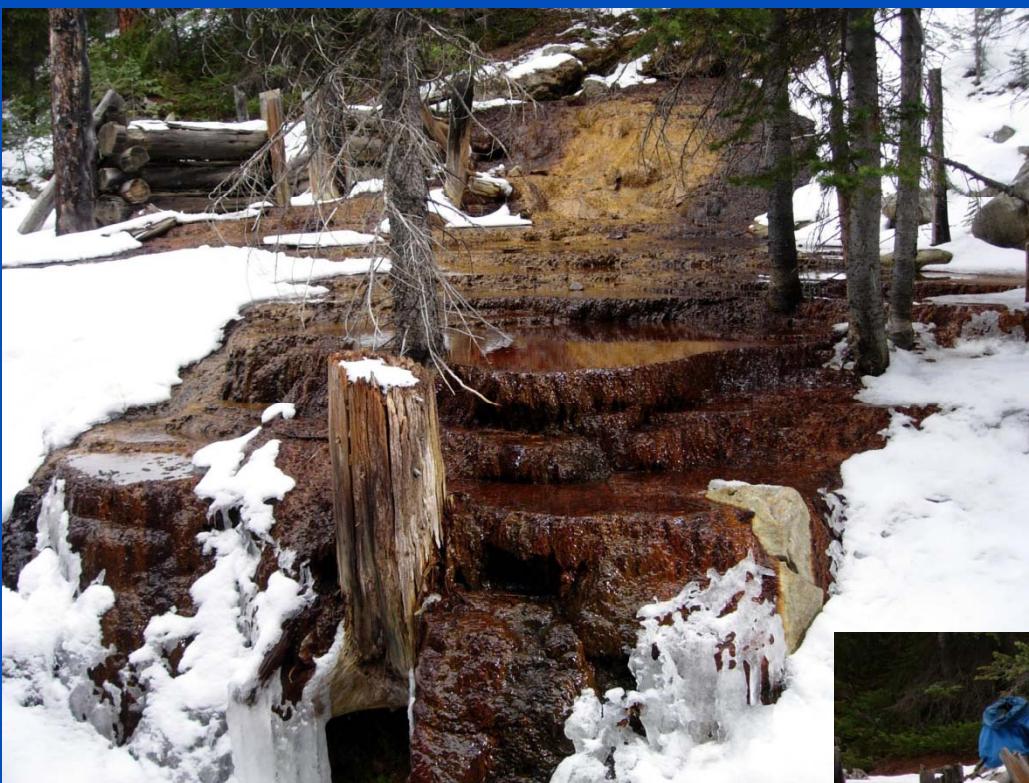
Adit #101

~6 gpm (June)

pH of 3.7

Al concentration: 82,000 µg/L

Fe concentration: 110,000 µg/L

Mn concentration: 30,700 µg/L

Zn concentration: 6,950 µg/L

SO₄ concentration: 1,100 µg/L

Draining adit in Lower Warden Gulch

Ferricrete deposits

Only flowing point source in watershed
