EVALUATION OF THE LONG-TERM IMPACTS OF URBANIZATION ON A PIEDMONT HEADWATER STREAM:

A Comparison of Physical, Biological and Chemical Indicators of Response

Ted Mikalsen

Robert L. Bourne

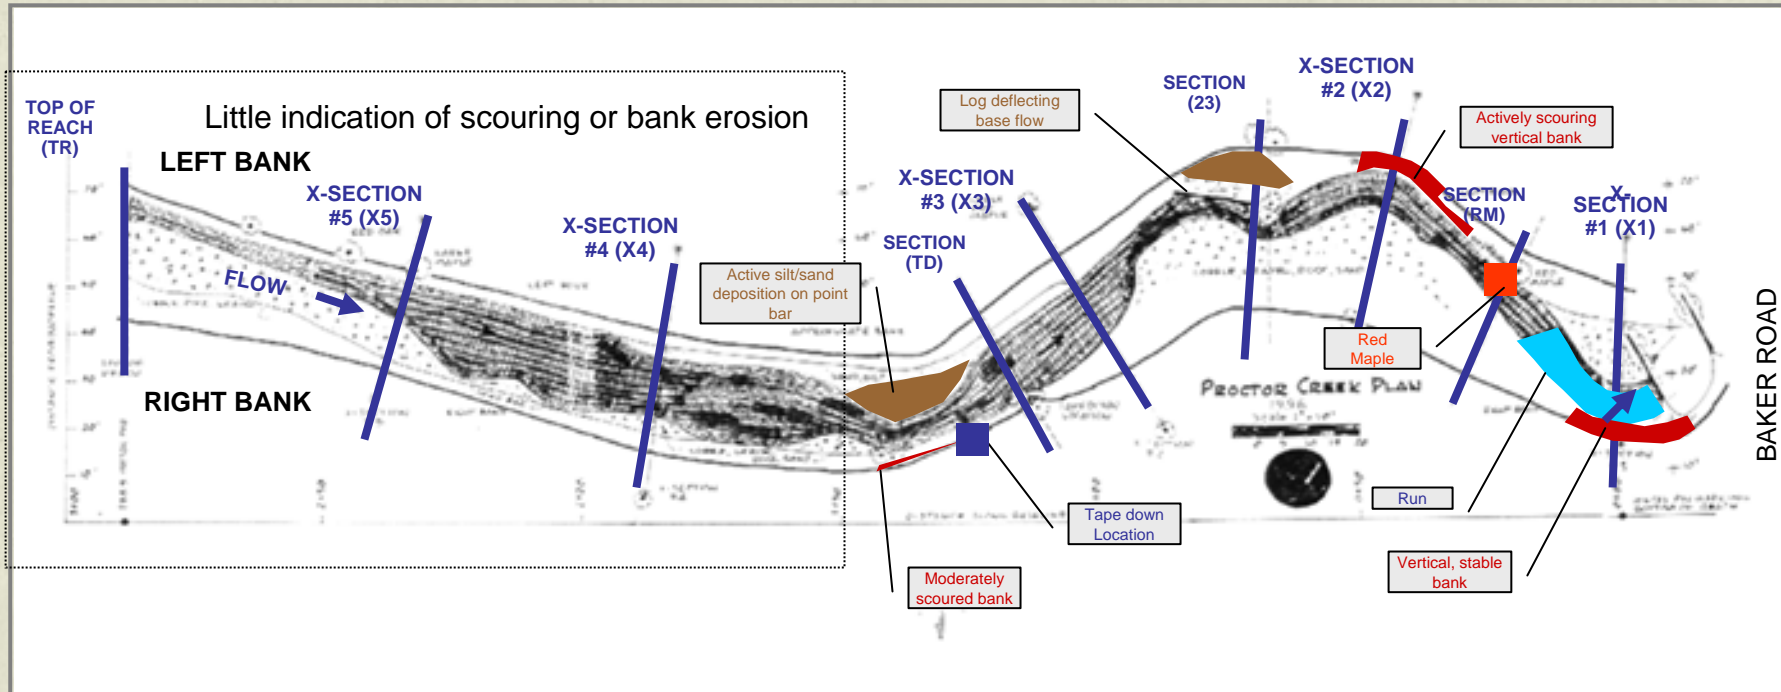
FIGURE 8: 1996 Plan View of Proctor Creek Tributary Sampling Reach

- Flow over the 288.5' (measured on a baseline) is from L to R, with LB & RB labeled looking DS.
- Channel X-sections & pebble counts taken at 4 & later 5 locations.

- Other sections are top of reach (TR), tapedown (TD), Sec. (23) below X2, & a large maple (RM) below X2.
- Little indication of scouring/erosion in upper reach.

- Active silt/sand sand deposition on point bar @ TD.
- Log armoring bank at Sec. 23 is diverting base flow & promoting pooling & deposition at higher flows.

- Vertical, actively scouring bank, outside bend @ X2.
- Active sediment deposition observed over reach (24% of particles silt or sand, very light silt covering riffles & runs).

- The mean bankfull area of 4 X-sections in 1996 was 32 ft², vs. 29 ft² for basins of a similar size derived from regional curve of eastern basins.
- Mean riffle spacing of 52', with 46% of the reach in pools. Mean entrenchment ratio of 1.80, width/depth ratio of 12.04, sinuosity ratio of 1.21, & slope of 0.01 ft/ft indicate Rosgen type B stream (moderately entrenched, moderate gradient, riffle dominated stream, with infrequently spaced pools).

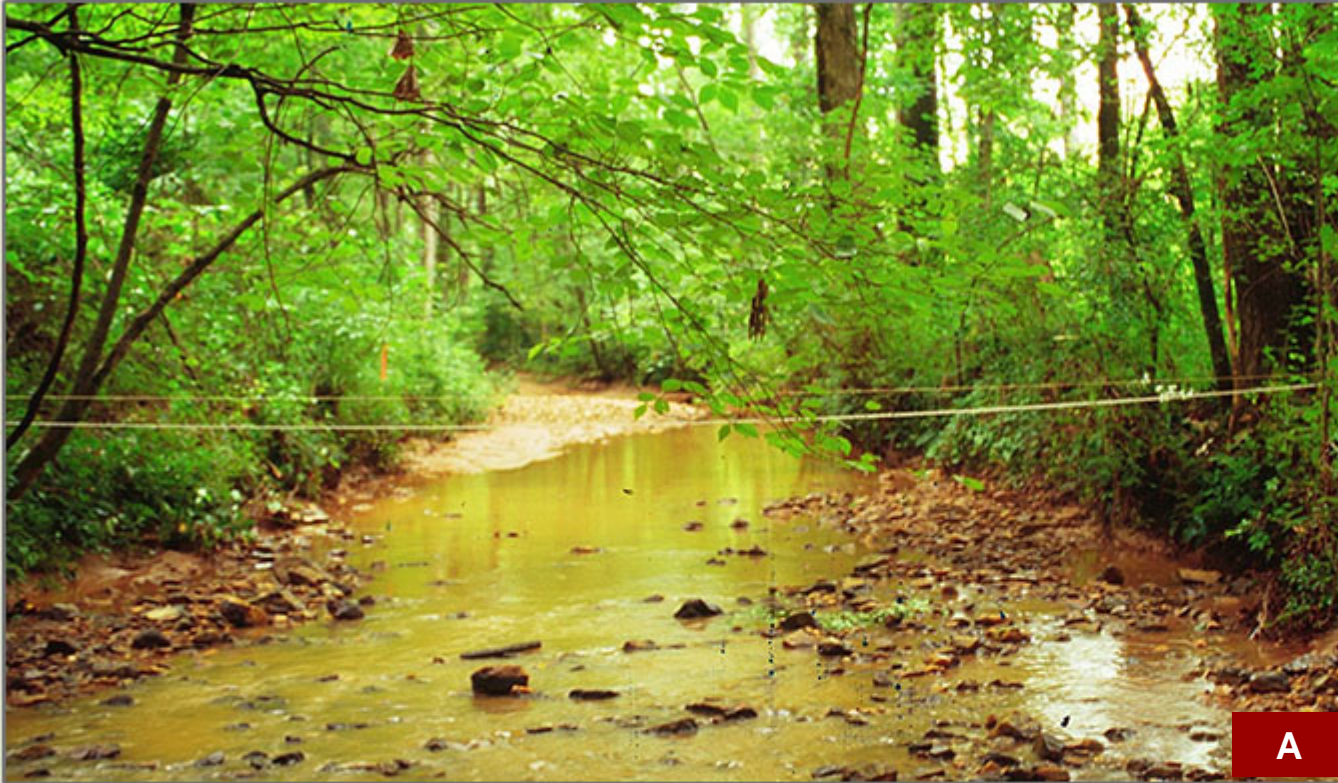
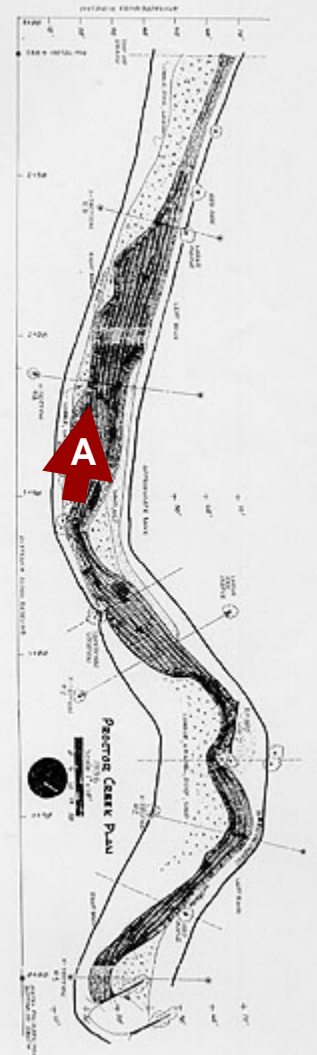
FIGURE 9: Proctor Creek Tributary 1996

Looking US at X-4, toward top of reach (TR)

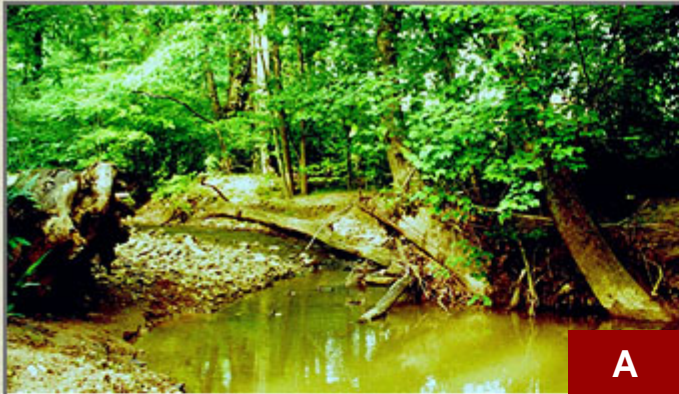
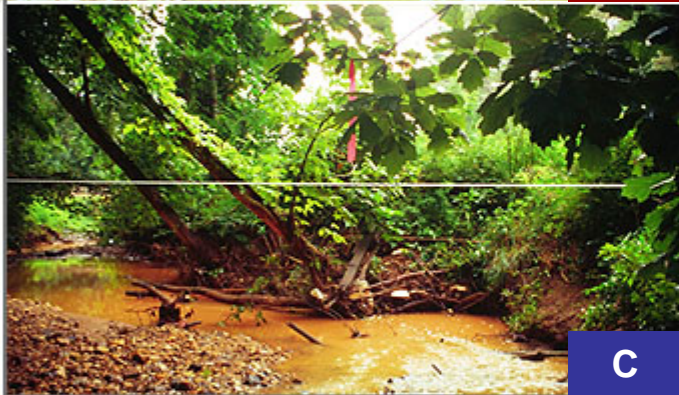
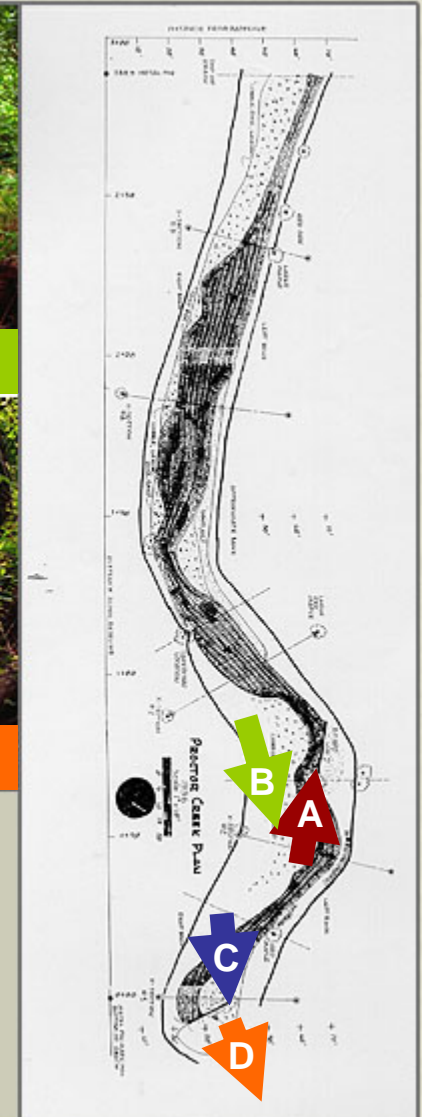
FIGURE 10: Proctor Creek Tributary 1996

- “A” Looking US past Sec. 2/3. Note transverse log and built up peninsular behind it.
- “C” Looking DS past X1. Note turbidity and run past X1.

- “B” Looking DS past X2 toward red maple (RM).
- “D” Looking DS at old Baker Road bridge. Note shallow run & pool above bridge.

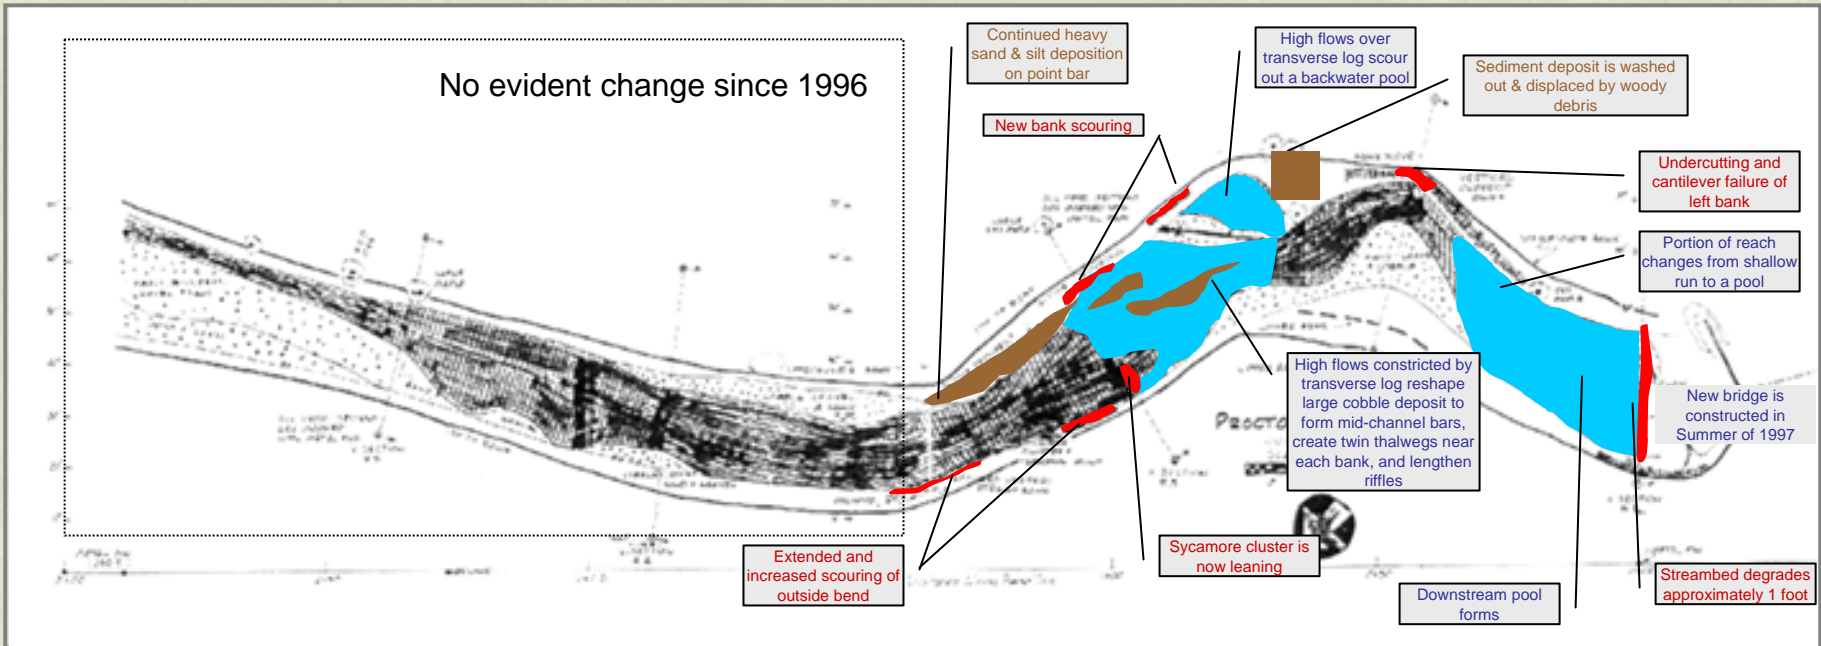
FIGURE 12: 1998 Plan View of Proctor Creek Tributary Sampling Reach

- No evident changes in the upper, relatively straight portion of reach.
- Increased & extended scouring of outside bend near tapedown (TD) site & continued heavy sand & silt deposition on opposite point bar.

- Sycamore cluster (TD) on edge of bank site has leaned into the stream at a pronounced angle.
- High flows constricted by transverse log below X-3 reshape large cobble deposit to form mid-channel bars and create thalwegs near each bank, and lengthen riffles.

- Higher flows have begun scouring LB below X3, scoured out a pool behind the transverse log, and displaced the sediment peninsular at Section 23 with woody debris.

- The upper portion of the outside (LB) bank @ X2 receded approximately 2 feet due to undercutting and cantilever bank failure.
- Construction of new bridge @ Baker road resulted in upstream ponding & ponding of the former shallow run above X1.

- The streambed at X1 degraded approximately 1 foot.

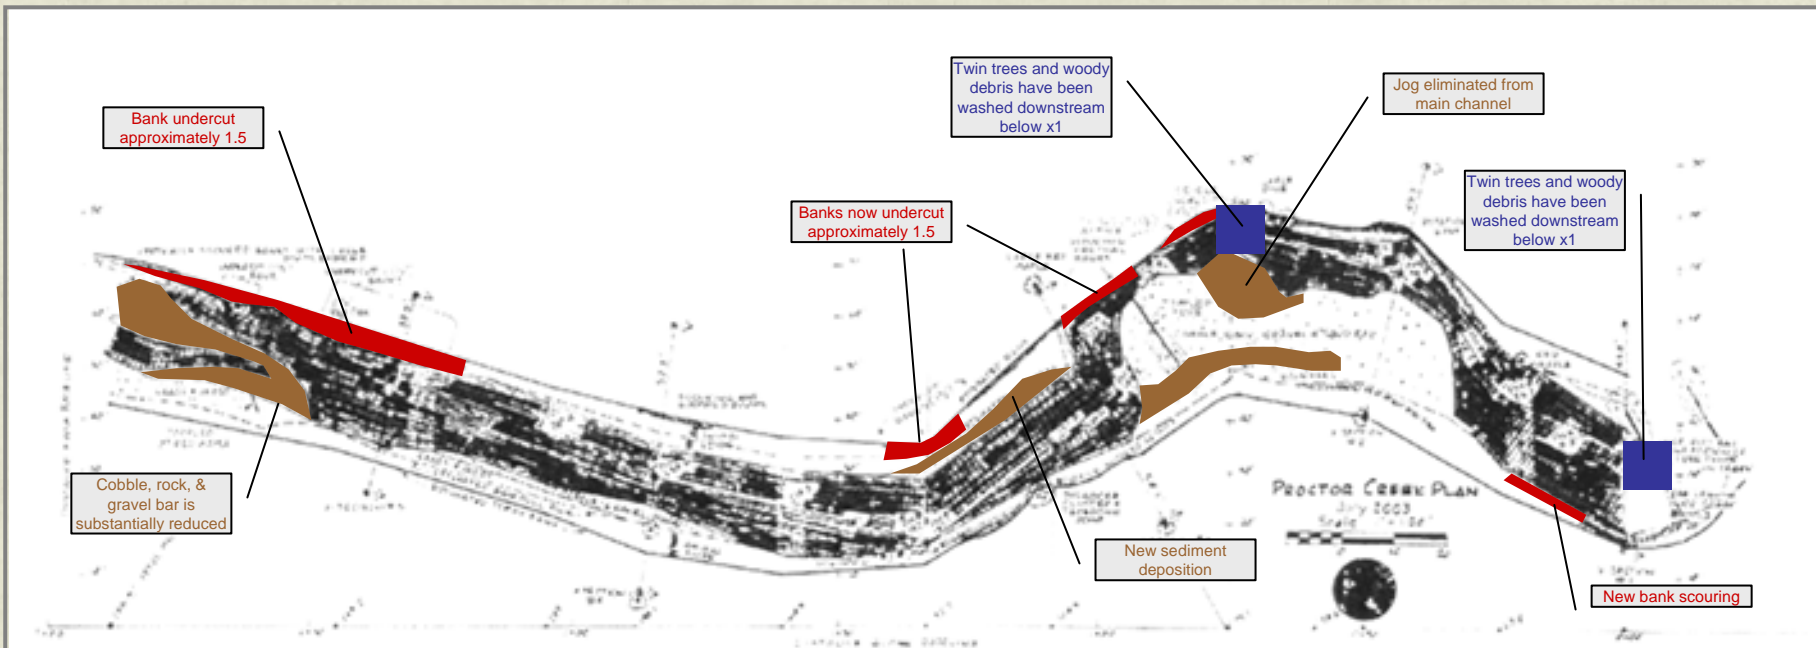
FIGURE 25: 2002-2003 Plan View of Proctor Creek Tributary Sampling Reach

- Between 2002 & July, 2003, the heavily scoured LB from the TR to X4 was undercut approximately 1½ ft.
- The cobble & rock bar US X4 was greatly reduced..
- The X5 bankfull area increased from 33.8 to 36.3 ft².
- Scouring of RB (outside bend) US X3 continued.
- The heavily scoured & receding LB US & DS from X-3 was undercut approximately 1½ ft.
- The right of the twin channels below X3 was filled by an increased accumulation of cobbles which diverted even higher flows to the left channel.
- High flows continued to scour the upper LB @ Sec. 23, washed away the twin red maple trees & debris peninsular, & scoured the bank to vertical by 2003.
- The point cobble bar between X3 & X2 increased in area and height as the outside bend continued to suffer bank undercutting & cantilever, planar failure.
- Between 2002 and 2003 bank scouring increased substantially on the RB near X1.

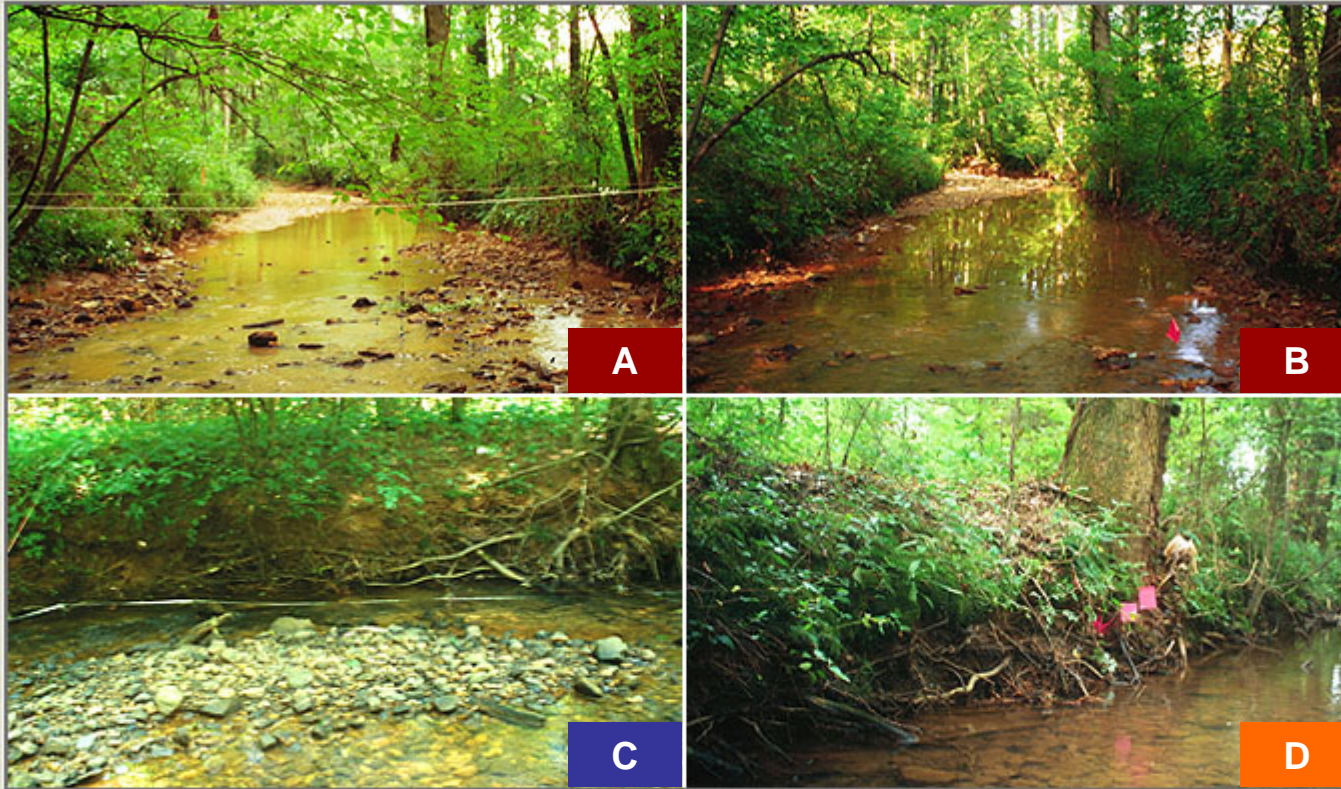
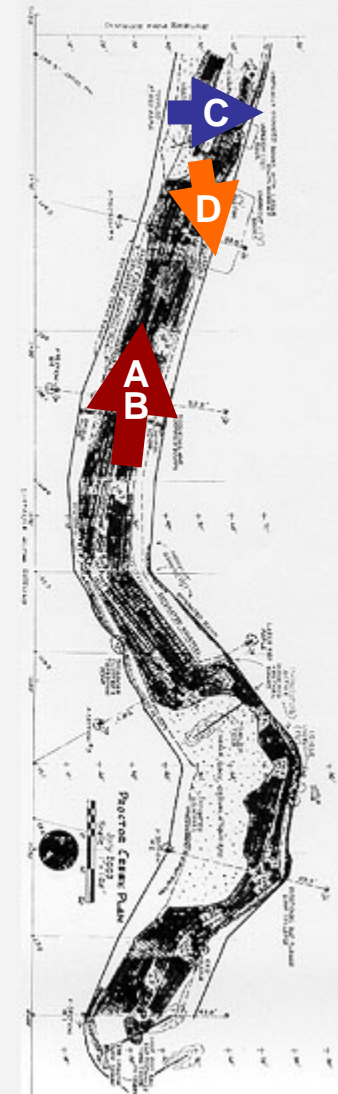
FIGURE 27: Proctor Creek Tributary 1996-2003

- “A” 1996 looking US past X4.
- “B” 2003 looking US past X4.
- “C” 2003 Erosion of LB between TR & X5.
- “D” 2003 Erosion of LB between TR & X5.

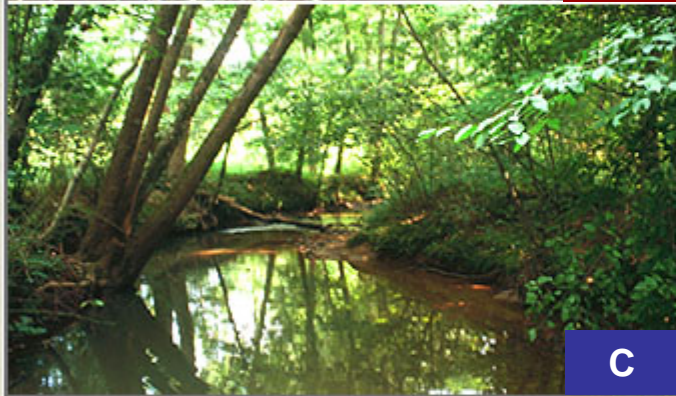
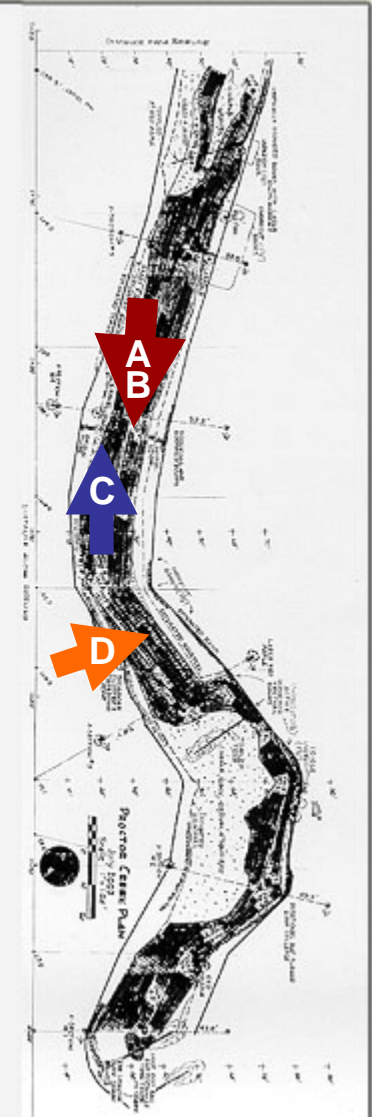
FIGURE 28: Proctor Creek Tributary 1996-2003

- “A” 1997 looking DS past TD.
- “B” 2003 looking US past TD toward X4.

- “B” 2003 looking DS past TD. Note leaning trees.
- “D” 2003 Looking at LB above X3.

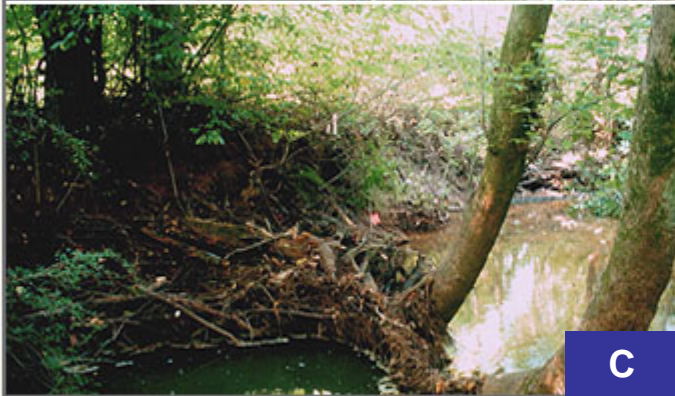
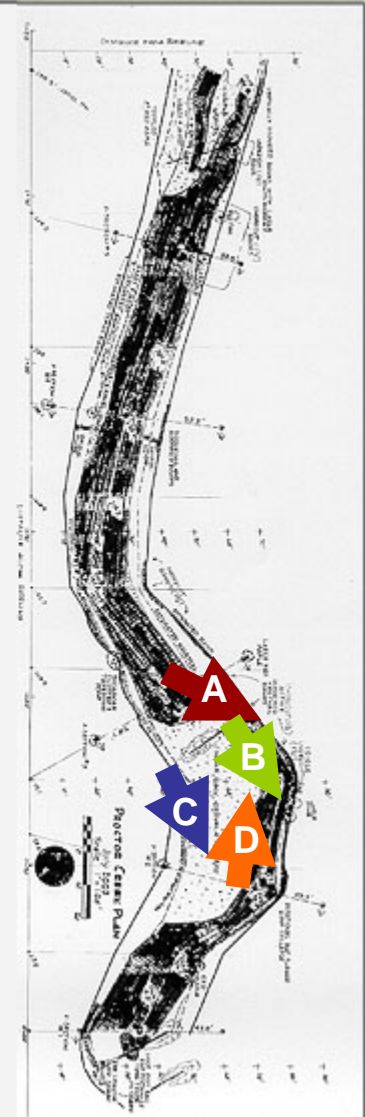
FIGURE 29: Proctor Creek Tributary 1996-2003

- “A” 2003 cobble, rock bed below X3.
- “B” 2003 looking DS @ LB above Sec. 23.
- “C” 2002 looking DS @ twin red maples & debris @ Sec 23.
- “D” 2003 looking US at former site of twin red maples shown in photo “C”.

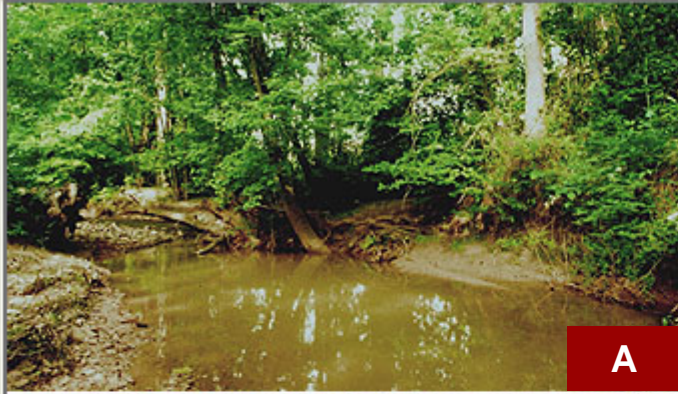
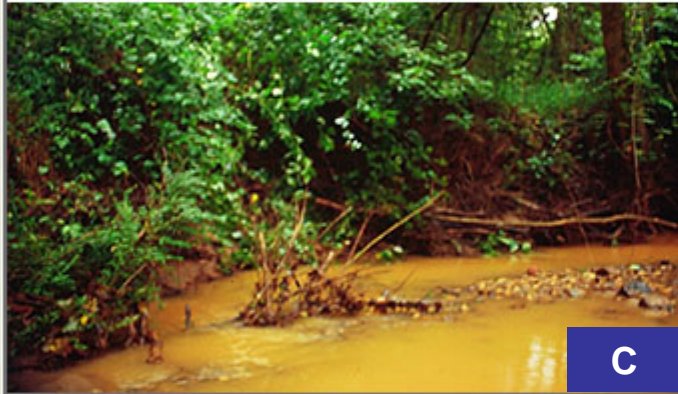
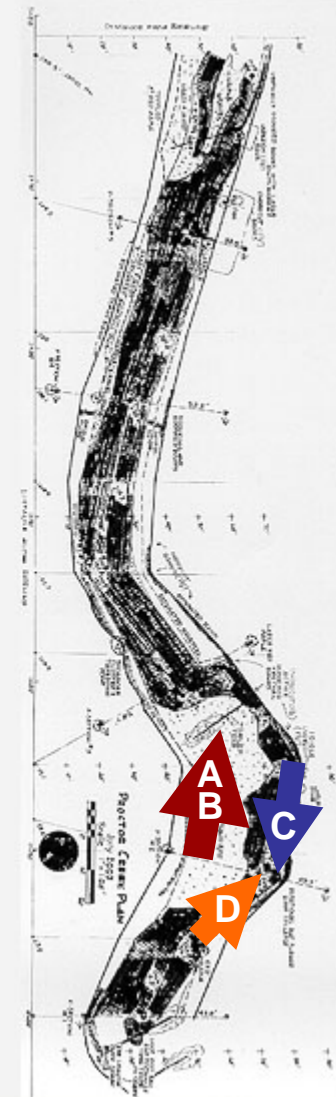
FIGURE 30: Proctor Creek Tributary 1996-2003

- “A” 1996 looking US at traverse log on LB just below X3.
- “C” 1996 looking DS toward LB @ X2.

- “B” 2003 looking US at former site of traverse log shown in photo “A”.
- “D” 2003 looking US toward LB @ X2.

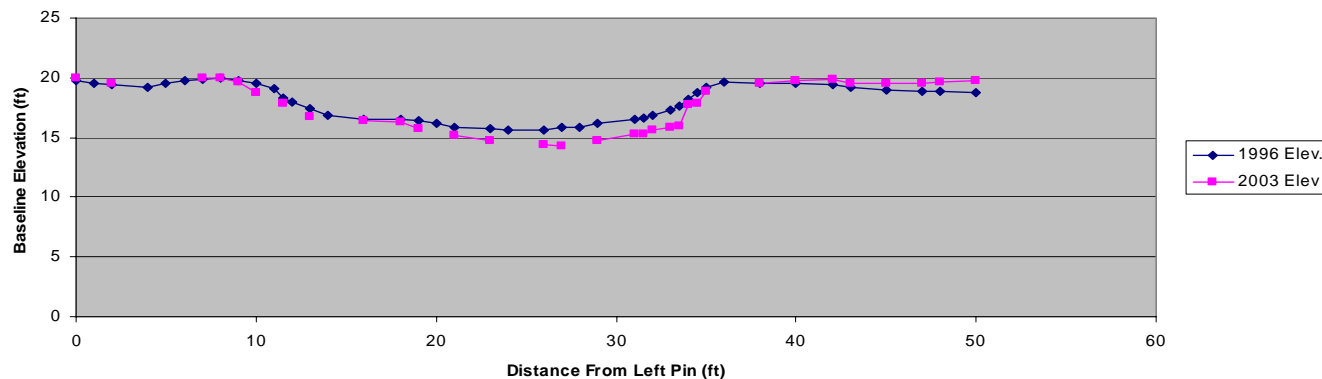
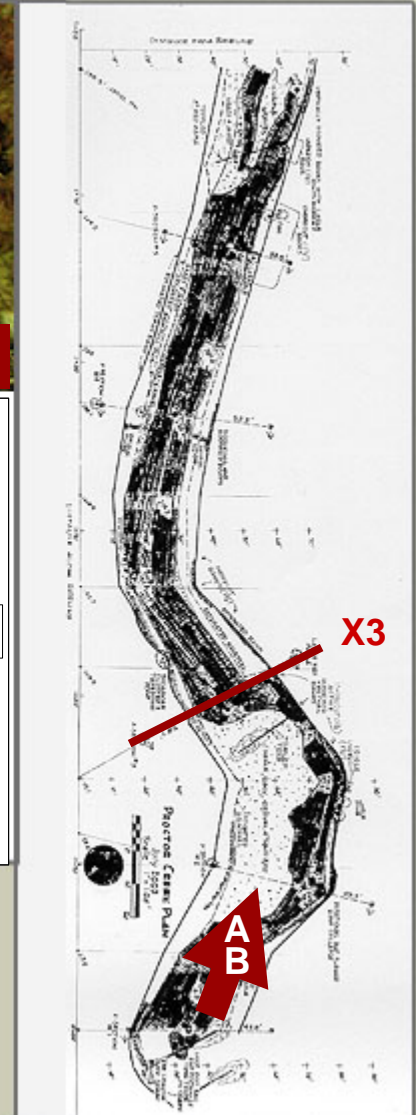
Cross-section 3 Changes: 1996-2003

- Photo "A" 1996 looking US past Red Maple on LB.
- Photo "B" 2003 looking US past Red Maple on LB.
- Major changes in X3 were an up to 1.5' degradation of the right channel bed (left on the map) & 72% increase in bankfull area from 28.5 to 49.1ft².

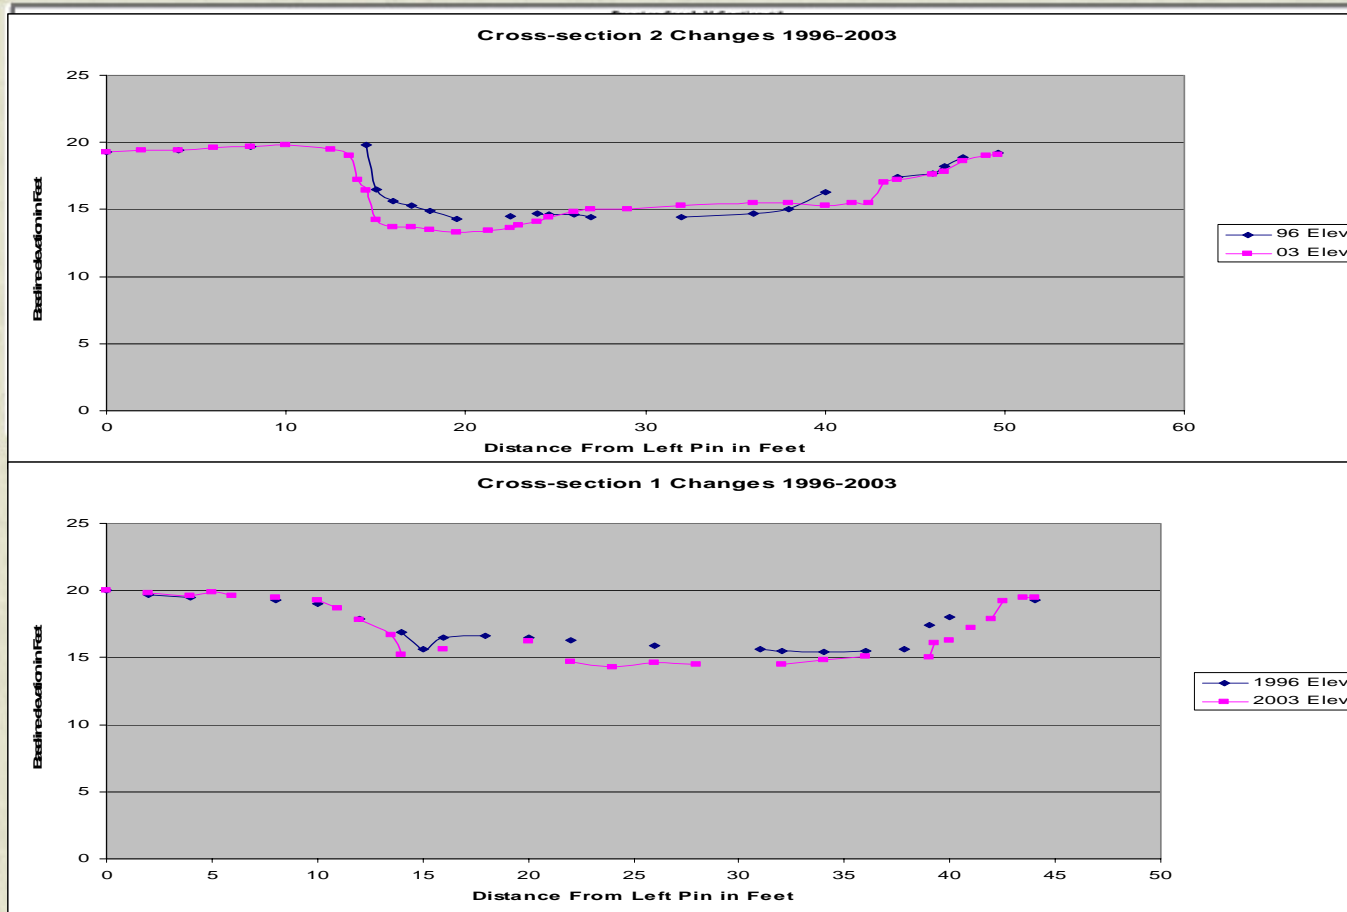
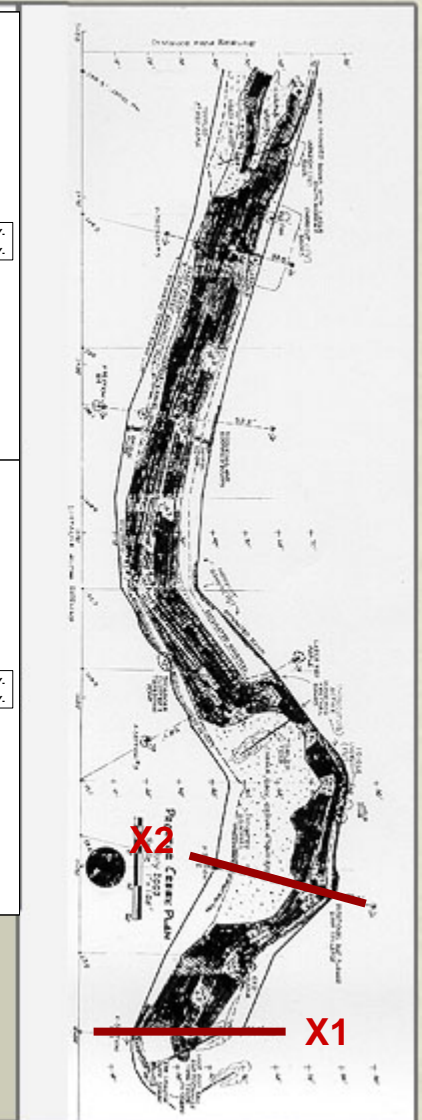
FIGURE 33: Proctor Creek Tributary 1996-2003

Major changes in X2 were a 1'+ recession of the LB, excavation of a scour pool below the LB, up to 1' build-up of the cobble & rock and cobble bed on right side, and a 2'+ recession of the lower RB. Bankfull area increased 105% from 31.9 to 65.4ft². Major changes in X1 an up to 2' degradation of the stream bed and the expansion of the RB by 3 + feet. Bankfull area increased 72% from 29.8 to 51.3ft².

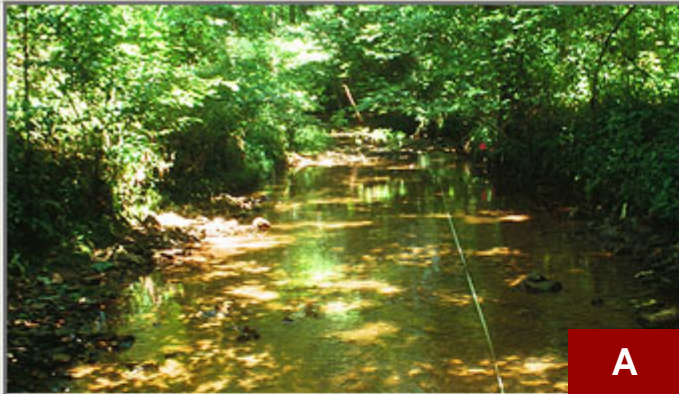
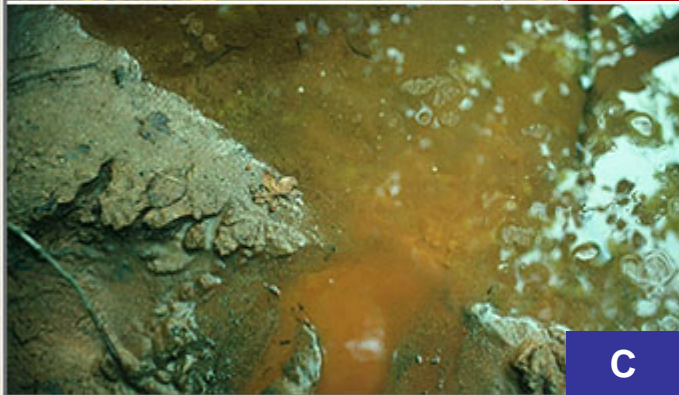
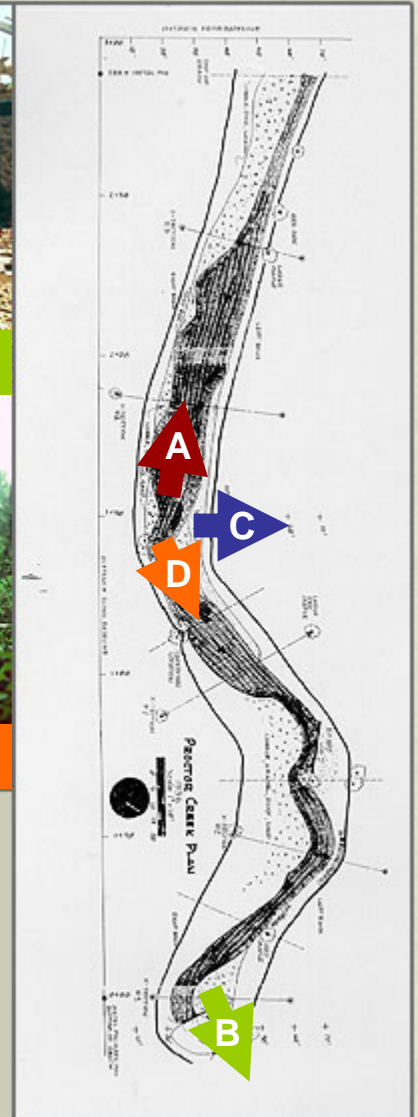
FIGURE 13: 1998 Plan View of Proctor Creek Tributary Sampling Reach

- "A" Looking US past X4 toward TR.
- "B" Construction of new bridge @ Baker Rd. Note ponding.
- "C" Silt deposition on LB opposite TD.
- "D" sycamore cluster @ TD leaning into stream, indicating undercutting.

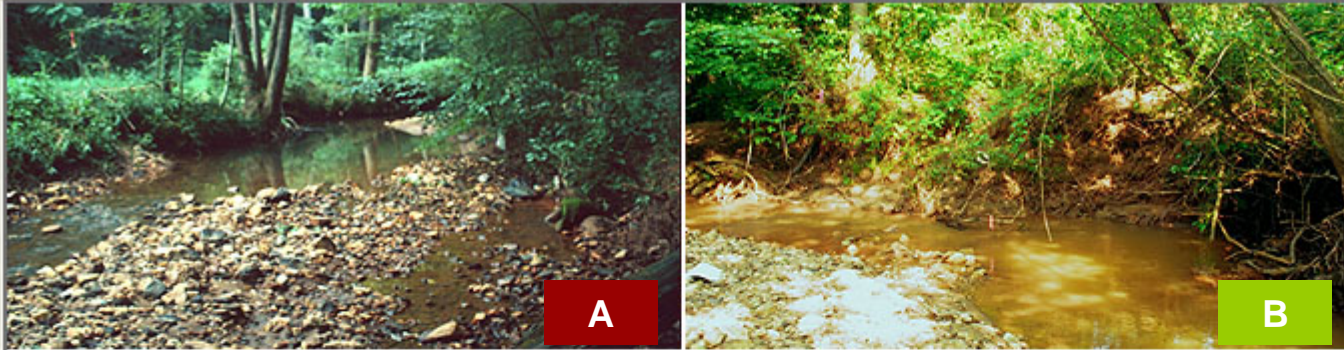
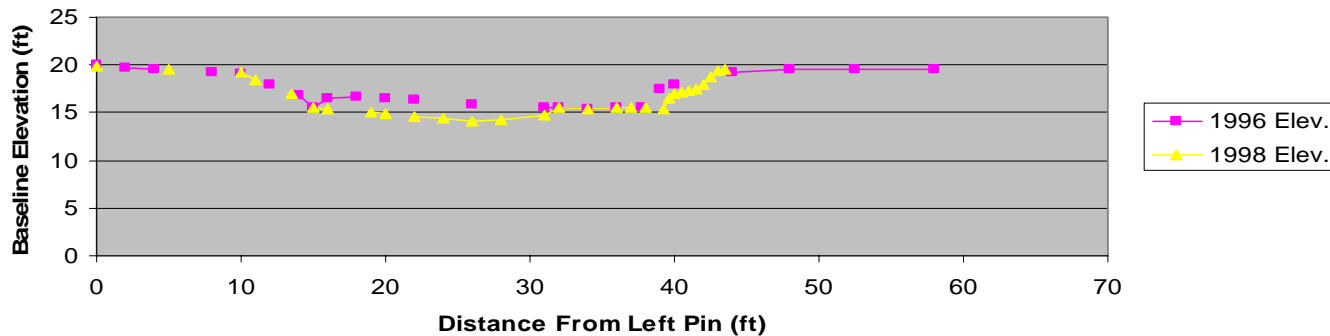
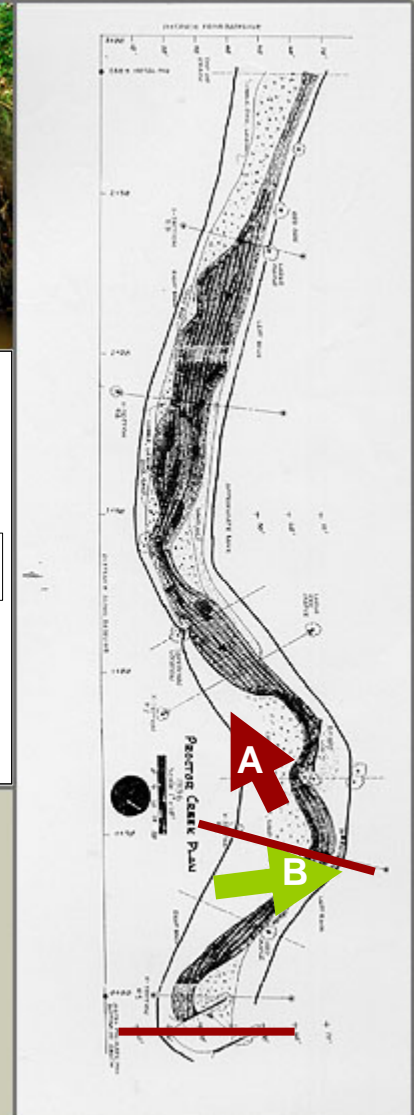
Cross-section X1: 1996-98

- The mean bankfull area of the four cross-sections increased 32 ft² to 41.2 ft² (29%) from 1996-98.
- The largest increases were for X1 and X2, respectively, 74% & 36%.
- The increase in the area of X1 (above) due primarily to bed degradation.
- The increase at X2 (Photo "B" above) due primarily to bank erosion & excavation of a deep scour pool below the outside (LB) bank.

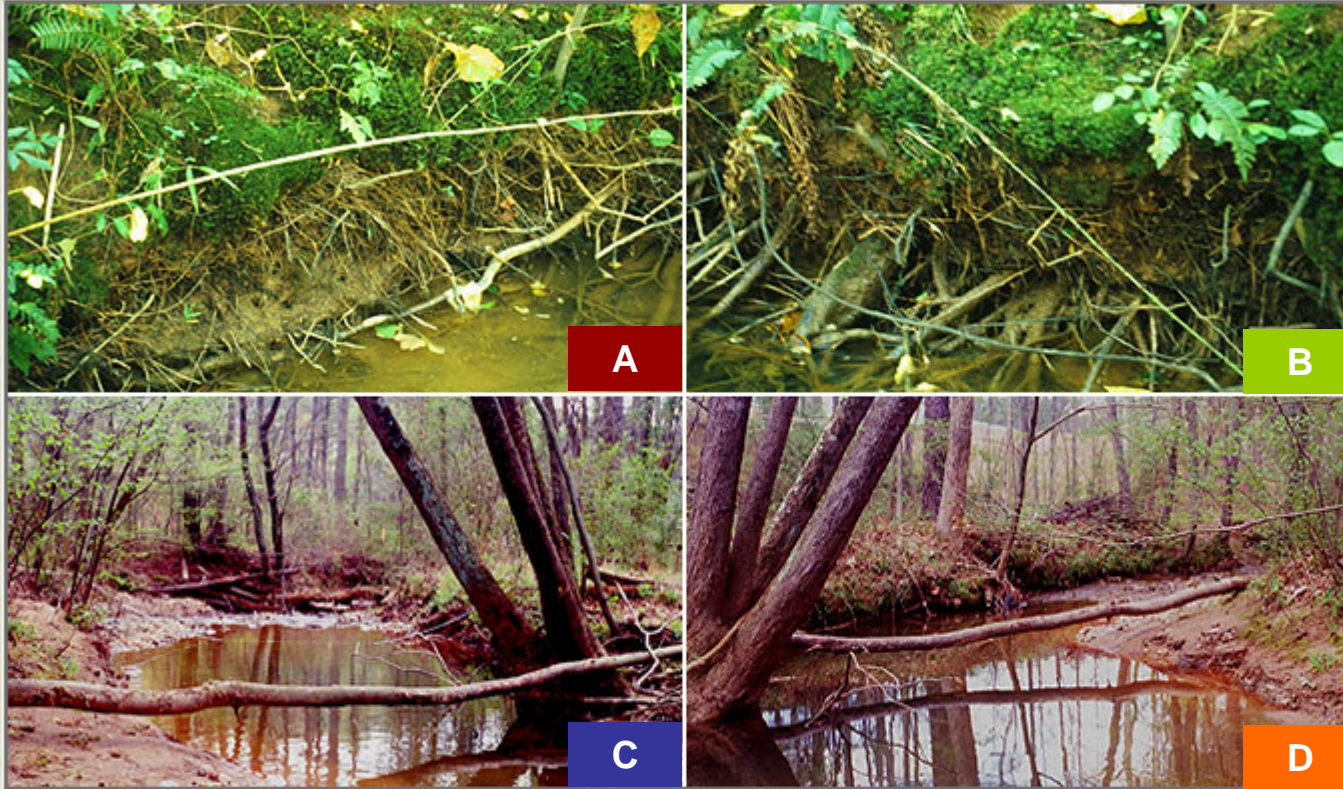
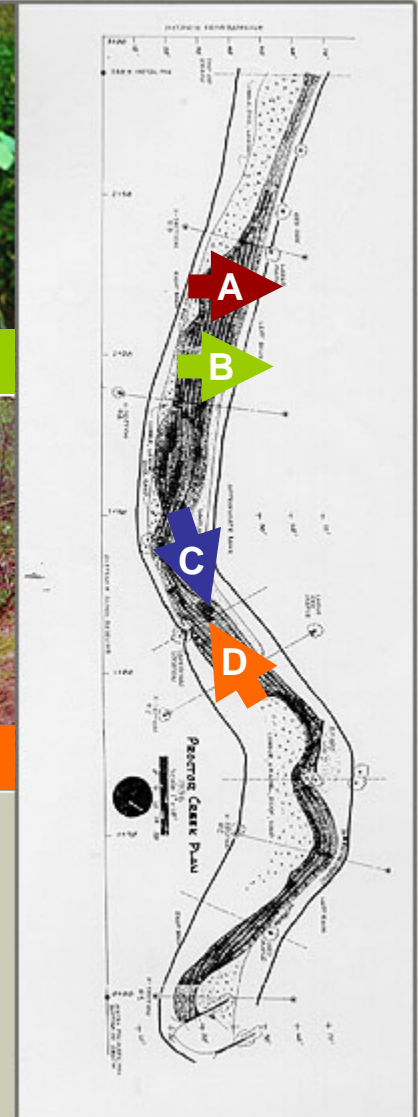
FIGURE 17: Proctor Creek Tributary 1998-2000

- “A” new scouring of LB between TR & X4. Note exposed white roots.
- “C” looking DS past TD toward X3 and cobble bar.
- “A” new scouring of LB between TR & X4.
- “D” looking US past TD @ leaning sycamore cluster. Note sediment deposition on right.

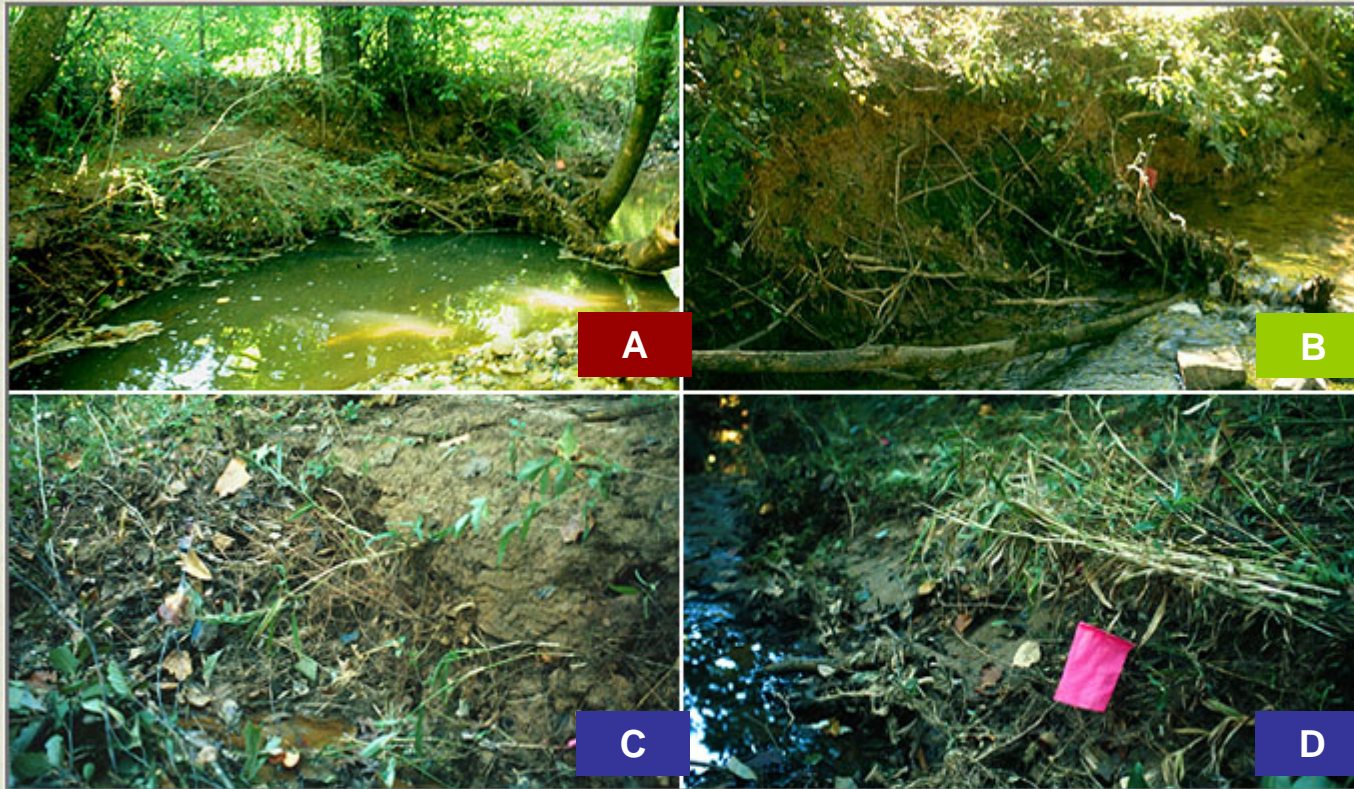
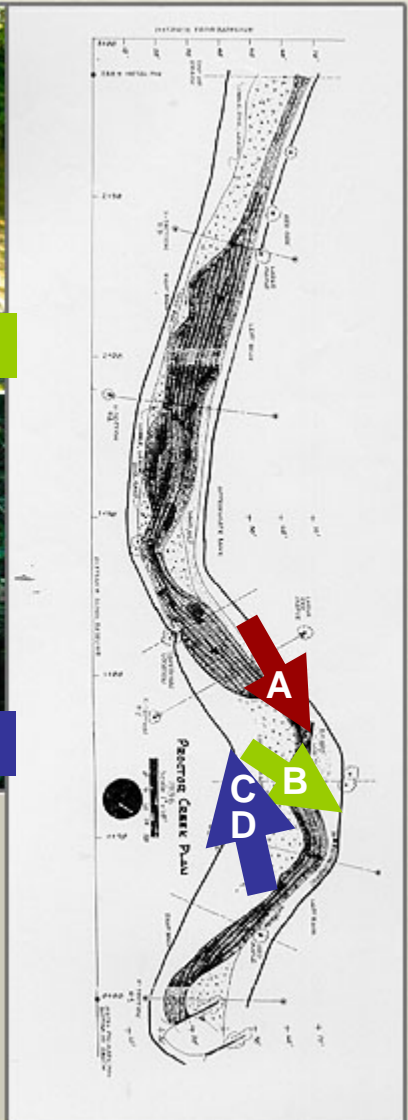
FIGURE 19: Proctor Creek Tributary 1998-2000

- “A” looking DS @ debris pile behind twin red maples.
- “B” undercutting & bank failure @ X2
- “C” Sediment deposition & lower bank scouring of RB @ X2.
- “D” Sediment deposition & lower bank scouring of RB @ X2.

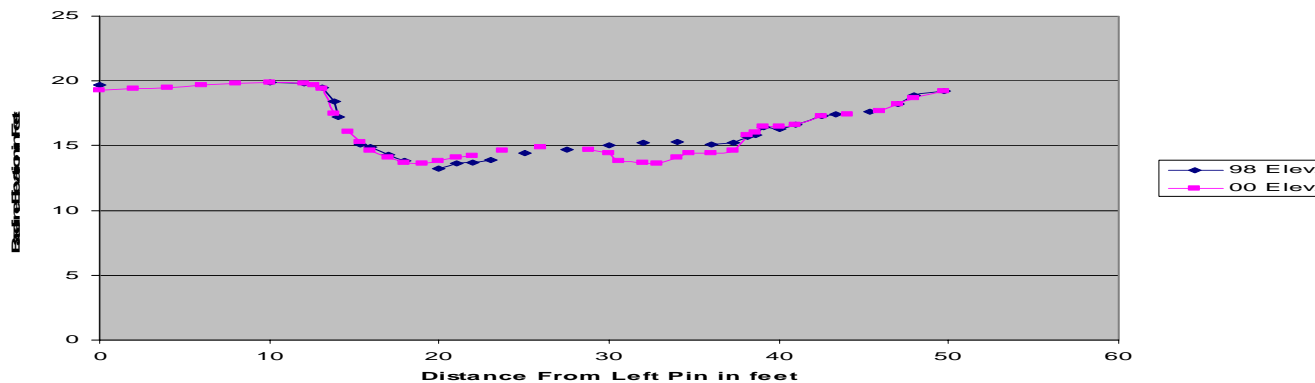
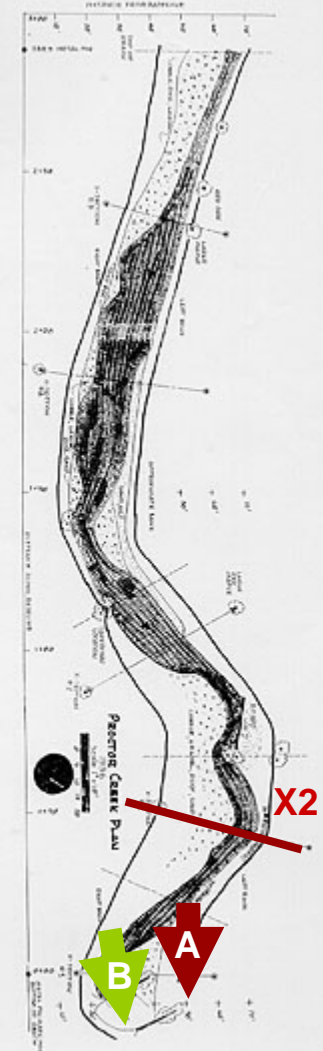
Changes in Cross-section 2: 1996-2000

- Photos "A" & "B" show upstream ponding caused by new bridge @ Baker Rd.
- While the mean bankfull area of the four cross-sections increased but 7% from 1998 to 2000, X1 & X2 both increased by 17%.
- The increase in X2 above was due primarily to a gully in the rock & cobble bar on right side of the stream bed & an increase in the estimated bankfull stage elevation.

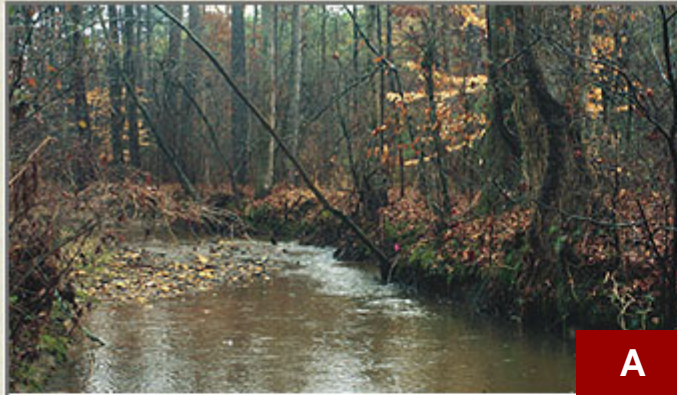
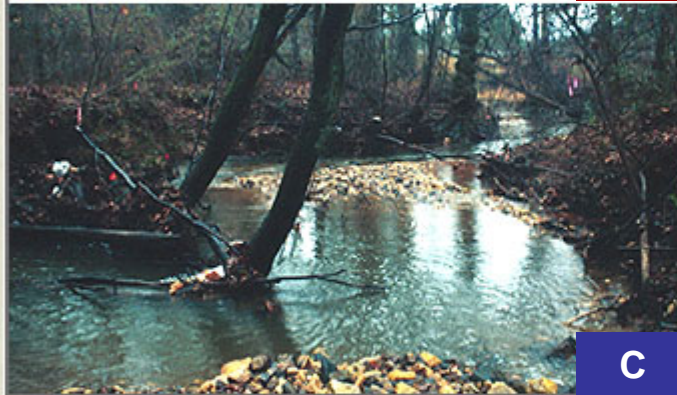
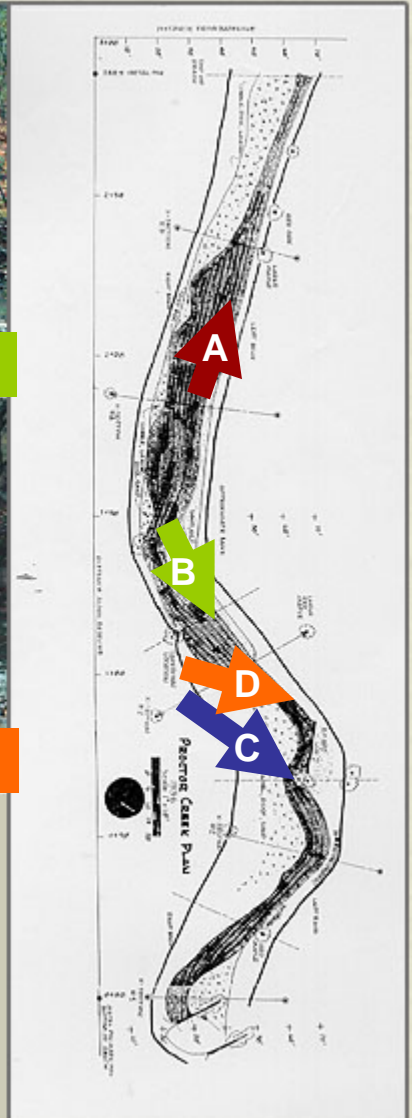
FIGURE 22: Proctor Creek Tributary 2000-2002

- “A” looking US at newly established X-5 & TR.
- “B” looking DS past TD & X3 toward cobble bar.
- “C” looking DS past twin red maples (@ Sec 23) toward bottom of reach (Sec. RM).
- Heavily scoured & undercut LB above twin red maples (on right side of photo).
