EVALUATION OF THE LONG-TERM IMPACTS OF URBANIZATION ON A PIEDMONT HEADWATER STREAM:

A Comparison of Physical, Biological and Chemical Indicators of Response

Ted Mikalsen

Robert L. Bourne

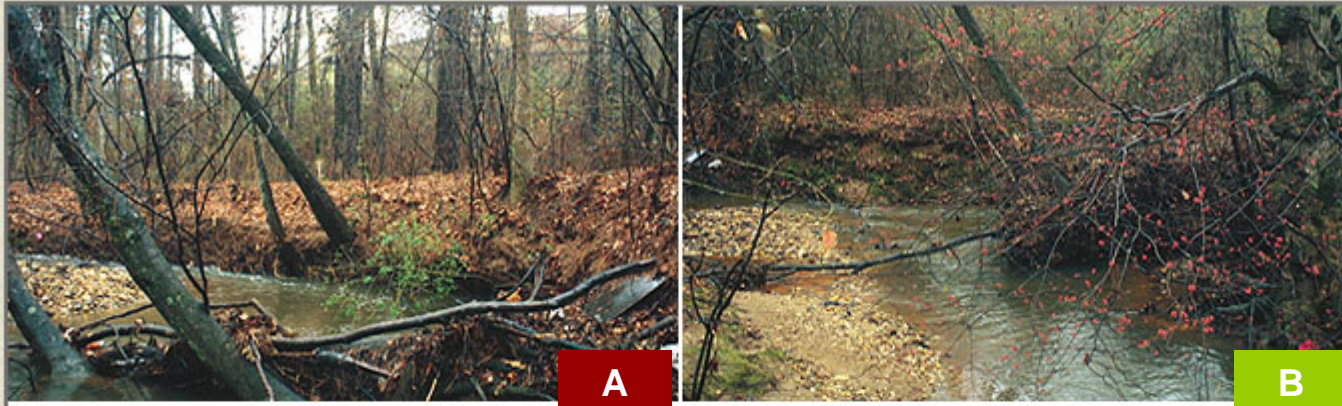
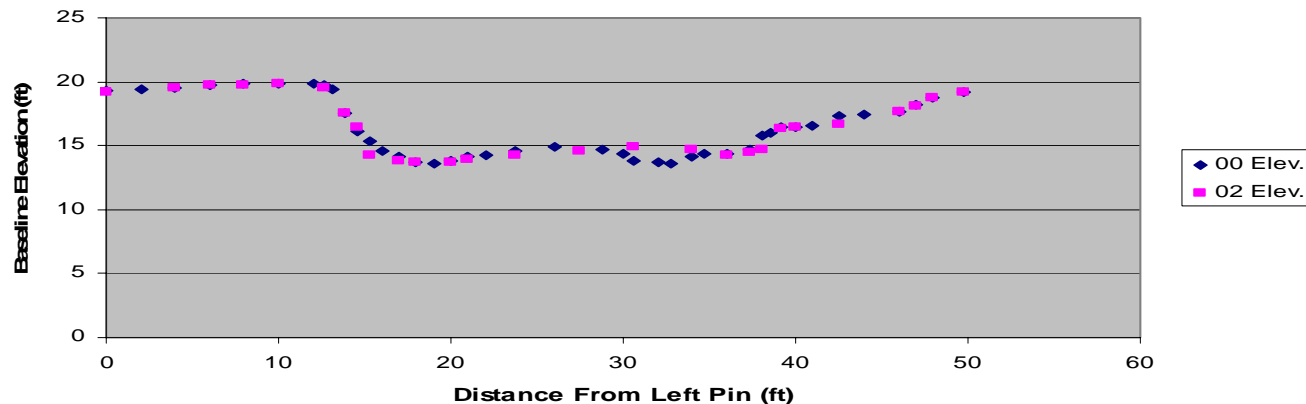
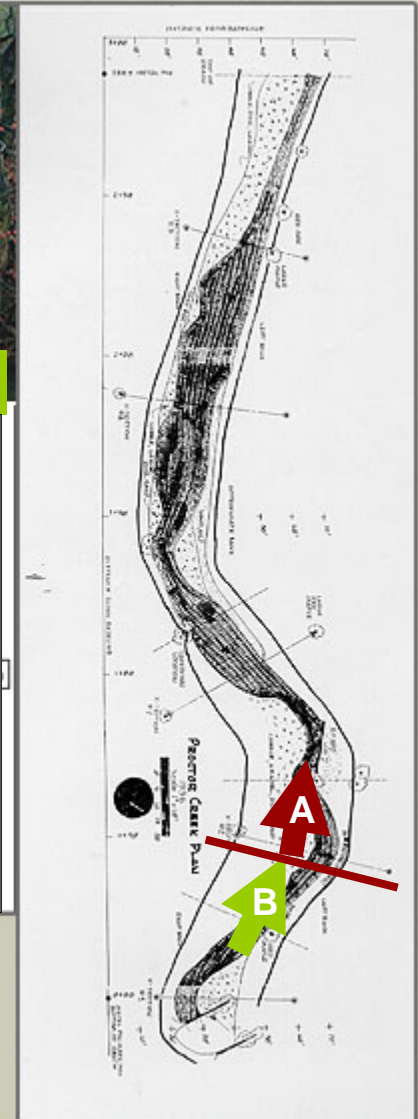
Cross-section 2 Changes: 2000-2002

- Photo "A" shows remaining debris behind twin red maples, which had diverted moderate flow. Photo "B" shows building rock and cobble bed below X2.
- While little change in the mean bankfull area from 2000-02, X2 did incur a 10 sq. ft. increase in bankfull area, due to continued erosion of the outside bank, the scour pool, & erosion of inside bank.

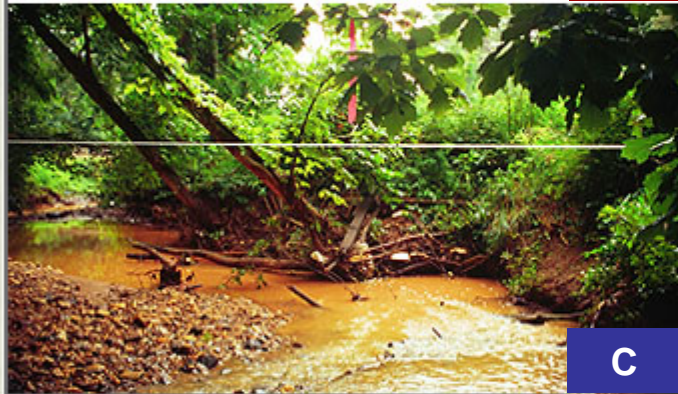
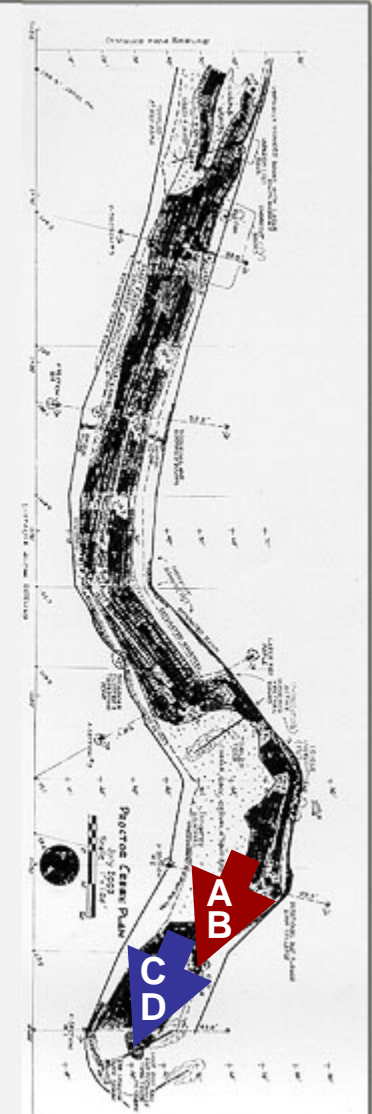
FIGURE 31: Proctor Creek Tributary 1996-2003

- “A” 1996 looking DS past Red maple on LB toward X1.
- “B” 1996 looking DS at X1.

- “B” 2003 looking DS past red maple on LB toward X1.
- “D” 2003 looking DS at X1. Note ponding.

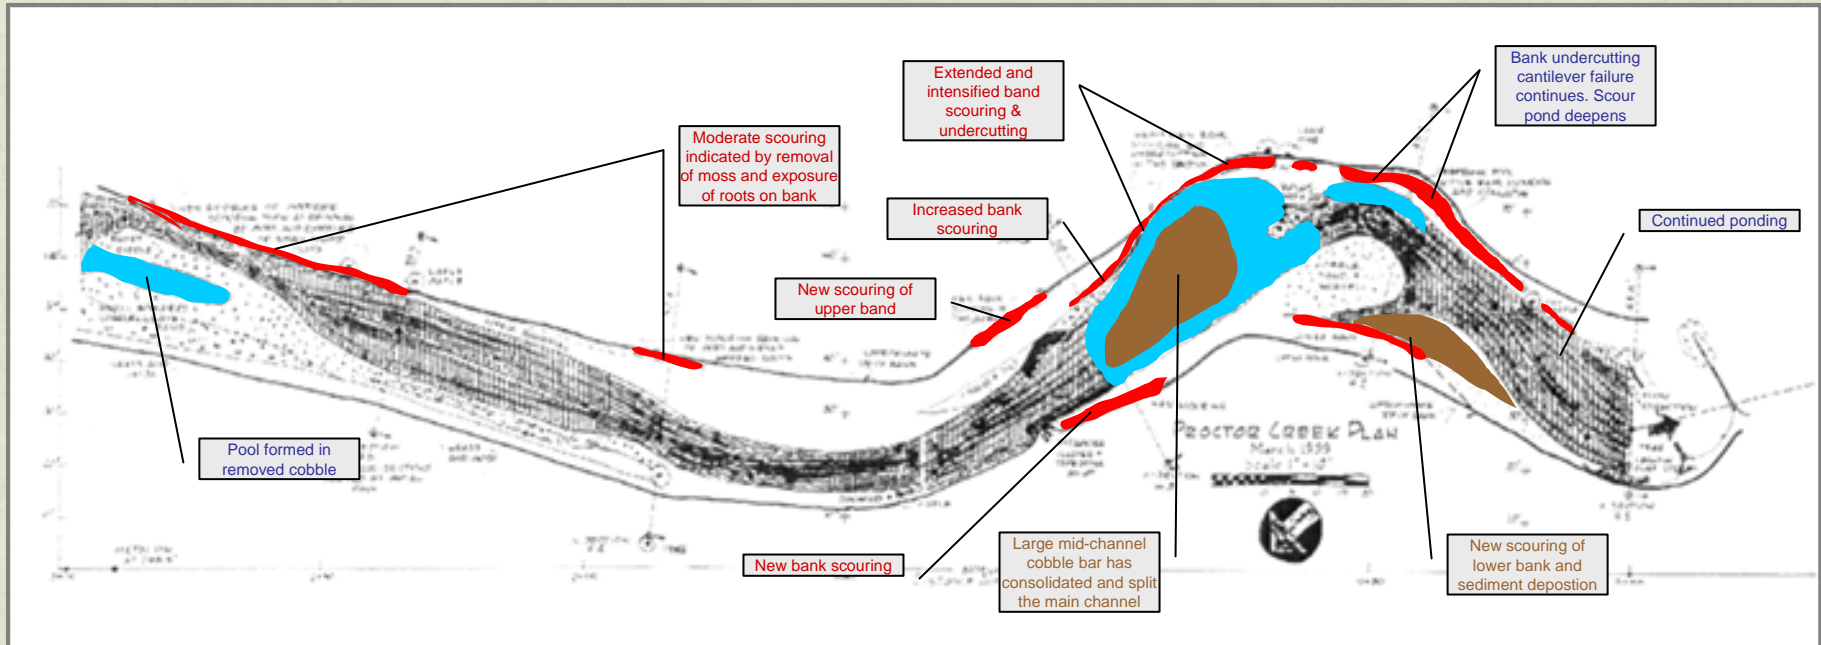
FIGURE 16: 1999 Plan View of Proctor Creek Tributary Sampling Reach

- Moderate bank scouring (indicated by removed moss and exposed roots) began on LB from TR to X4.
- Moderate bank scouring on both banks above X3.
- A large mid-channel cobble bar consolidated below X3 and diverted main channel flow through riffles adjacent to the LBb & RB.
- The LB below X3 & adjacent to cobble bar has been heavily scoured and undercut. (3 of 4 bank pins installed in 1998 washed away . Remaining pin reveals 0.45 ft erosion of the bank.
- Transverse log above Sec. 23 was removed & high flows scoured the upper bank behind the protruding twin red maple trees. The peninsular behind twin red maple trees has been reduced to a narrow pile of woody debris.
- Undercutting and cantilever bank failure continue on the LB at X2 & scour pool has deepened.
- The lower RB above and below X2 has been heavily scoured & new sediment is accumulating below X2.

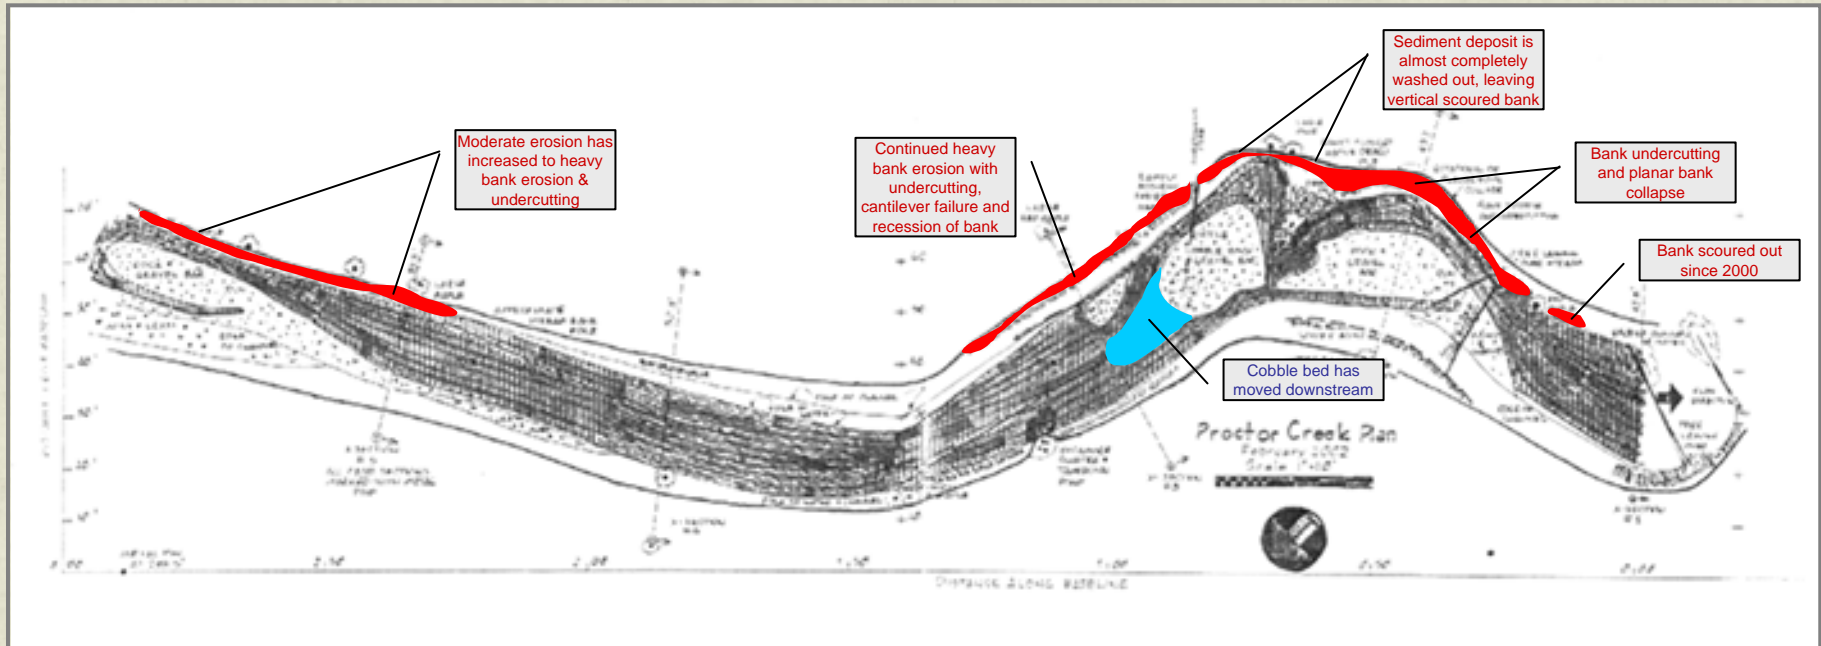
FIGURE 21: 2002 Plan View of Proctor Creek Tributary Sampling Reach

- The moderately scoured LB above X5 was now become heavily scoured and undercut.
- The moderately scoured LB above and below X3 was now receding due to undercutting & bank collapse.
- The mid-channel cobble bar below X3 had migrated DS.
- The LB at Sec. 23 has been scoured to vertical. The tip of the peninsular behind the protruding twin red maples remained a narrow pile of woody debris.
- Severe bank erosion, undercutting, and cantilever failure continued on the outside bend (B) above and below X2.
- The LB below the Red Maple was scoured out.
