Challenges in Evaluation of Structural BMP Efficiency

- Woodside Avenue Extended Detention Basin
- Lakeside, CA

- McClellan-Palomar Airport Tarmac Expansion
- Carlsbad, CA

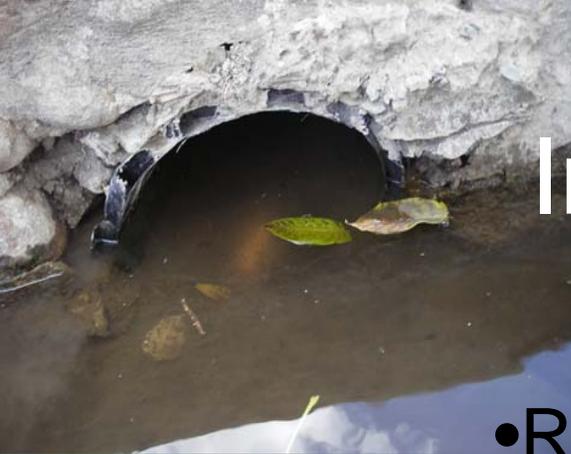
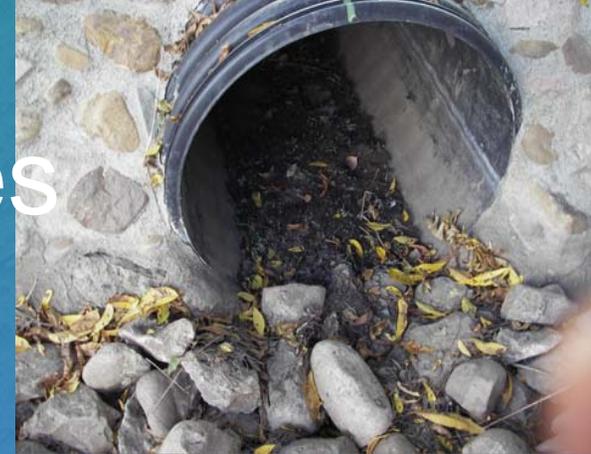
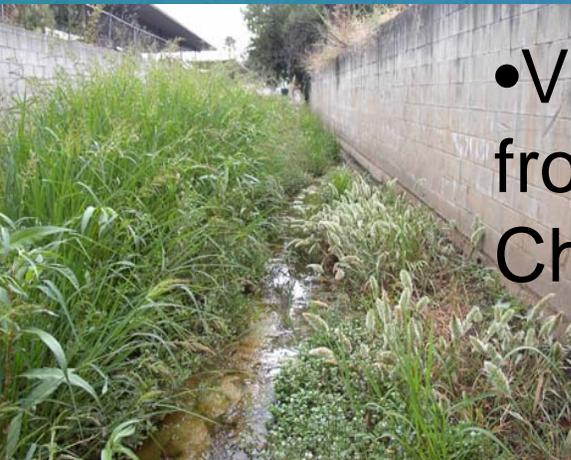
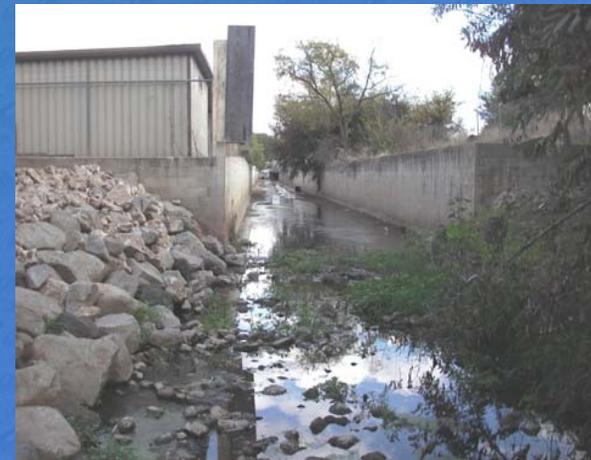
Installation Issues

- Rip-Rap was Lowered
- Effluent Channel was Raised to Grade
- Vegetation was Cleared from the Primary Influent Channel

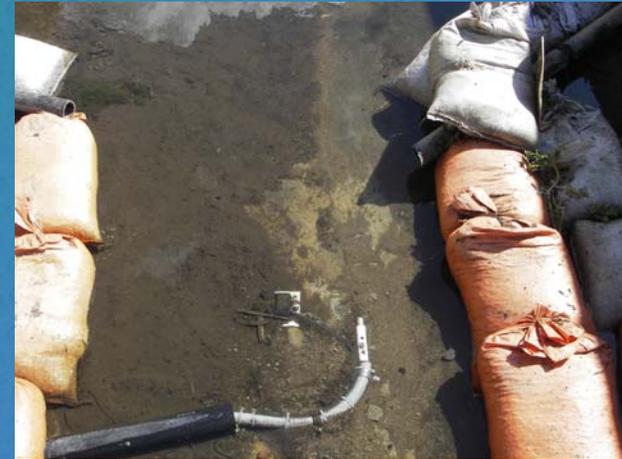
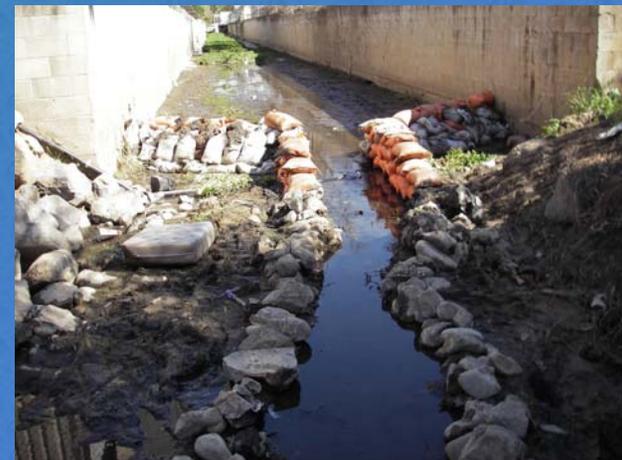
Primary Influent Installation

- Sand bag flume was ineffective despite strengthening it several times
- Trash and large vegetative mats repeatedly destroyed the flume
- Sand bags were removed
- High sedimentation and vegetative growth still complicated this monitoring station

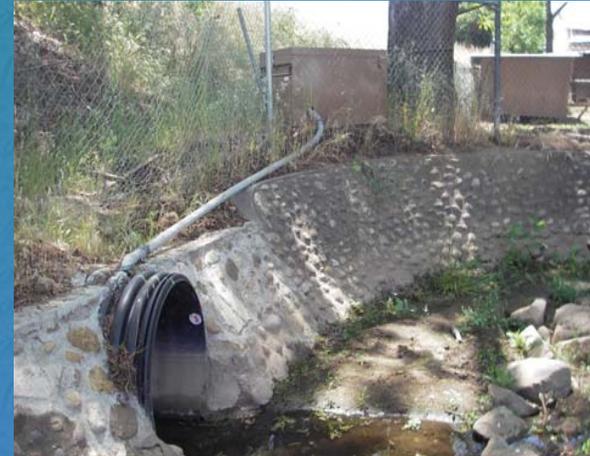
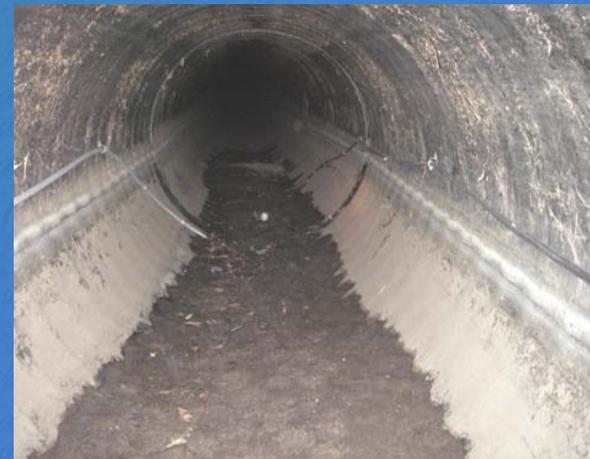
Secondary Influent Installation

- Low angle of pipe and Rip-Rap in front of bottom reach necessitated installation of equipment further into pipe than originally planned

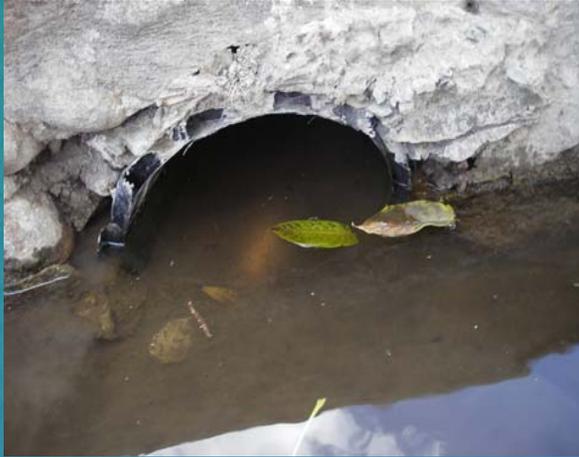
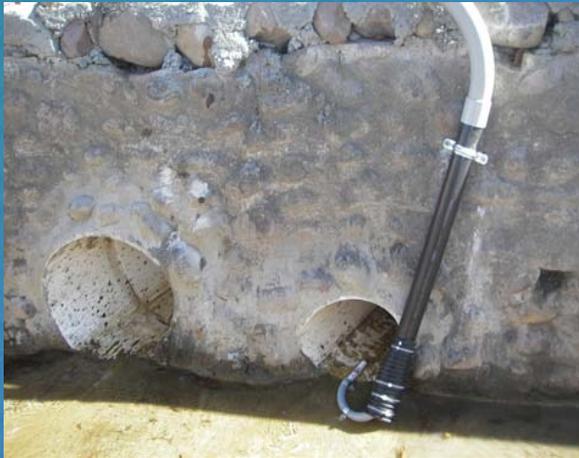
Effluent Installation

- Effluent channel was graded incorrectly following construction of the basin. Following correction of the grading monitoring equipment was installed as originally planned
- However, an emergency bypass was added to the spillway
