A BROAD LEVEL CLASSIFICATION SYSTEM FOR DAM REMOVALS

Laura Wildman, P.E., Ecological Restoration Engineer, Princeton Hydro, LLC, New England Regional Office, 20 Bayberry Road, Glastonbury, CT 06033, 860-652-8911, lwildman@princetonhydro.com; James MacBroom, P.E., Vice President, Milone & MacBroom Inc, 99 Realty Drive, Cheshire, CT 06410, 203-271-1773, jimm@miloneandmacbroom.com

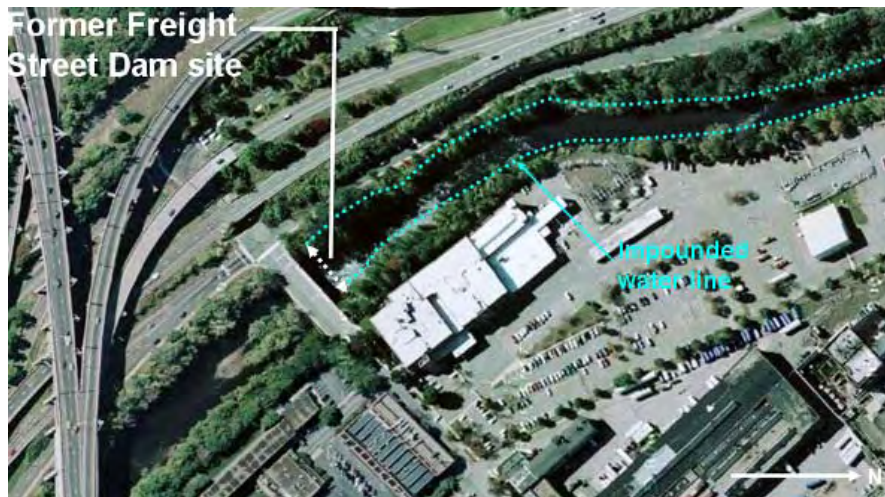
Figure 2 Freight Street Dam site 10 years post removal.

There was little to no sediment impounded behind the Freight Street Dam, and during the dam removal, the site was excavated an additional 3 feet so that the crushed concrete from the dam could be disposed of on site. The crushed concrete fill was then topped with large rounded cobbles, typical of the river bed both upstream and downstream of the dam. The impoundment was minimal due to the low head of the dam and the fact that the channel width above and below the dam were consistent throughout this reach of the river. Ten years later the site appeared much as it did the day the dam was fully removed. No sediment appeared readily mobile either above or below the dam, and, if it were not for the west abutment that was left in place, most observers would never guess that there had been a dam at this site (Wildman et al. 2008).

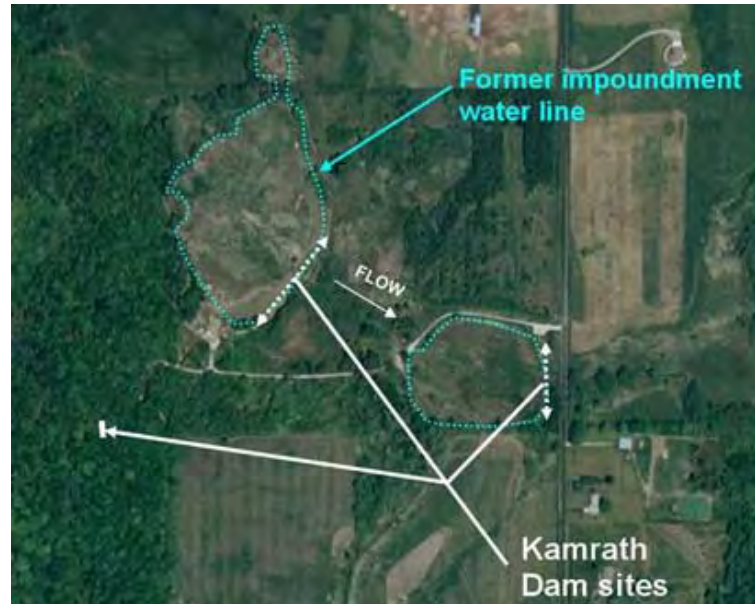
Figure 3 Kamrath Dams site 10 years post removal.

Ten years after the initiation of dam removal there are no obvious signs of bank erosion within the former impoundments and the banks appeared to be very stable. The water clarity was excellent. There were also no signs of persistent deposition below the former dam sites. The site appeared to have fully stabilized (Wildman et al. 2008).

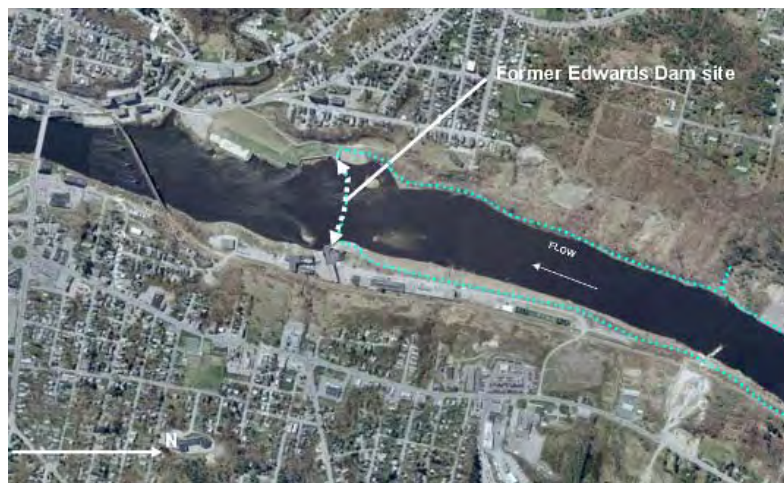
Figure 4 Edwards Dam site 10 years post removal.

There was very little impounded sediment above the Edwards Dam, likely due to the low profile of the dam in comparison to the width of the Kennebec River at the site. This low dam-height-to-channel-width ratio allowed for the scour and transport of the river's sediment load over the crest of the dam. In addition, there are several other dams upstream, also on the Kennebec River, that likely trap a portion of the sediment that would have reached the former Edwards Dam site.

The dam's impoundment was linear and extended upstream 17 miles. The width of the impoundment varied little from the width of the undammed reaches of the river. Therefore, when the dam was removed in 1999, the upstream channel width only reduced slightly, exposing a limited amount of the formerly submerged upstream channel banks.

Ten years later, there were few visible signs of bank erosion within the former 17 mile impoundment. However, directly upstream of the former dam site, there were sections where undercut river banks and sand sediment bars were still evident along the eastern side of the riverbed during periods of lower flow. Signs of dam removal within the former upper impounded reach were minimal. There were no signs of large sediment deposits or islands created below the dam site, and it is likely that the majority of course grained sediment transported downstream through the system and out to the ocean (Wildman et al. 2008).

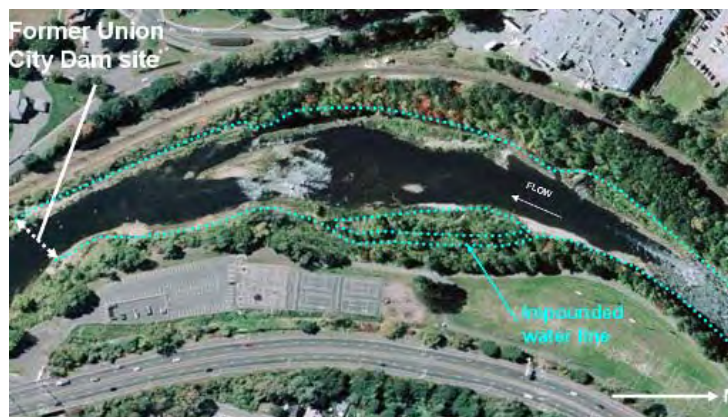
Figure 5 Union City Dam site 10 years post removal.

A portion of the impounded sediment was removed from behind the Union City dam prior to dam removal. However, the remainder of the impounded sediment was allowed to be transported downstream. Little evidence remains of the course grained deposits that were evident downstream of the dam directly after its removal.

The Union City Dam removal project was unique in the fact that, when the dam was removed and the headcut propagated upstream, it encountered a previously unknown and unused pipe encased in riprap that traversed the width of the river. This obstruction created a hydraulic jump that spread the width of the impoundment and created excessive bed degradation below the elevation of the original channel bed. It also temporarily stalled the headcut in this location and created a secondary headcut that then migrated upstream below the elevation of the pre-dam channel bed. This condition was still evident after ten years. The stalled headcut location had become a riffle approximately mid way up the former impoundment length. A deep pool persisted just below the riffle. Large sections of the pipe were fully exposed and

dislodged from their channel bed location. The secondary headcut migrated the length of the impoundment and was in the same location it was three years after the removal. However, the grade change in this location was no longer dramatic and the headcut appeared stable, as a steep gradient cobble riffle. The channel bed upstream of the former impoundment was comprised of imbedded cobbles and therefore further progression of the uppermost headcut would likely only occur under significantly high flow events.

Although we have classified the Union City Dam removal an R3, it also has characteristics of a category RL dam removal, due to the down cutting of the channel below the original pre-dam riverbed grade and the slowly progressing headcut, created by the exposure of the riprap encased pipe that traversed the entire channel width (Wildman et al. 2008).

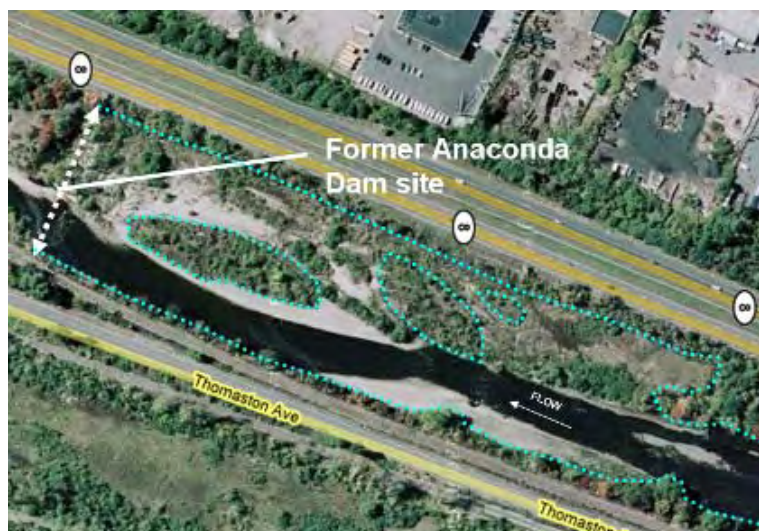
Figure 6 Anaconda Dam site 10 years post removal.

Ten years post removal there were still obvious signs of bank erosion along the western bank of the channel upstream of the former dam site. However, this undercut bank appeared much as it did during a 2003 site visit, and the bank seems to have reached a semi-equilibrium state, even though it was not vegetated down to the water level. The eastern bank of the upstream channel had continued to aggrade since the 2003 observations, with new sand and gravel deposits from upstream, on top of what was initially an undercut bank directly after removal.

Due to the wide nature of the former impoundment much of the impounded sediment remained on site and was stabilized by vegetation on the far western side of what was once a string of vegetated islands in the center of the former impoundment. These islands were created by the coarse grained sediment delta

that formed behind the Anaconda Dam. The delta had progressed from the upstream end of the impoundment to the dam itself. The impounded sediment islands also remained intact upstream of the dam, although the former impoundment was only inundated, as a floodplain, under high flow conditions. Post-removal, a headcut migrated upstream and stalled approximately mid impoundment. A riffle formed in that location and the headcut then proceeded to the upper end of the former impoundment where it appeared relatively stable, ten years post removal. Large coarse grained sand and gravel bars, made up of former impounded sediment, still resided mid-channel and along the riverbanks downstream of the former dam site, and have dissipated little in the last 9 ½ years since the dam was removed (Wildman et al. 2008).

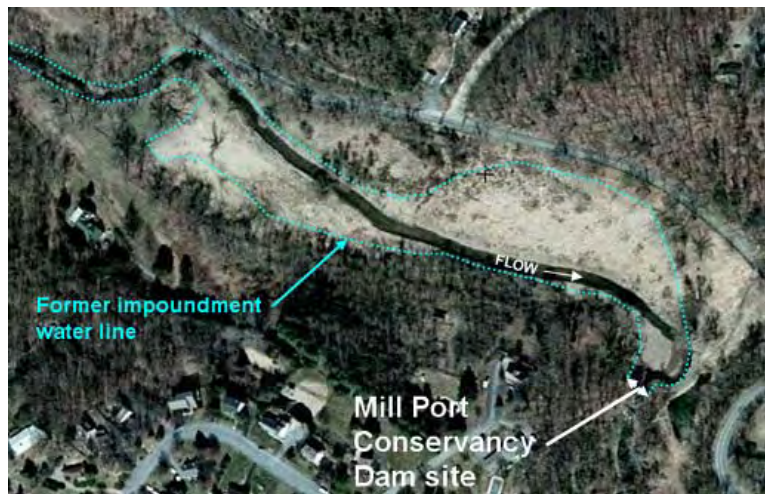
Figure 7 Mill Port Conservancy Dam site 10 years post removal.

The dam was breached in a different location from its likely original channel, causing, in effect, an approximately 3 foot high dam to remain in place. Therefore, much of the impounded sediment is still retained within the former impoundment site, and underlies the current channel bed. The site shows no significant signs of continued down-cutting and head-cutting and is now heavily vegetated. However, if the remaining portion of the dam were to ever breach naturally, the site would likely go through another period of transition and down cutting before it reached its original channel bed elevation. Ten years post removal, the site retained many characteristics of an impounded channel. Some coarser grained material appeared to be depositing on top of the finer grained underlying impounded sediment that still remained within the channel bed. There were some undercut banks, but, otherwise, banks were generally incised with dense herbaceous vegetation along them (Wildman et al. 2008).
