From Control Site to Treated Site: Quantifying Improvements at Walters Creek

Annie Gillespie, *Morro Bay National Estuary Program*
Andrew Schaffner, *California Polytechnic State University*
Anna Halligan, *Morro Bay National Estuary Program*

Morro Bay National Monitoring Program: Paired Watershed Study

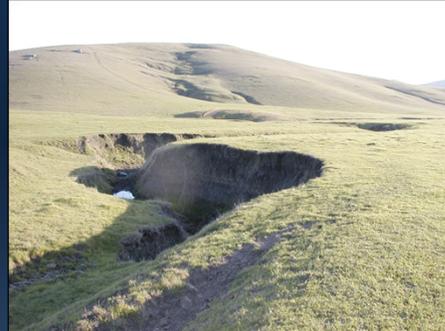
Walters Creek (control)

- Pre-BMP period spanned 1993-96
- Post- BMP period spanned 1997-2001
- Monitoring of rangeland vegetation
- Monitoring of suspended sediment concentration (SSC) and turbidity at Parshall flume stations

The bulk of water quality data collection focused on sample analysis for suspended sediment concentration and nephelometric turbidity at two flume sites that were installed in each watershed. The aim was to detect a significant reduction in annual suspended sediment load, with a target load reduction of 50%.

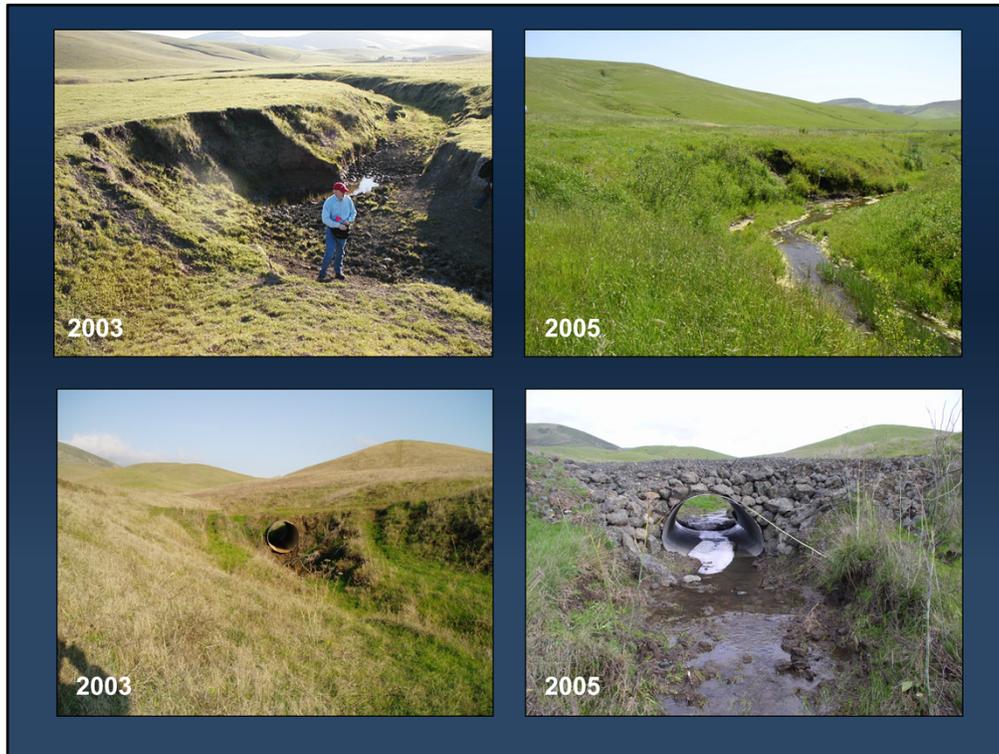
First step of Walters Creek restoration was riparian fencing installed in 2003. Fencing was designed to create a larger riparian buffer and a riparian pasture that is flash grazed seasonally. Includes off-creek water system, network of troughs throughout small pastures.

In Fall 2004, construction started for installation of instream structures, bank grading, and road improvements. In the winter of 04-05 large flows damaged some of the newly installed features, additional work was implemented to repair these bank and gully failures.

Grazing of the riparian pasture was reinstated in 2008, (3yrs after restoration) and during that time vaca cages were installed to protect younger trees. These were very intensive restoration efforts, completed at a greater scale than those applied to Chumash during the NMP.

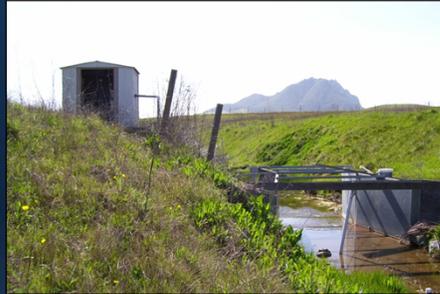
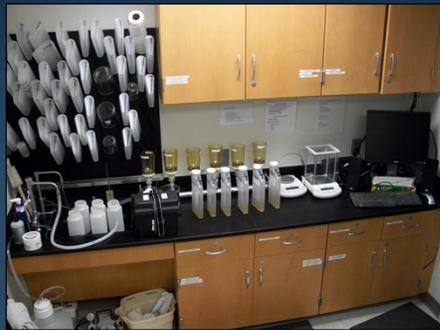
Flume was still intact, sampling gear needed to be repaired and replaced. Opted to not replace the flume as majority of data expected to be within flume sizing capabilities, not targeting load estimates. Flume station was reactivated for sampling in the 2008-09 water year. As indicated by NMP, accessibility proves to be a continuing challenge. Only road to site is off-limits during rain events due to soil type.

Increased the frequency of data collection to capture very dynamic stage conditions: stage height records every 5-minutes, storm event SSC sampling to 30-minute intervals. Currently run sampling equipment off of batteries and solar power.
