**History of Storm Water  
Management Activities and Trends  
in Streamflow and Water Quality,  
Dane County, Wis. 1975-2008**

By W. A. Gebert, W. J. Rose and H. S. Garn

Evaluation of the Effects of City of Middleton Stormwater –Management Practices on Streamflow and Water-Quality Characteristics of Pheasant Branch, Dane County, Wisconsin, 1975-2008.

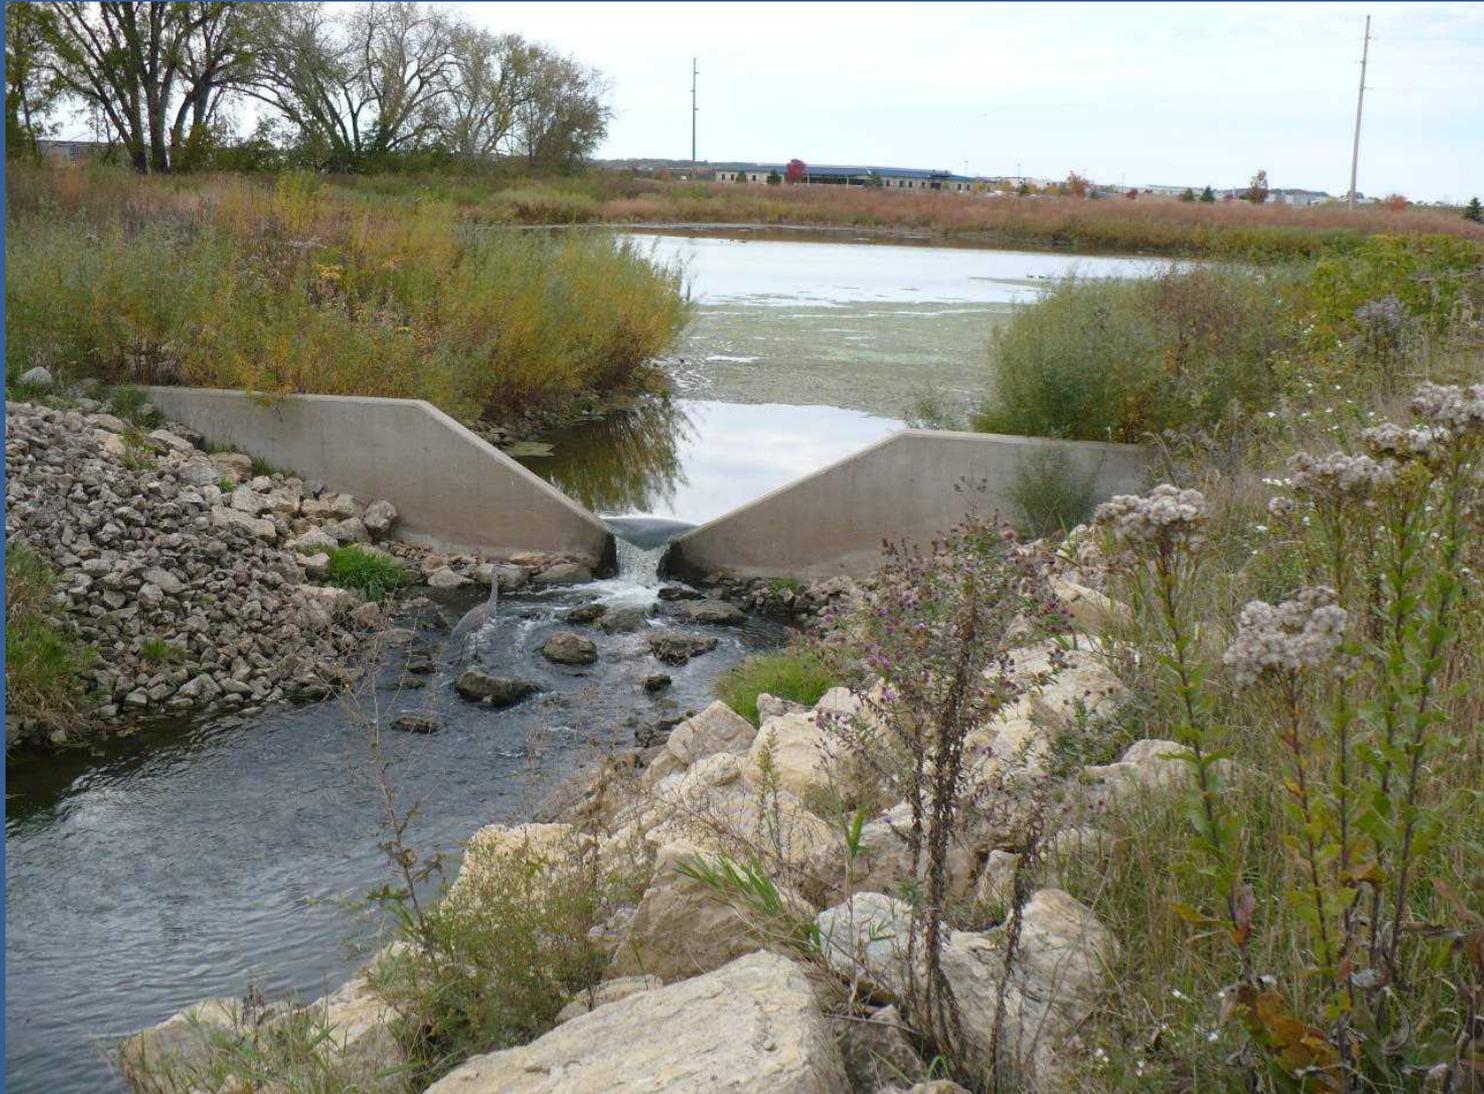
# Confluence Pond on Pheasant Branch with V-notch weir outlet structure

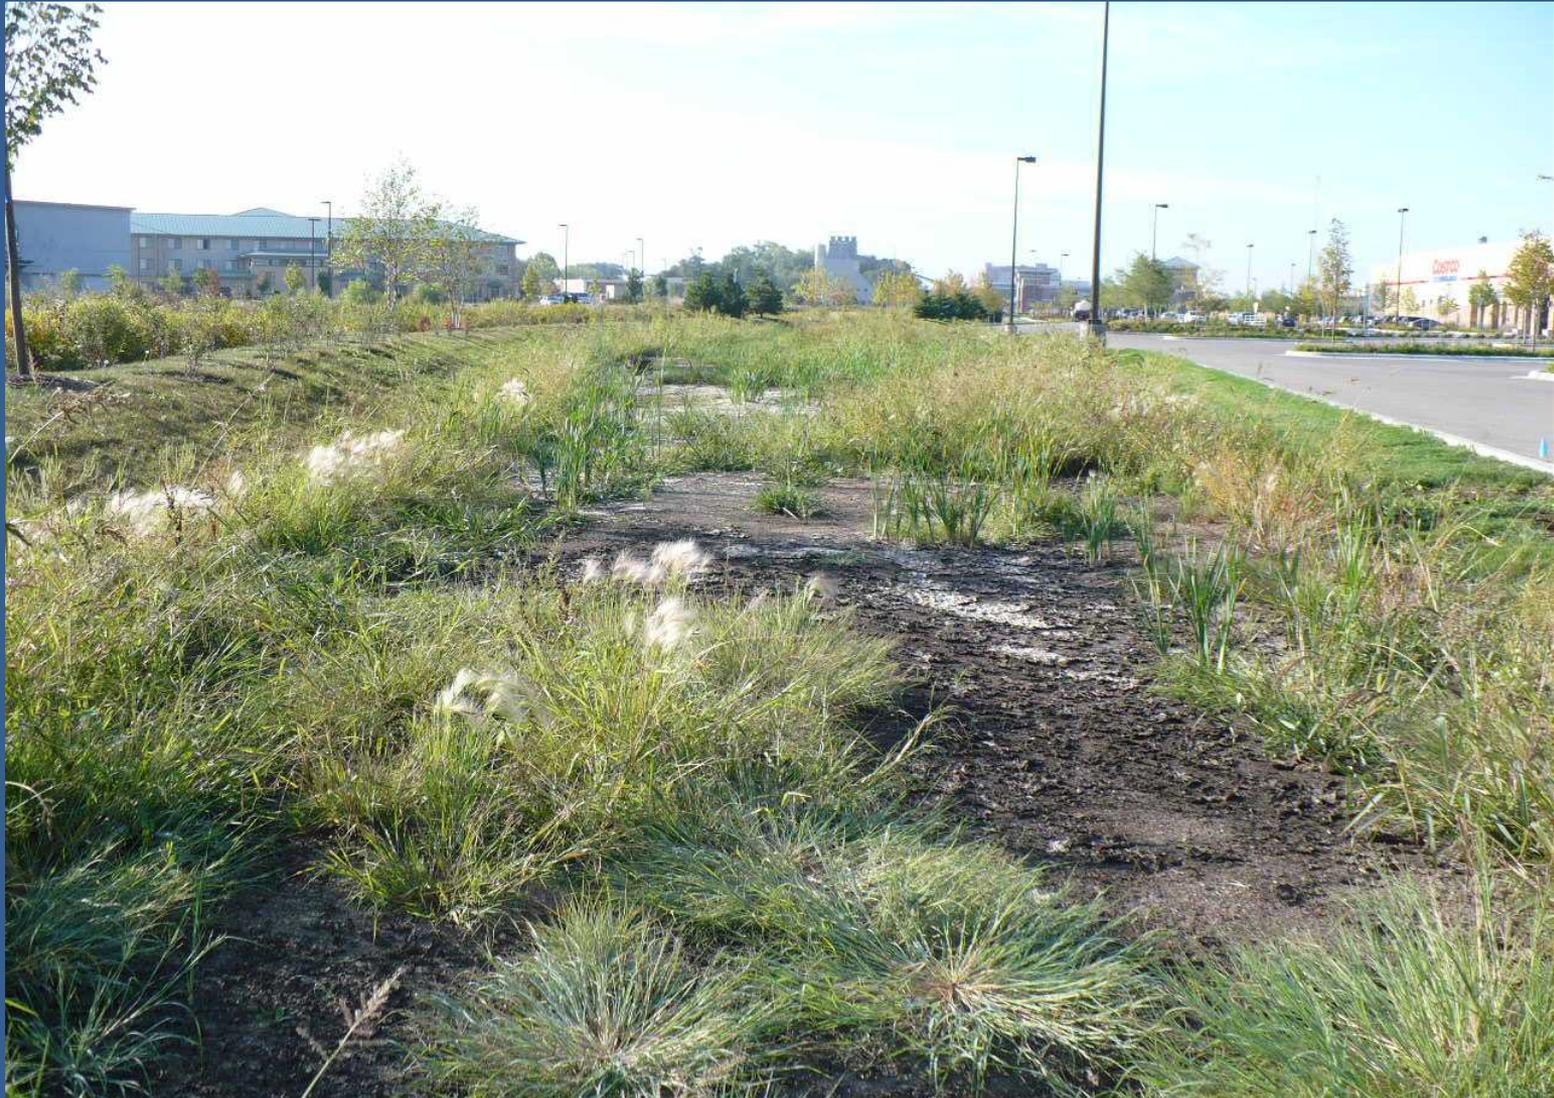
# Bioretention Basin at commercial parking lot

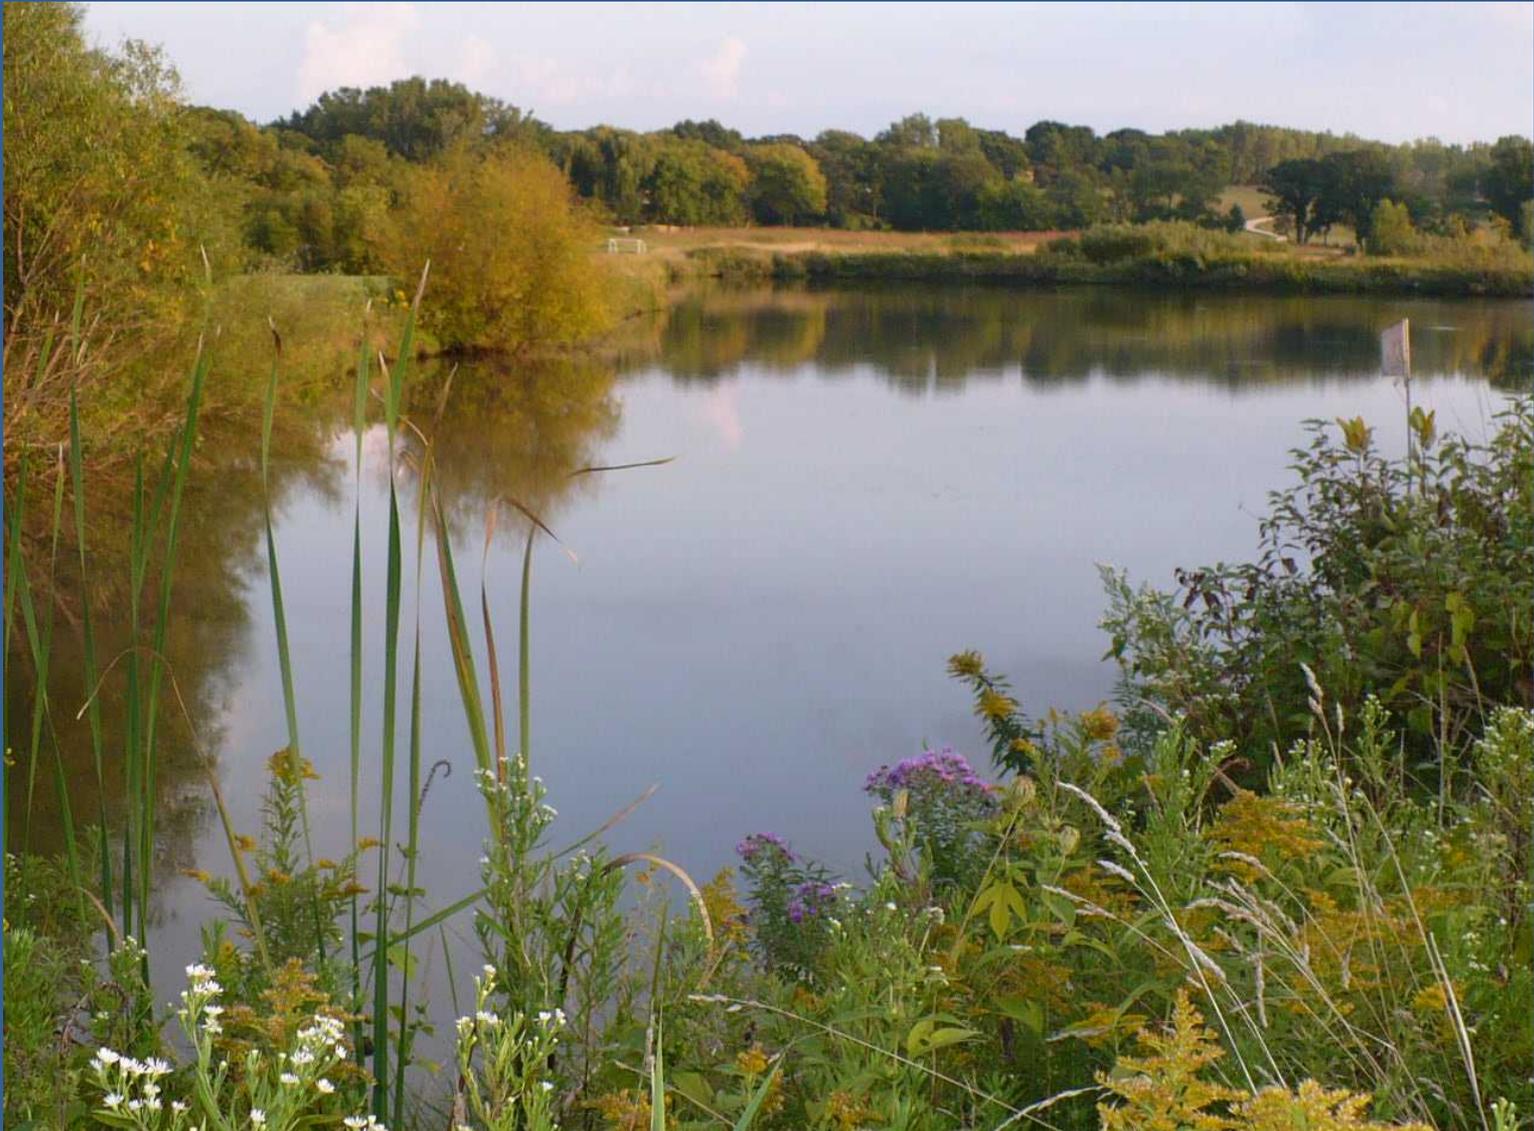
# Water Quality Retention Basin at North Lake Subdivision

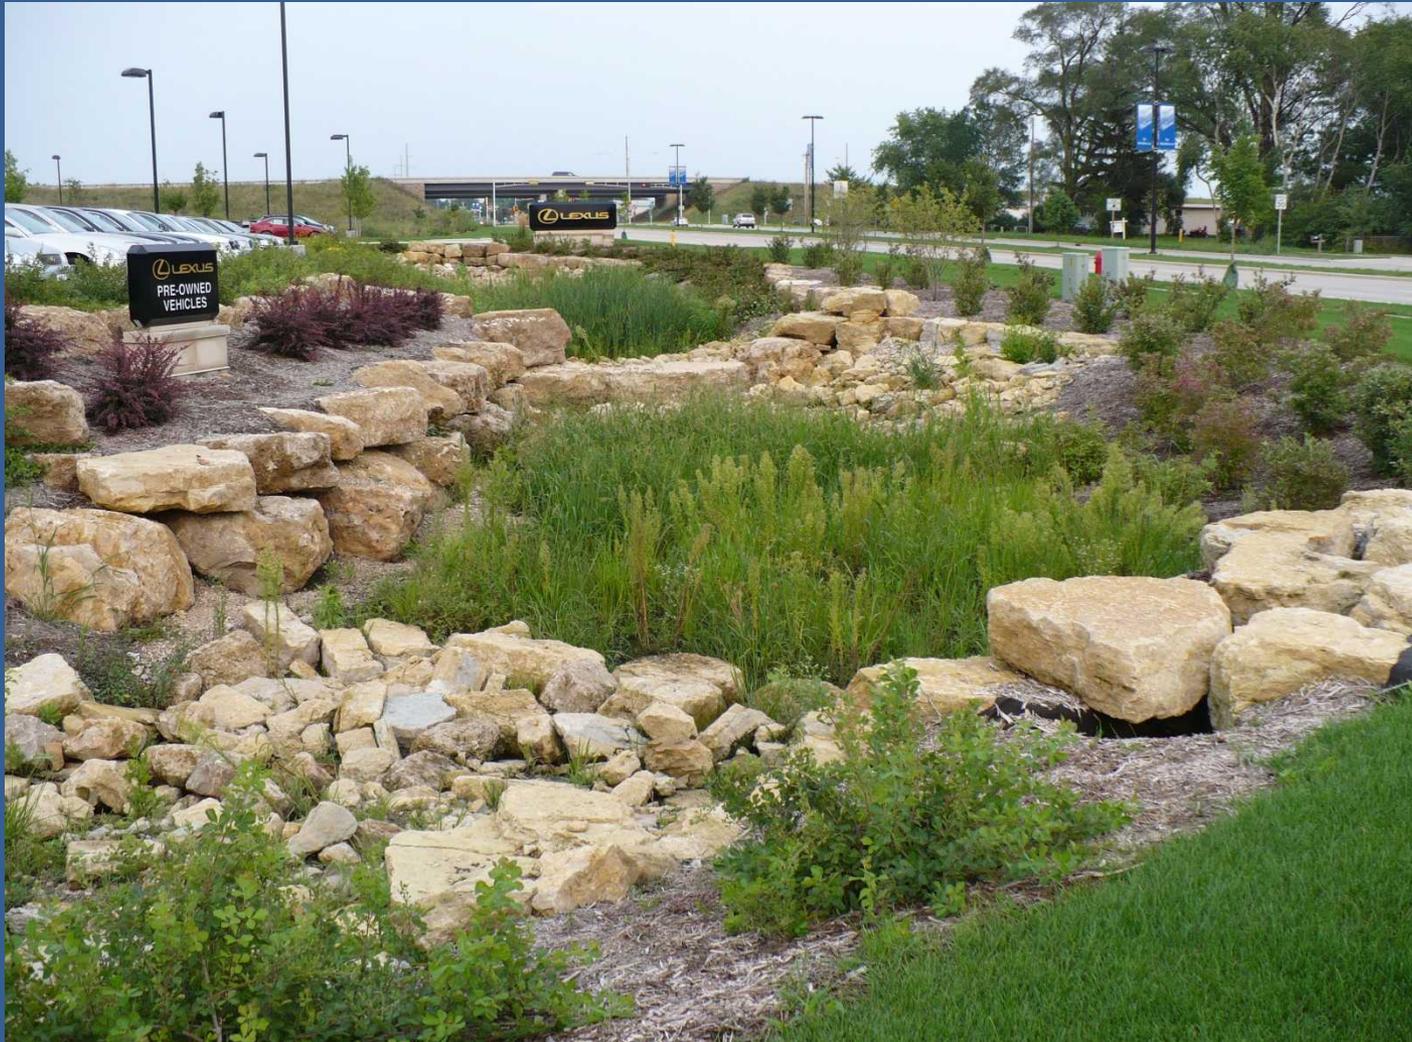
# Rain garden at car dealership on Airport Road

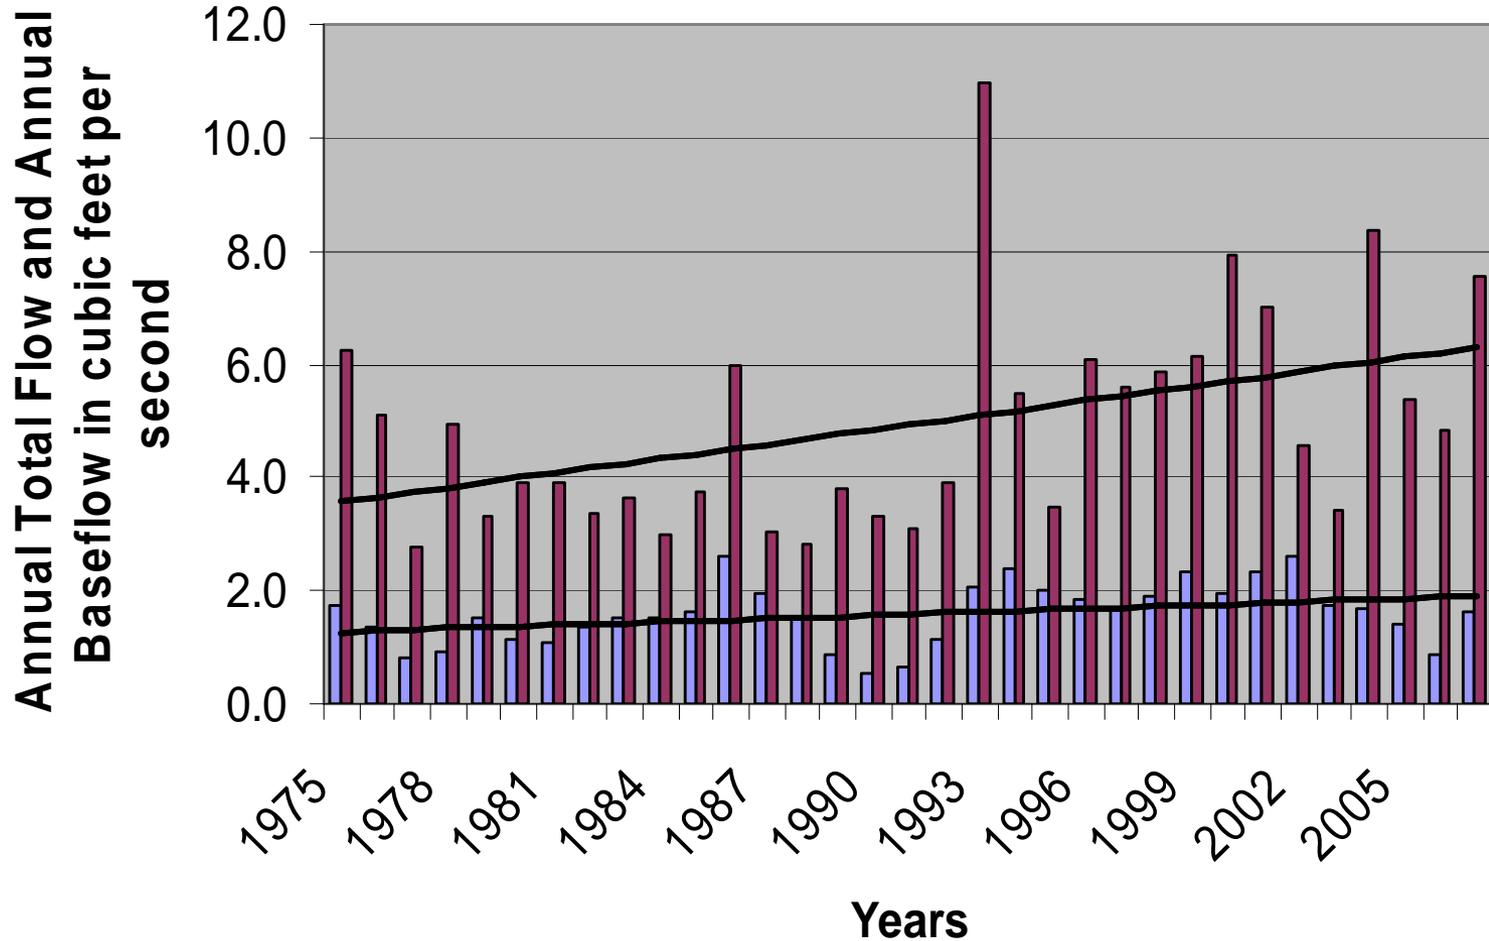
# Pheasant Branch At Middleton, Annual Total Flow and Annual Baseflow

- Total annual flow increased substantially
- Annual baseflow increased
- Annual flood peaks increased
- Frequency of flood peaks increased
- Flooding trends in Pheasant Branch behave similarly to rural streams contrary to increased urbanization

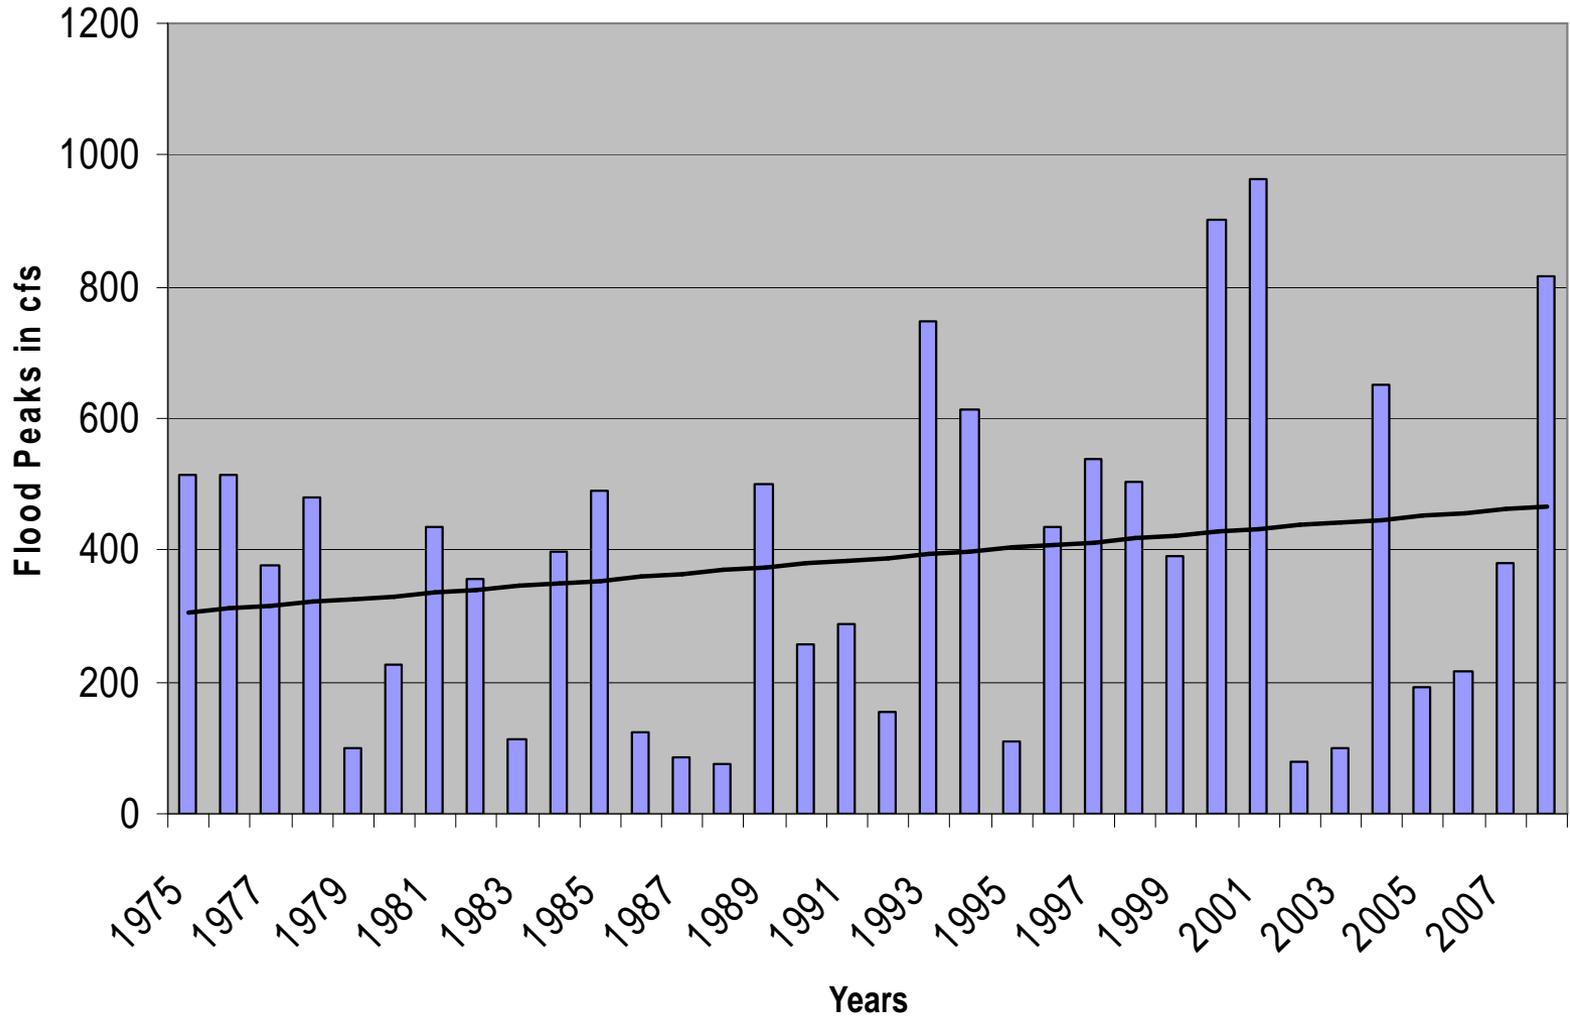
# Pheasant Branch Annual Flood Peaks

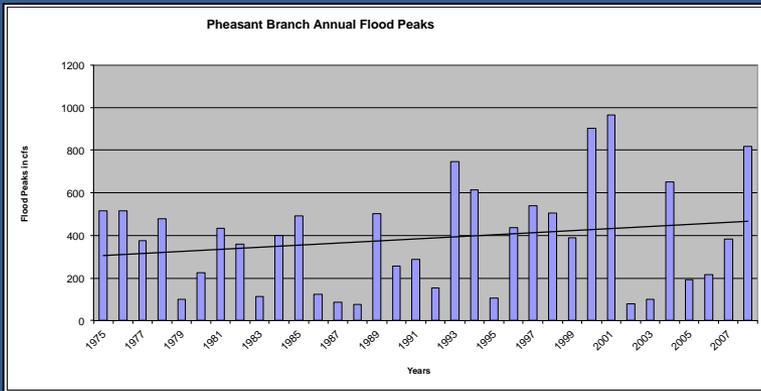
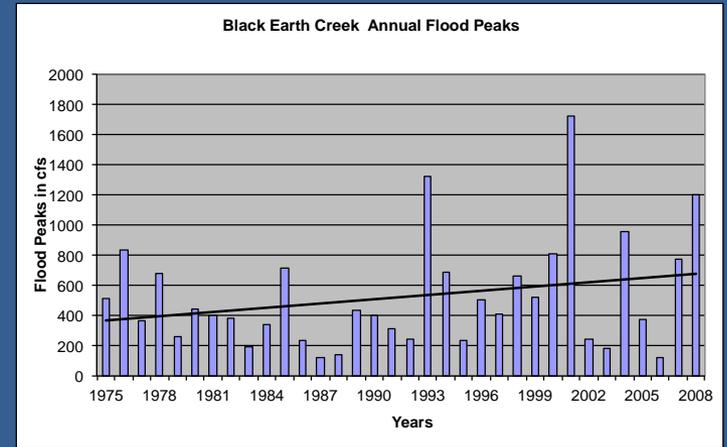
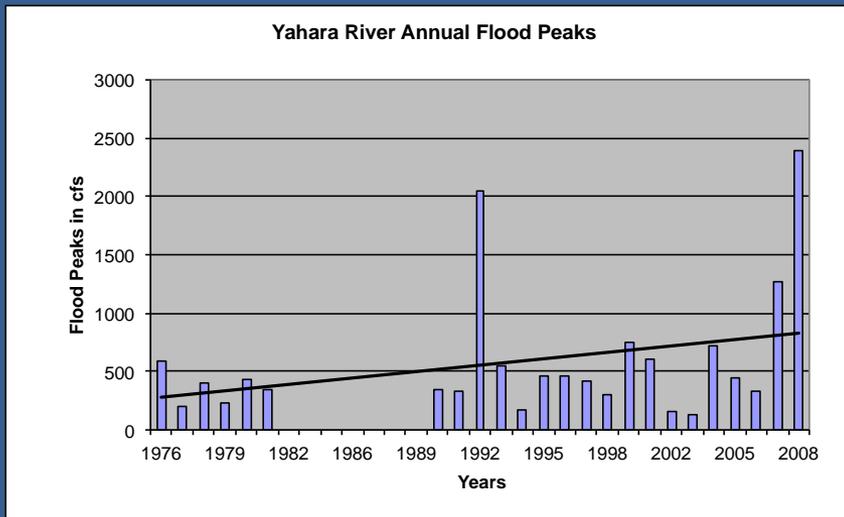
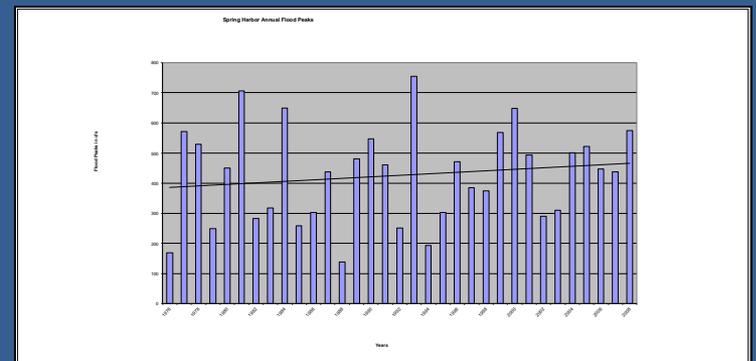
# Comparison of Annual Flood Peaks

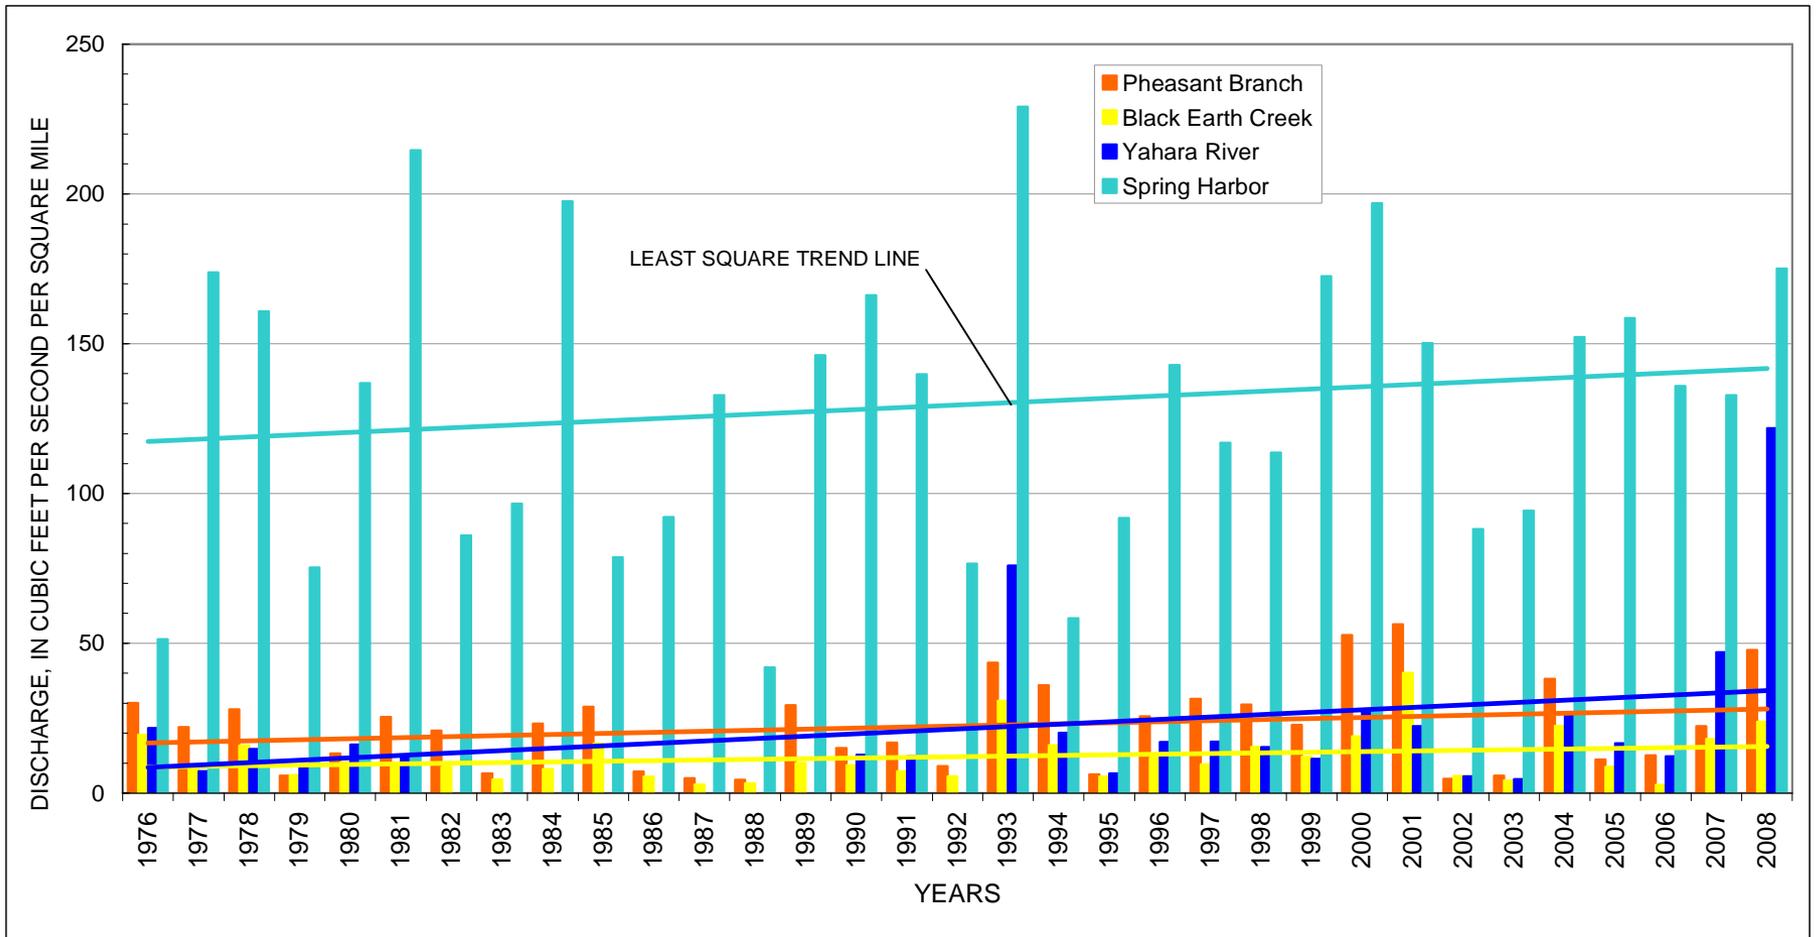
# Comparison of Flood Peaks

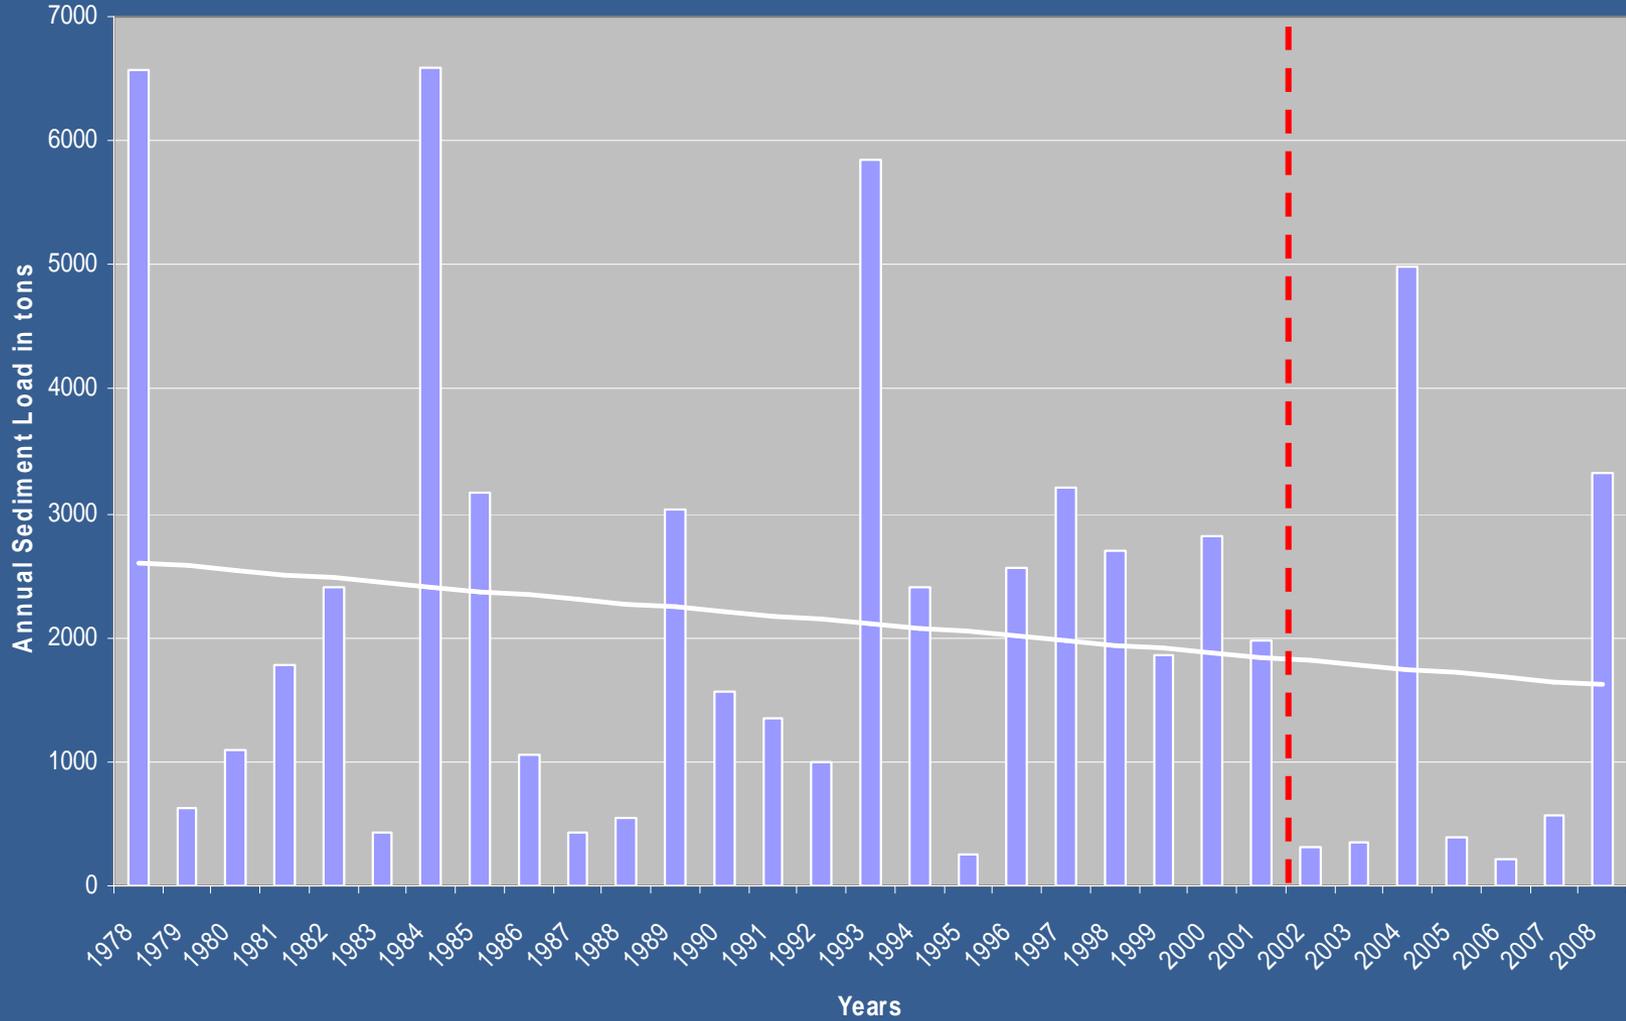
### Pheasant Branch at Middleton Annual Sediment Load

- Sediment loads have decreased by 45%
- Phosphorus loads have decreased by 48%

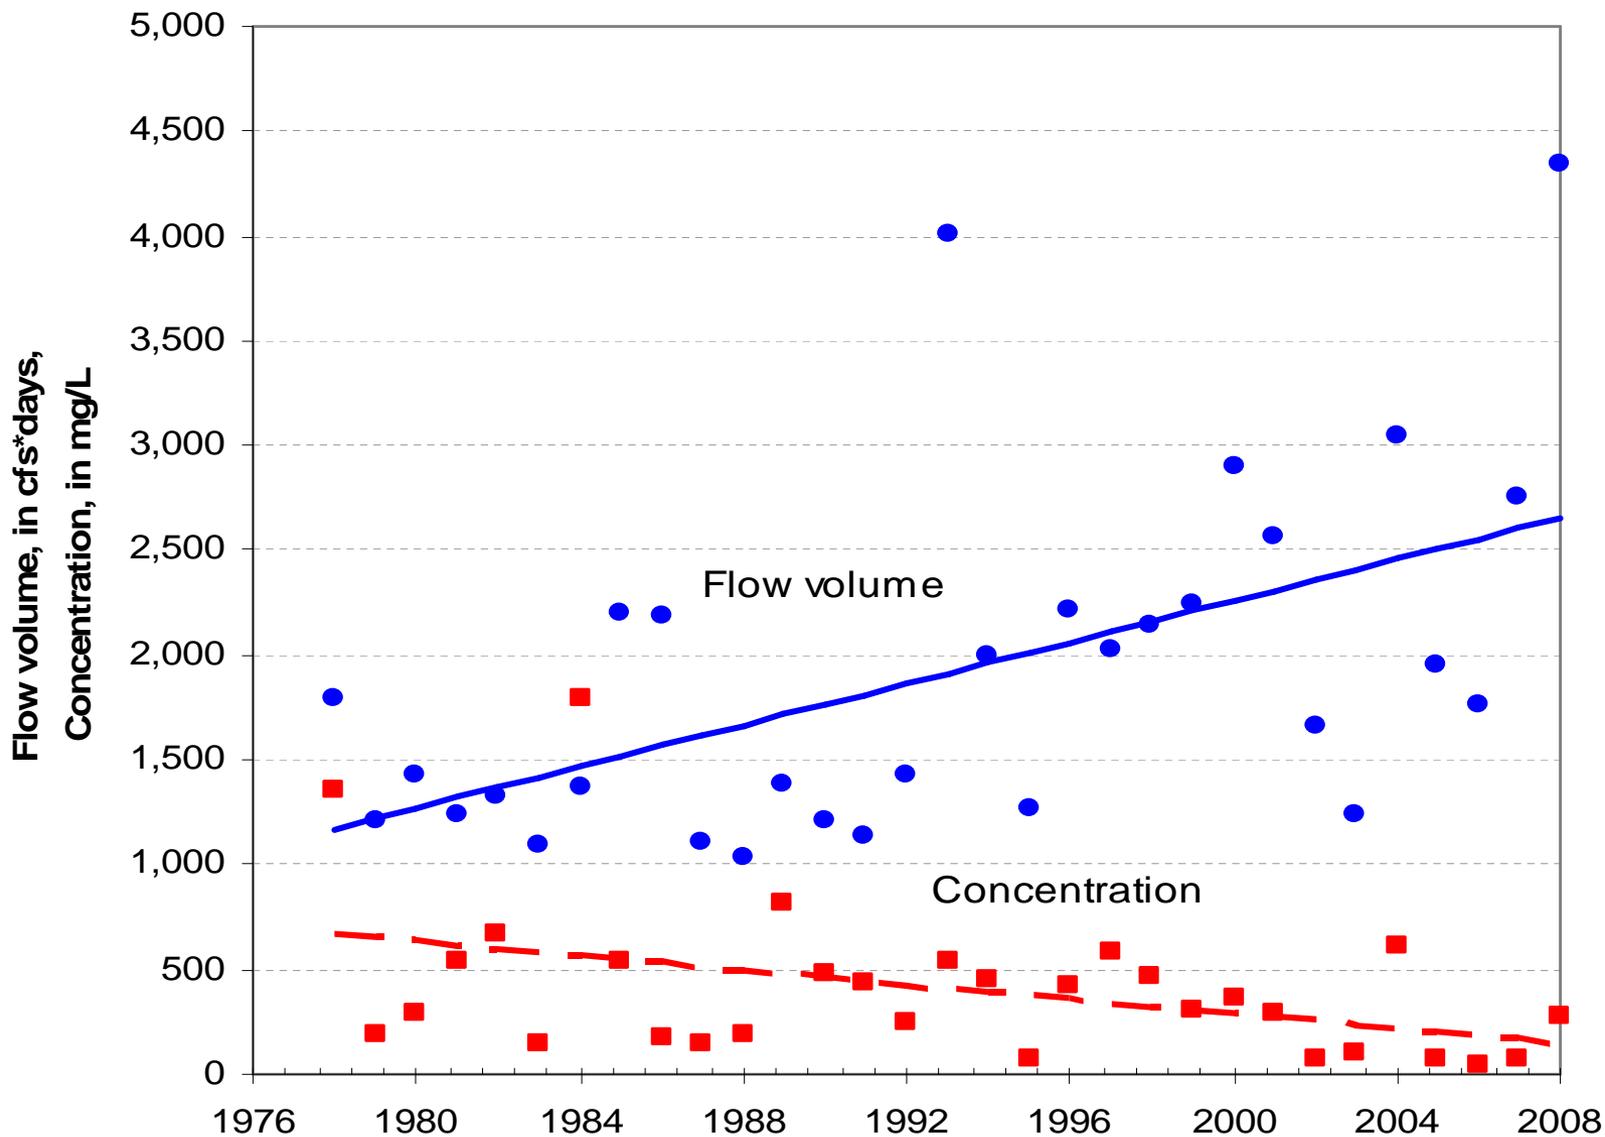
# Trends in annual flow volume and average suspended-sediment concentration for Pheasant Branch, 1978 -2008

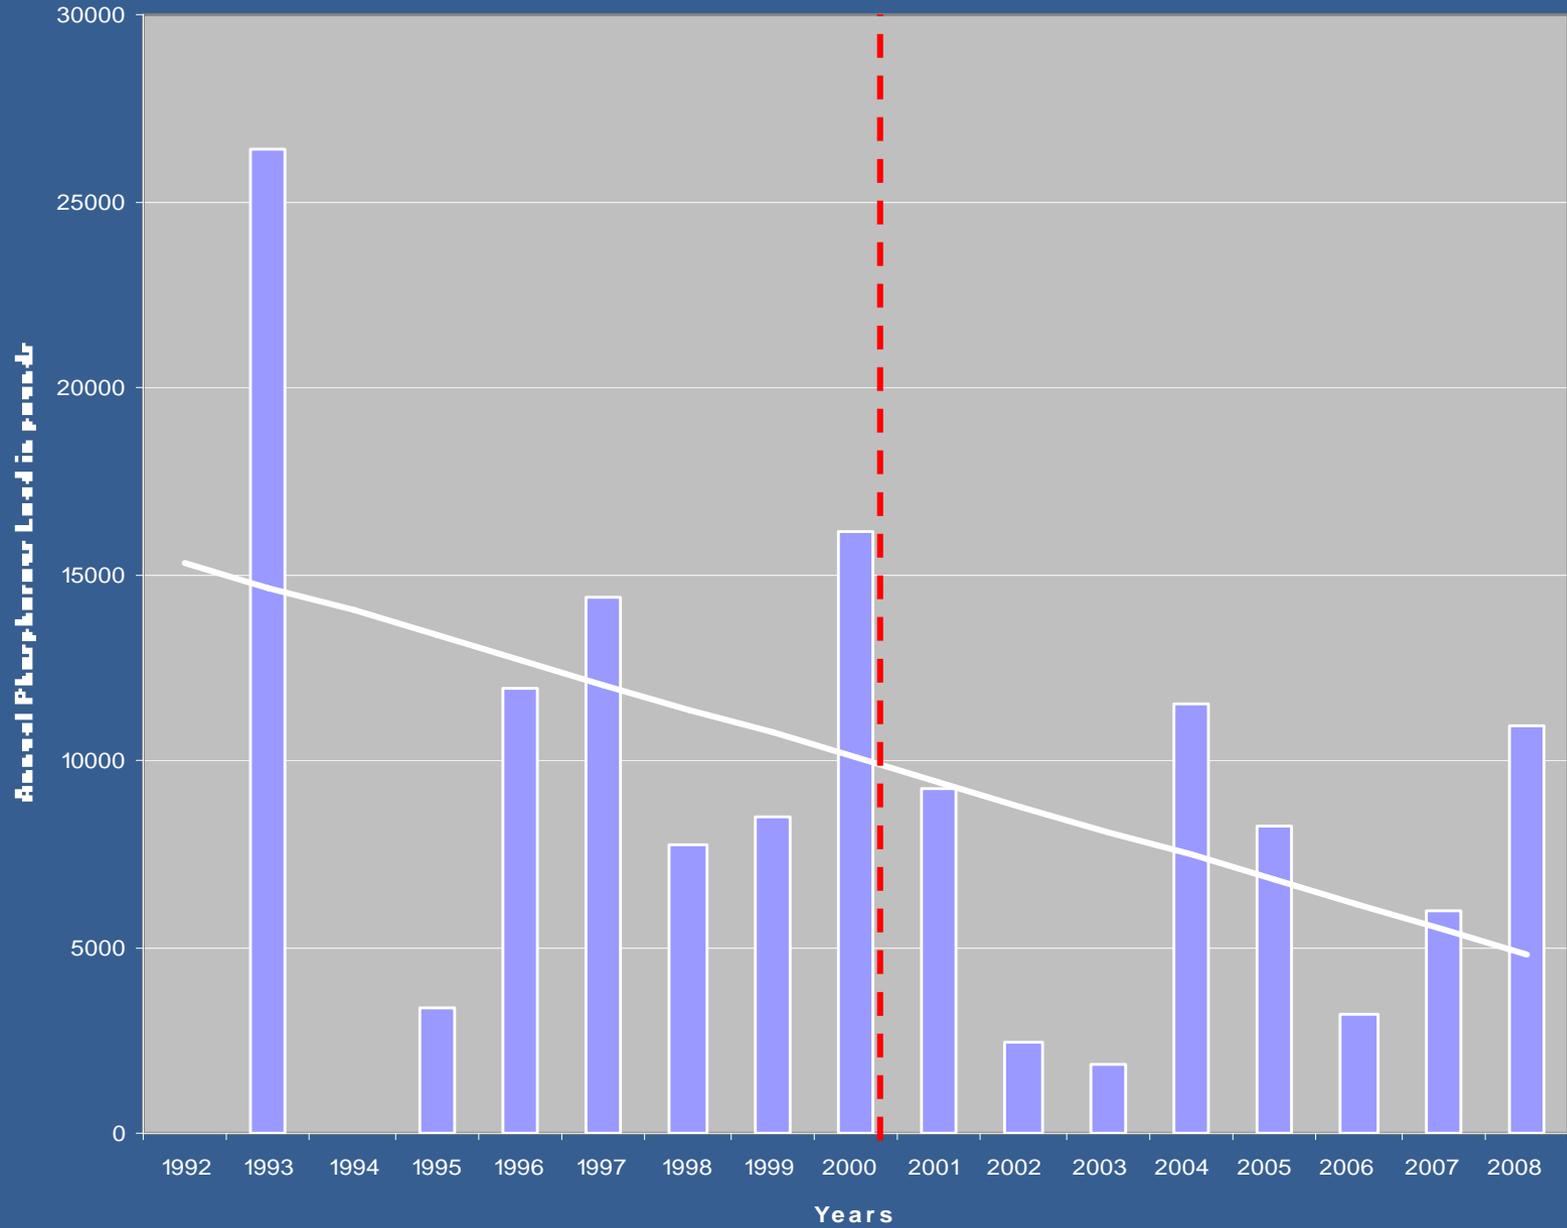
# Pheasant Branch Annual Phosphorus Load

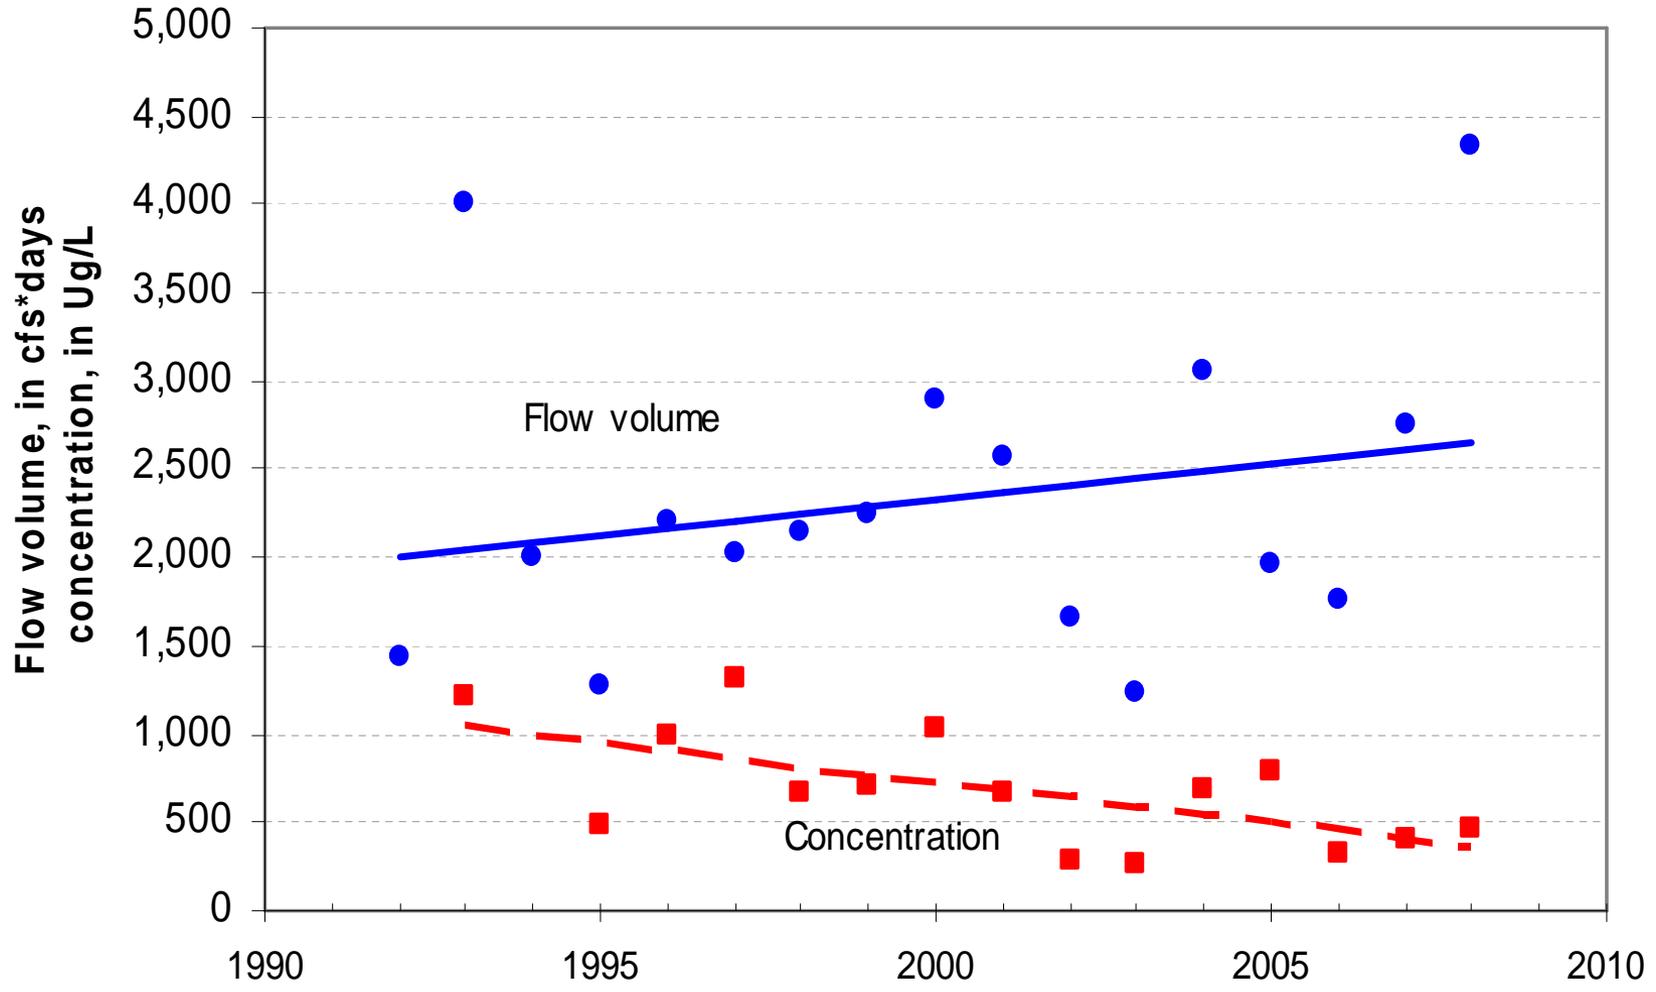
Trends in annual flow volume and average phosphorus concentration for Pheasant Branch, 1993-2008
