A Dynamic Monitoring Program -- Turkey Creek Watershed (Colorado) Case Study

*National Water Quality Monitoring Council (NWQMC)
2004 National Monitoring Conference,
Building and Sustaining Successful Monitoring Programs,
Chattanooga, Tennessee – May 18, 2004*

Timothy D. Steele, Ph.D., TDS Consulting Inc.

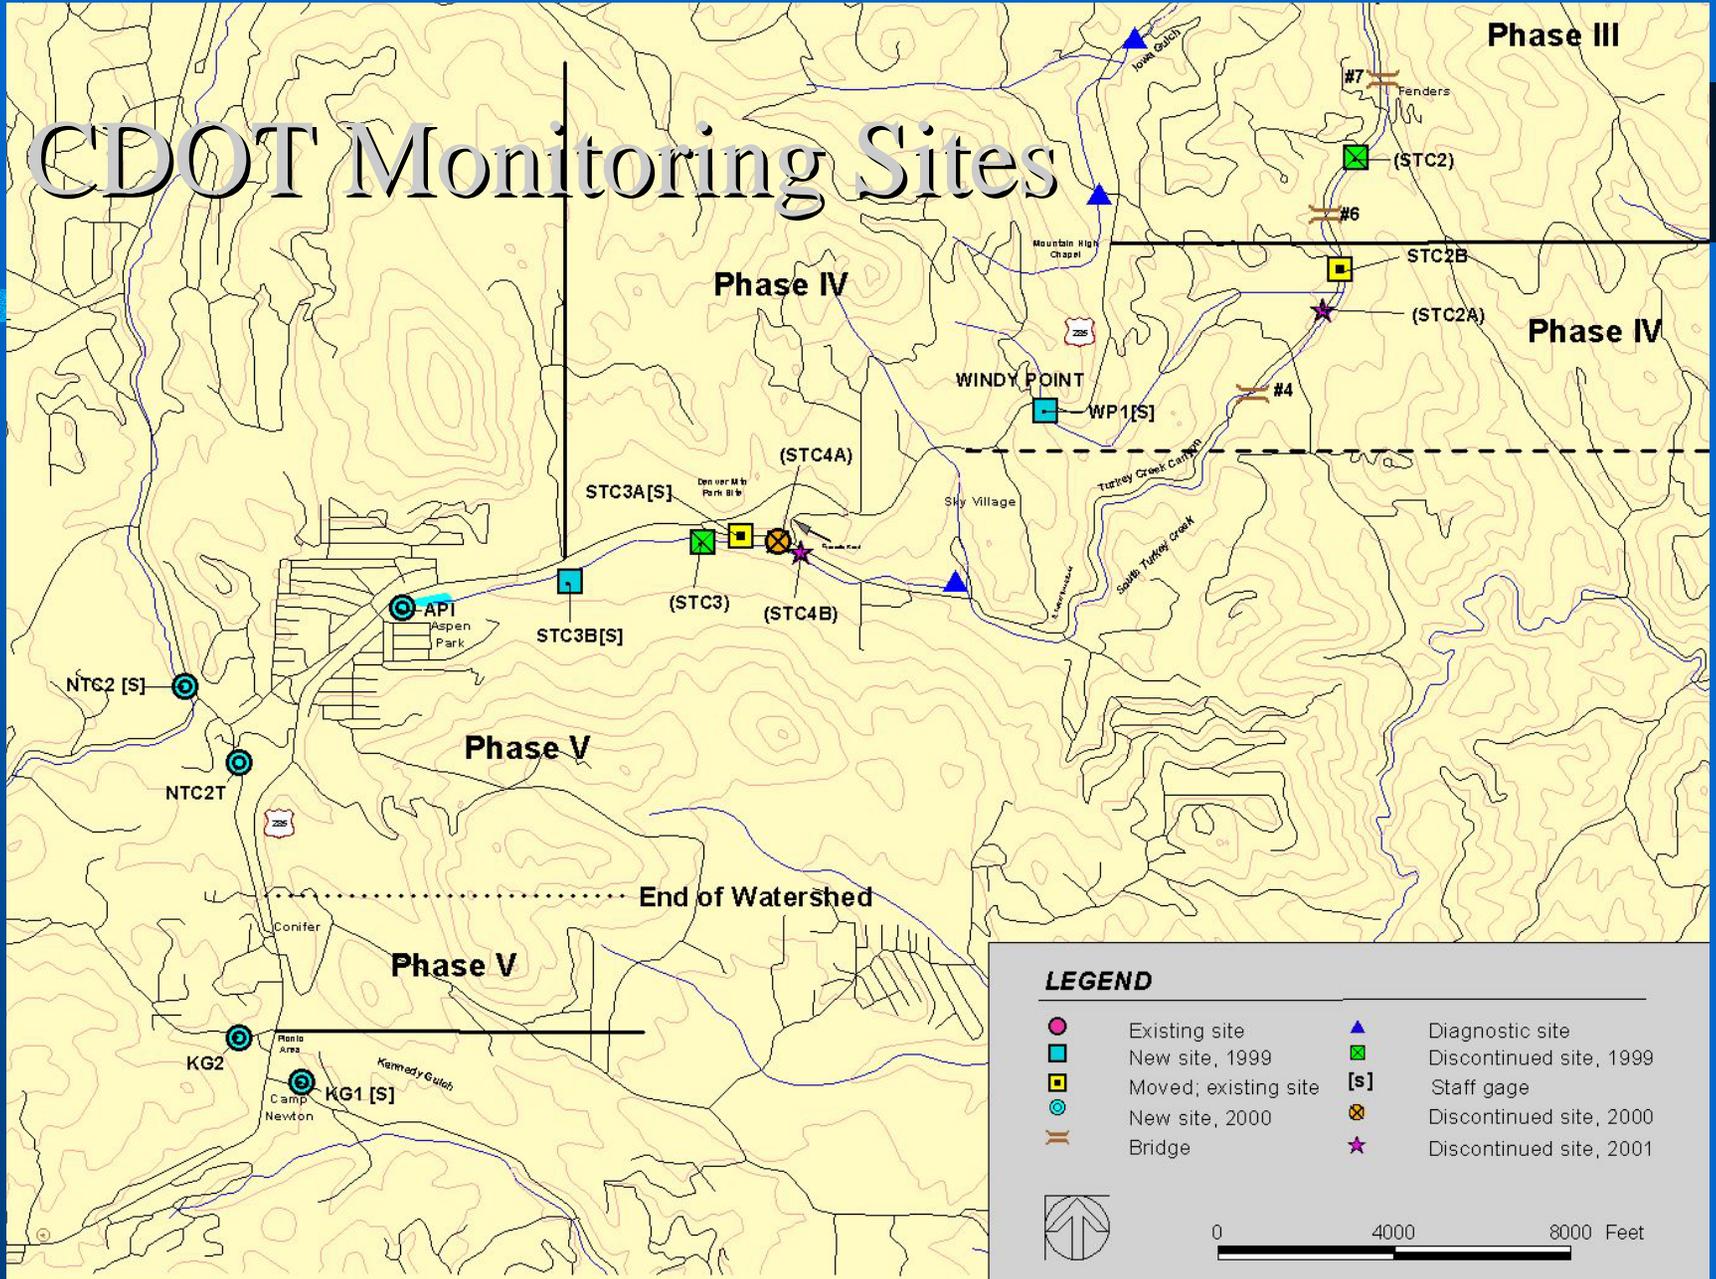
CDOT Monitoring Sites

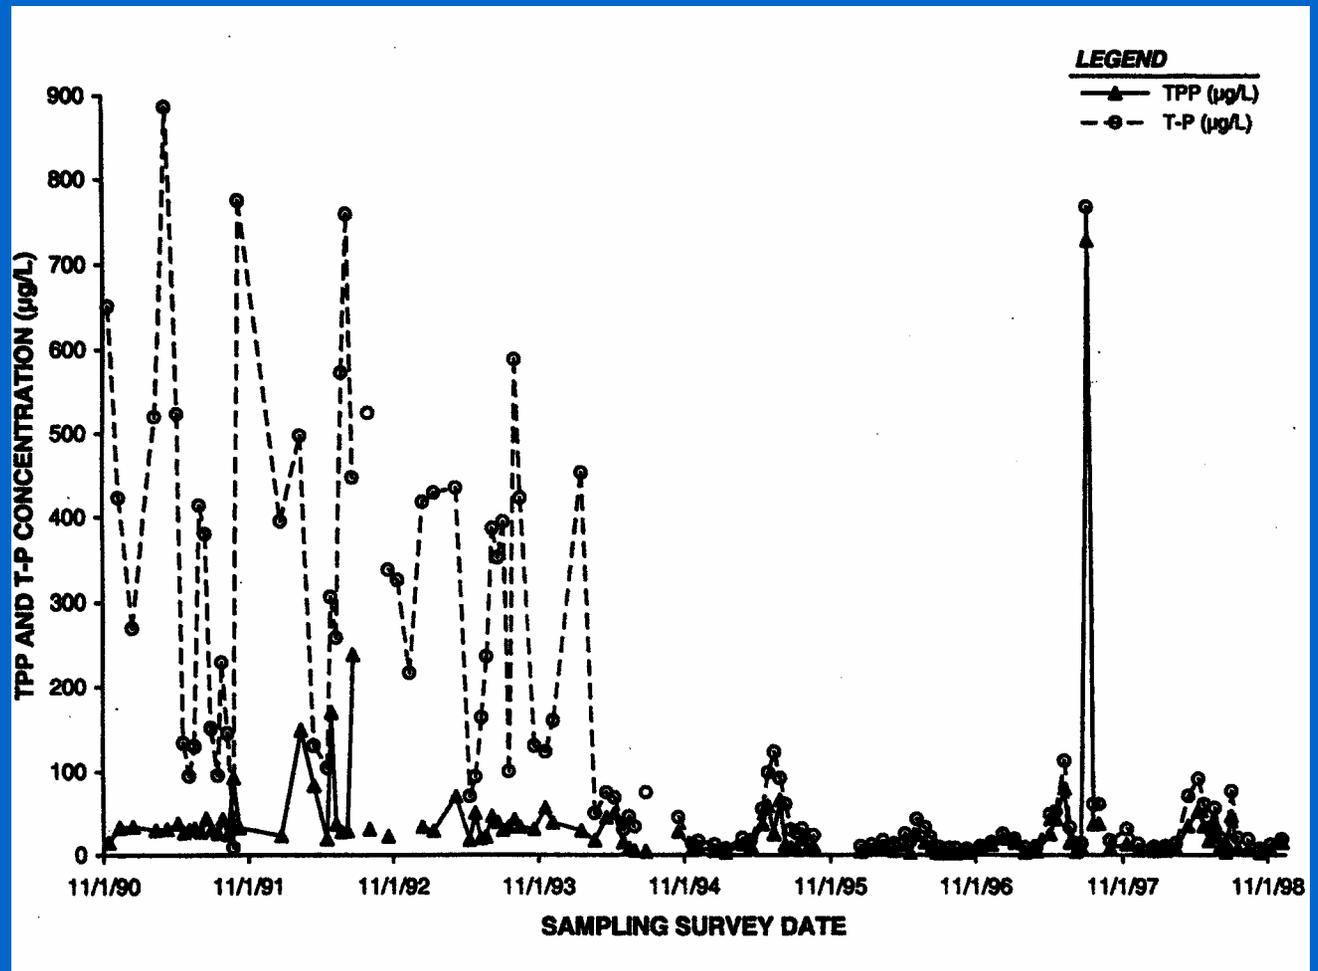
Historical T-P Time-Series, Site TCIN

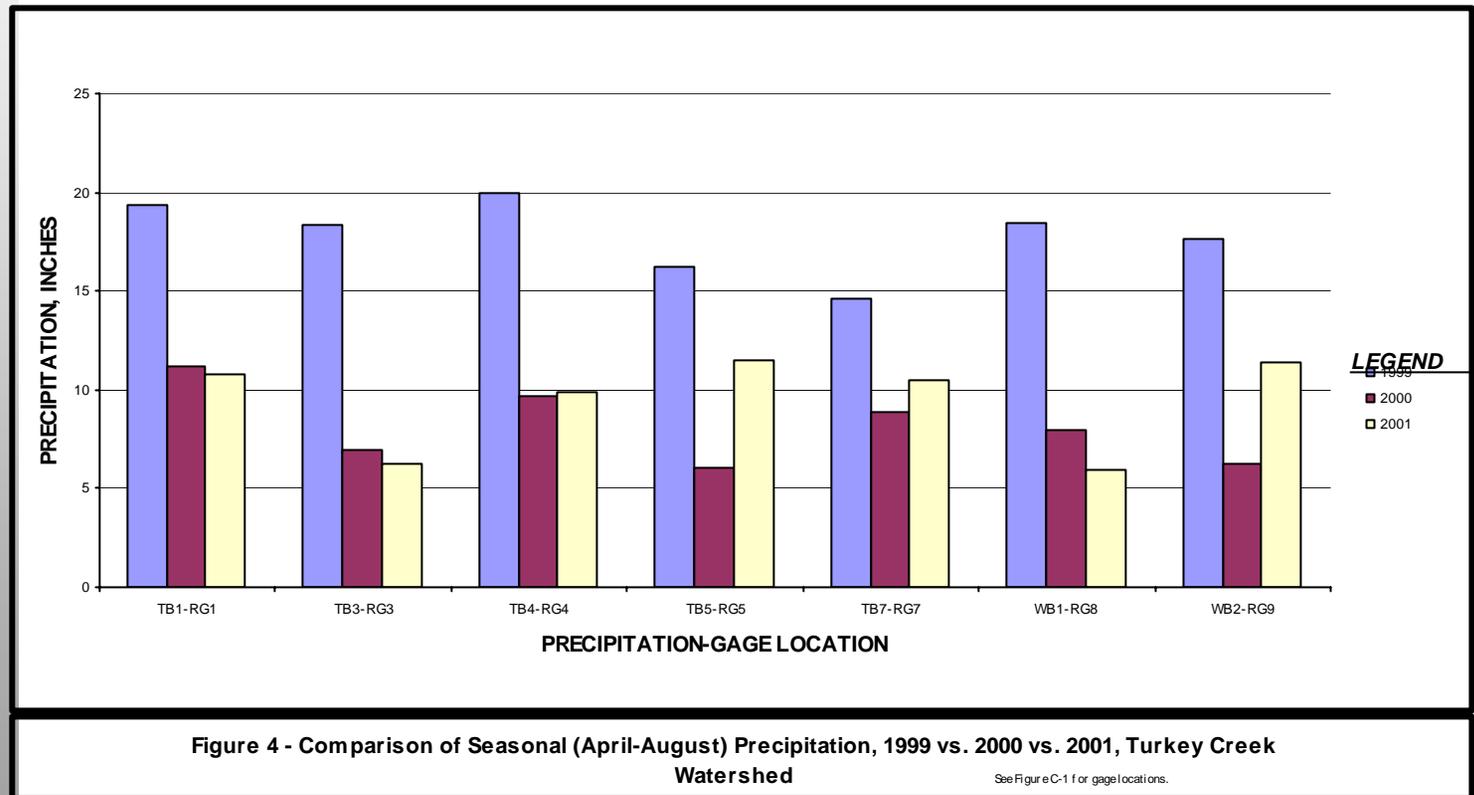
Comparison of Seasonal Precipitation: 1999 vs. 2000 vs. 2001 (April-August)

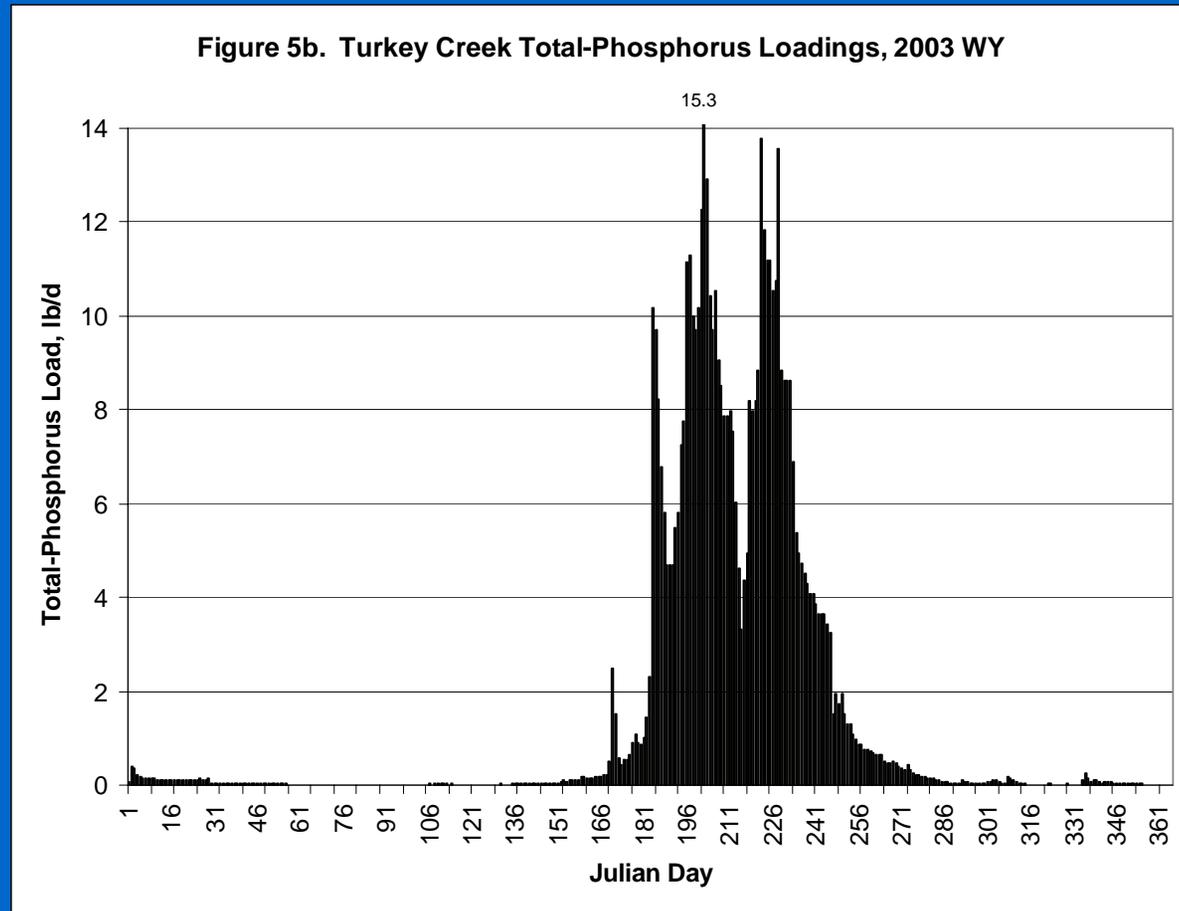
Total-Phosphorus Loadings, 2003 WY

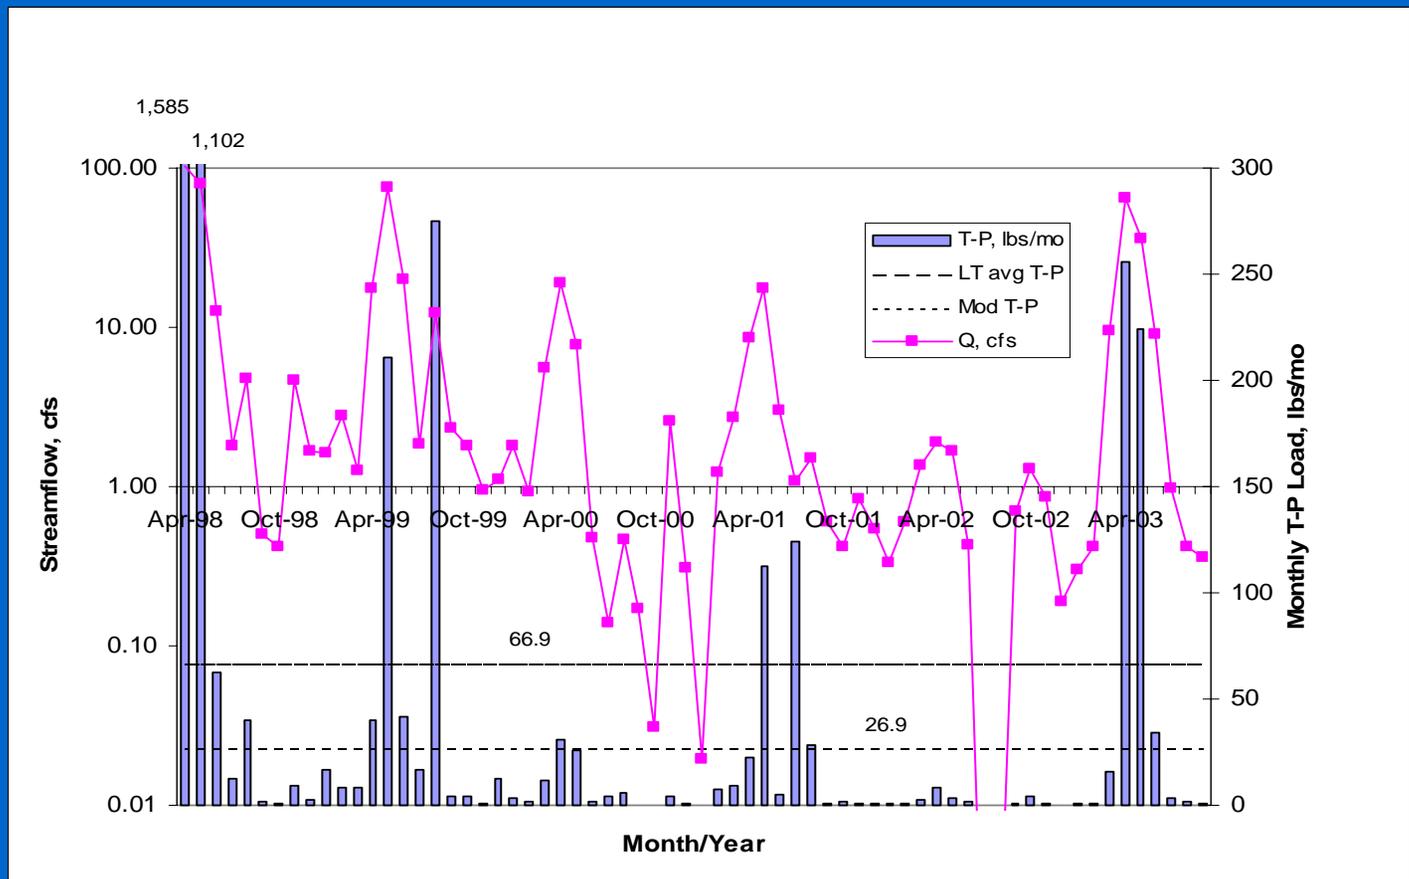
Monthly Total-Phosphorus Loads, 1998-2003

<u>Period</u>	<u>T-P Load</u>	<u>Source</u>
1990-95	2,800	DRCOG-Historical
1998 CY	1,821	DRCOG, 1998-1999
1998 (6)	2,804	Exponent-TDS
1999 CY	634	Exponent-TDS
2000 CY	103	Exponent-TDS
2001 CY	315	Exponent-TDS
2002 CY	20 [14.3]	Exponent-TDS/BCWA
2003 CY	542	TDS

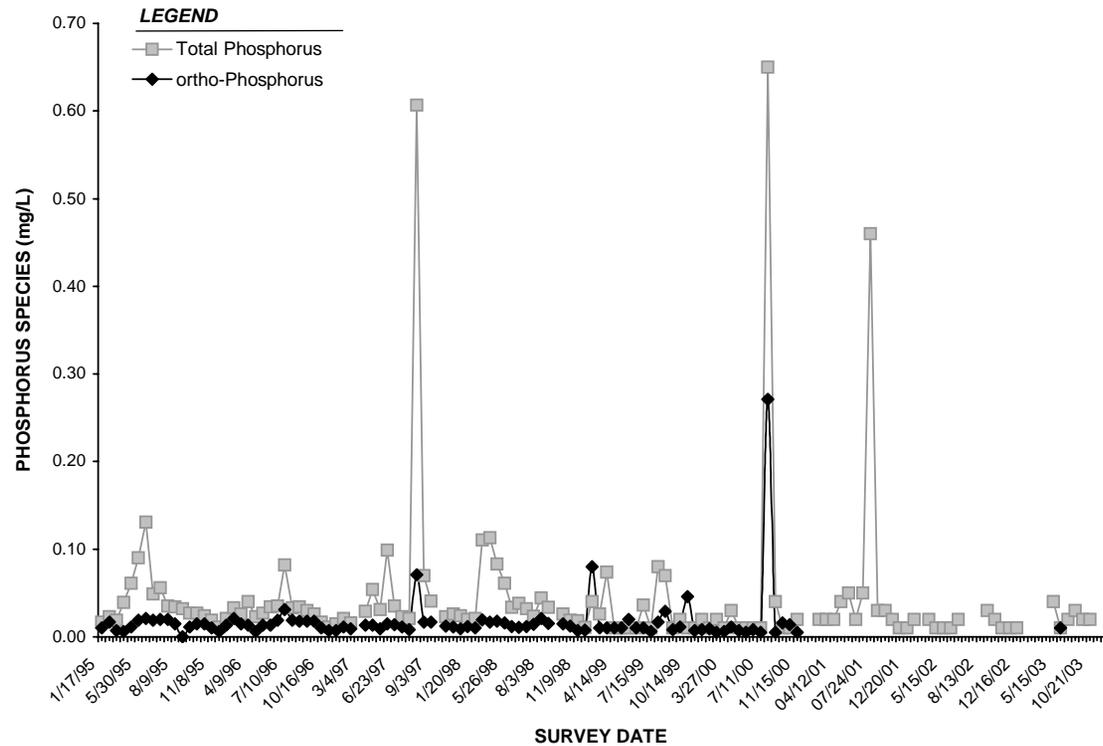
North Turkey Creek at STC Confluence, Ortho-Phosphorus and Total Phosphorus Concentrations

Figure B-4b. North Turkey Creek at South Turkey Creek confluence (NTC1/NTC1A), total phosphorus and ortho-phosphate

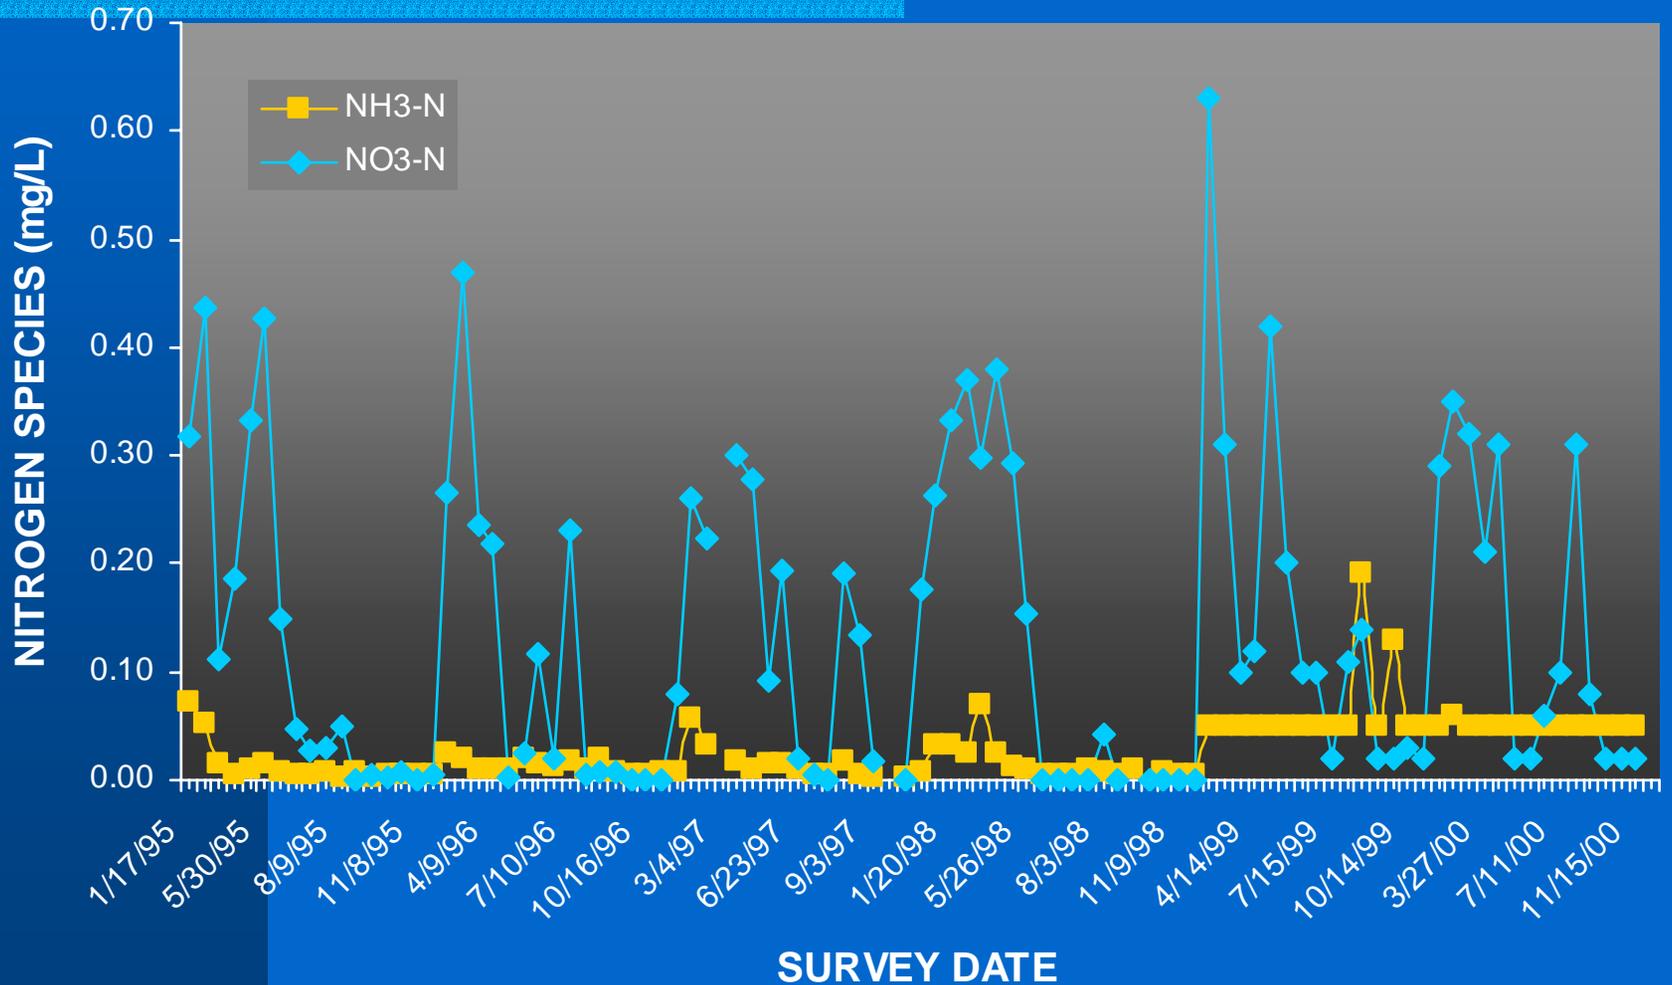
North Turkey Creek at South Turkey Creek Confluence, NH₃-N and NO₃-N

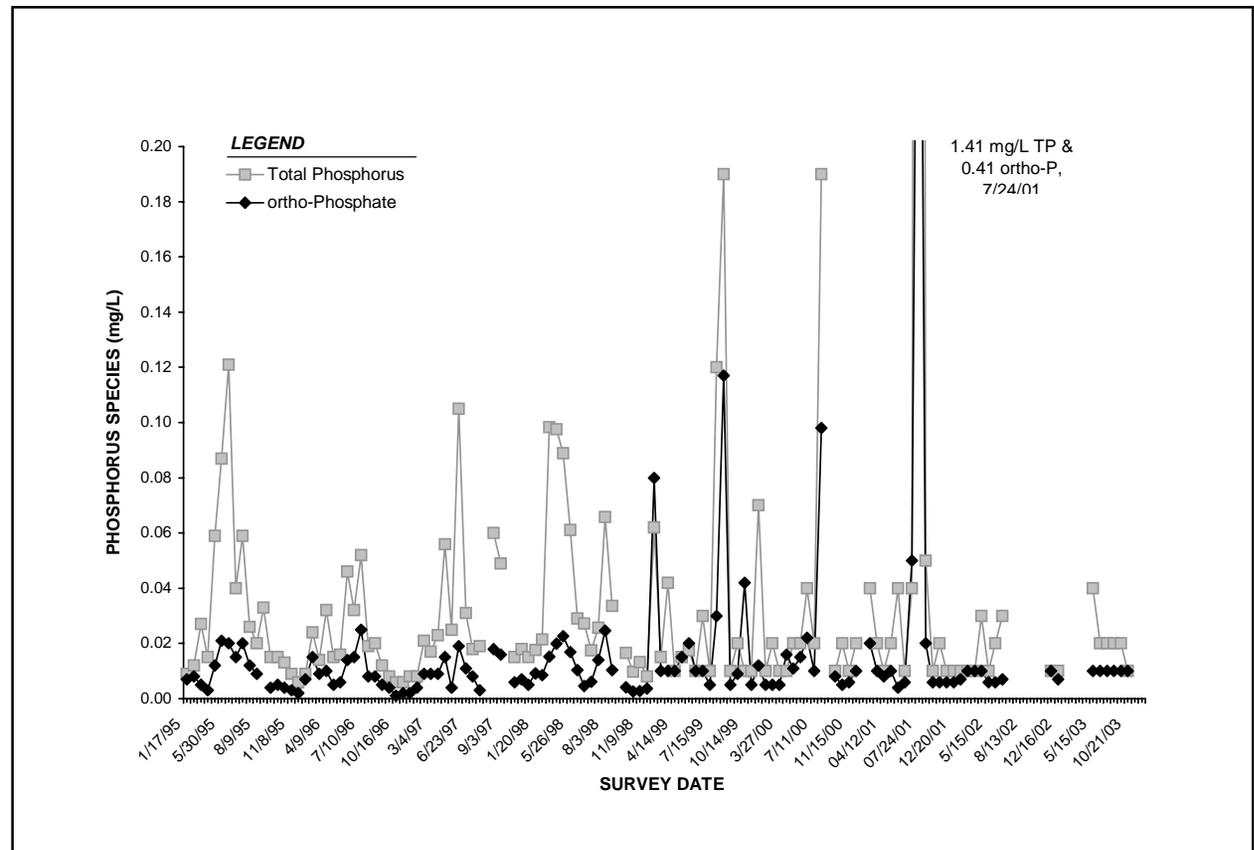
Turkey Creek near Willow Springs Development, Ortho-Phosphorus & Total-P Concentrations

Figure B-6b. Turkey Creek below Parmalee Gulch (TC2/TC2A), total phosphorus and ortho-phosphate

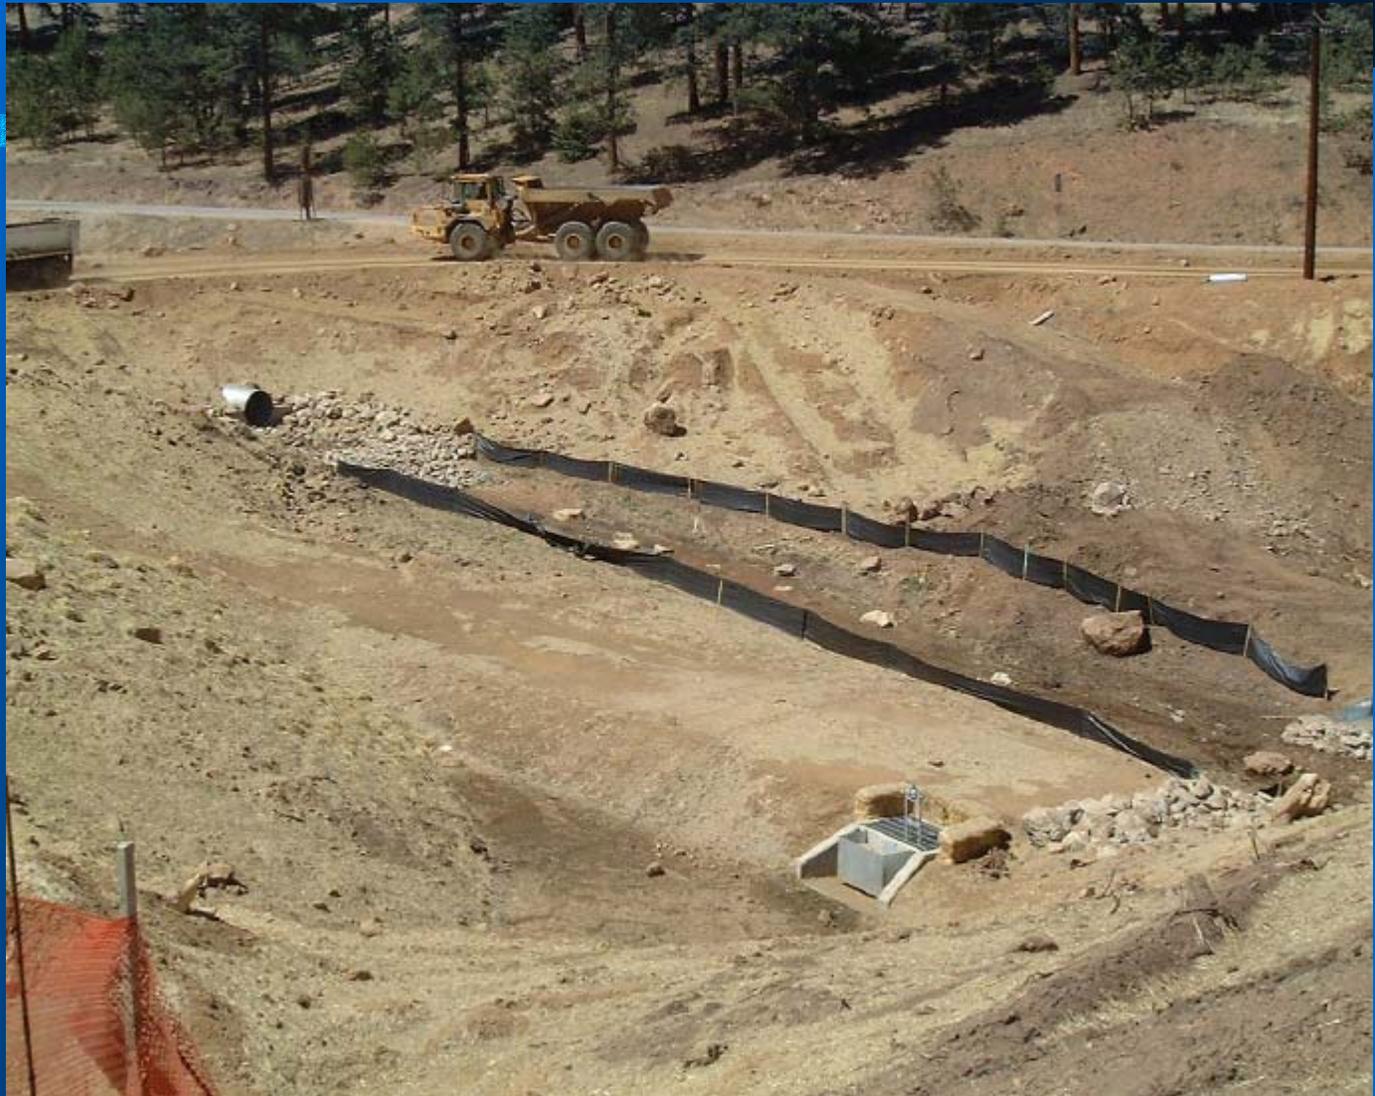
CDOT Sedimentation Basins – Kennedy Gulch Area

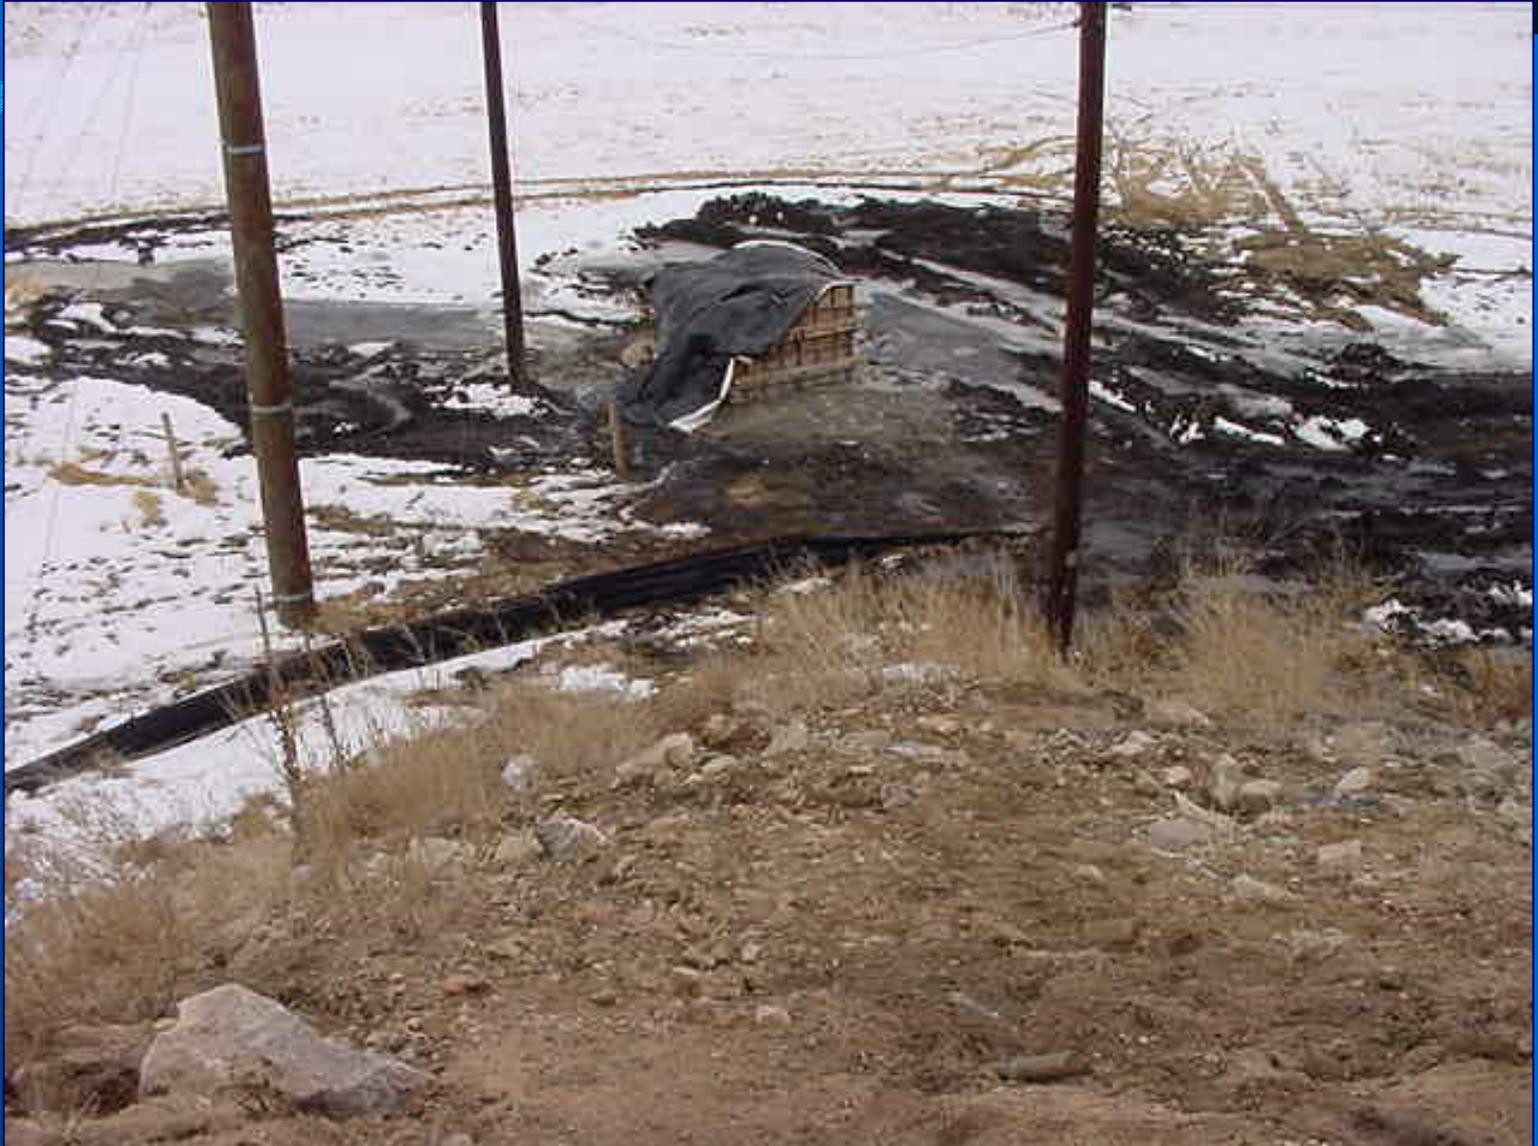
In-Channel Pole Footing Construction

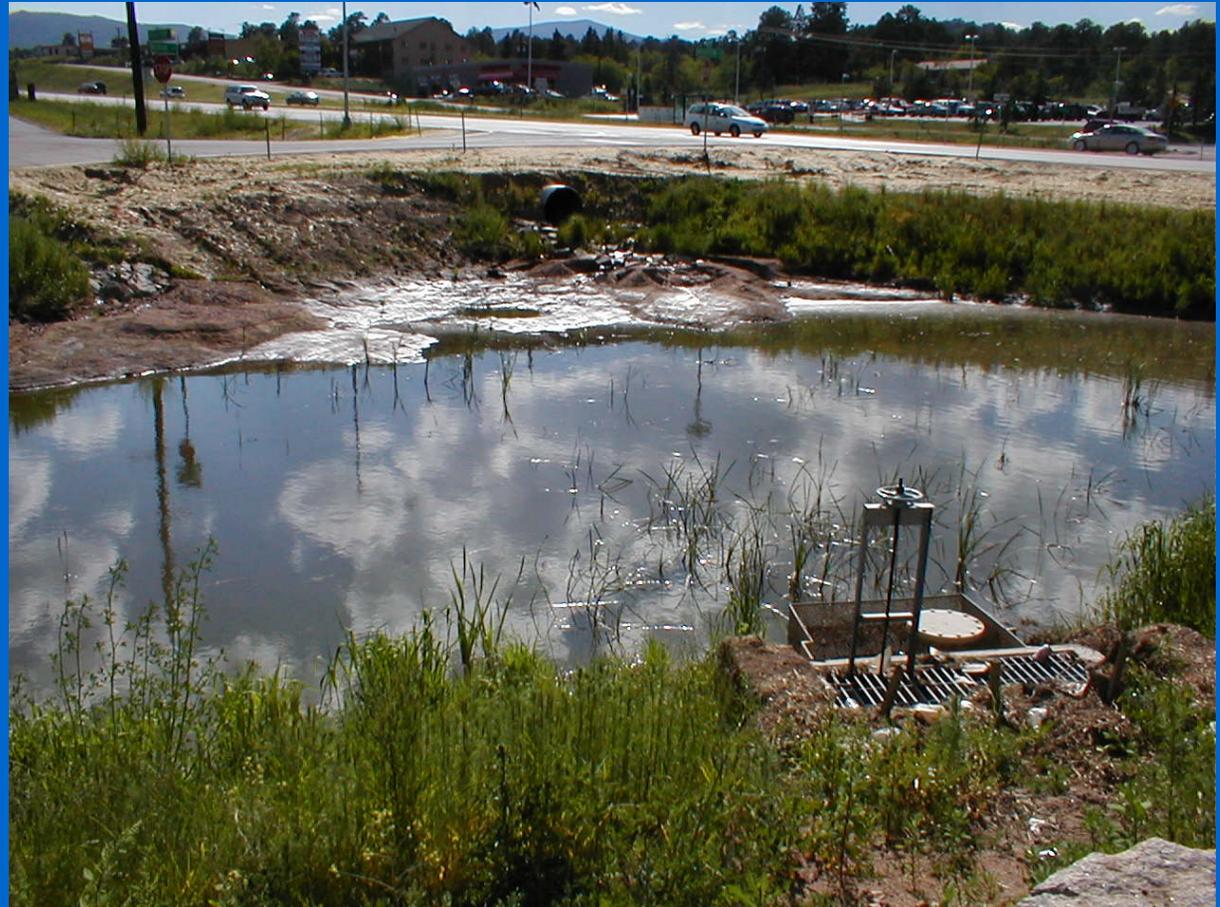
Aspen Park CDOT Sedimentation Basin (above Site AP1), 5/15/03

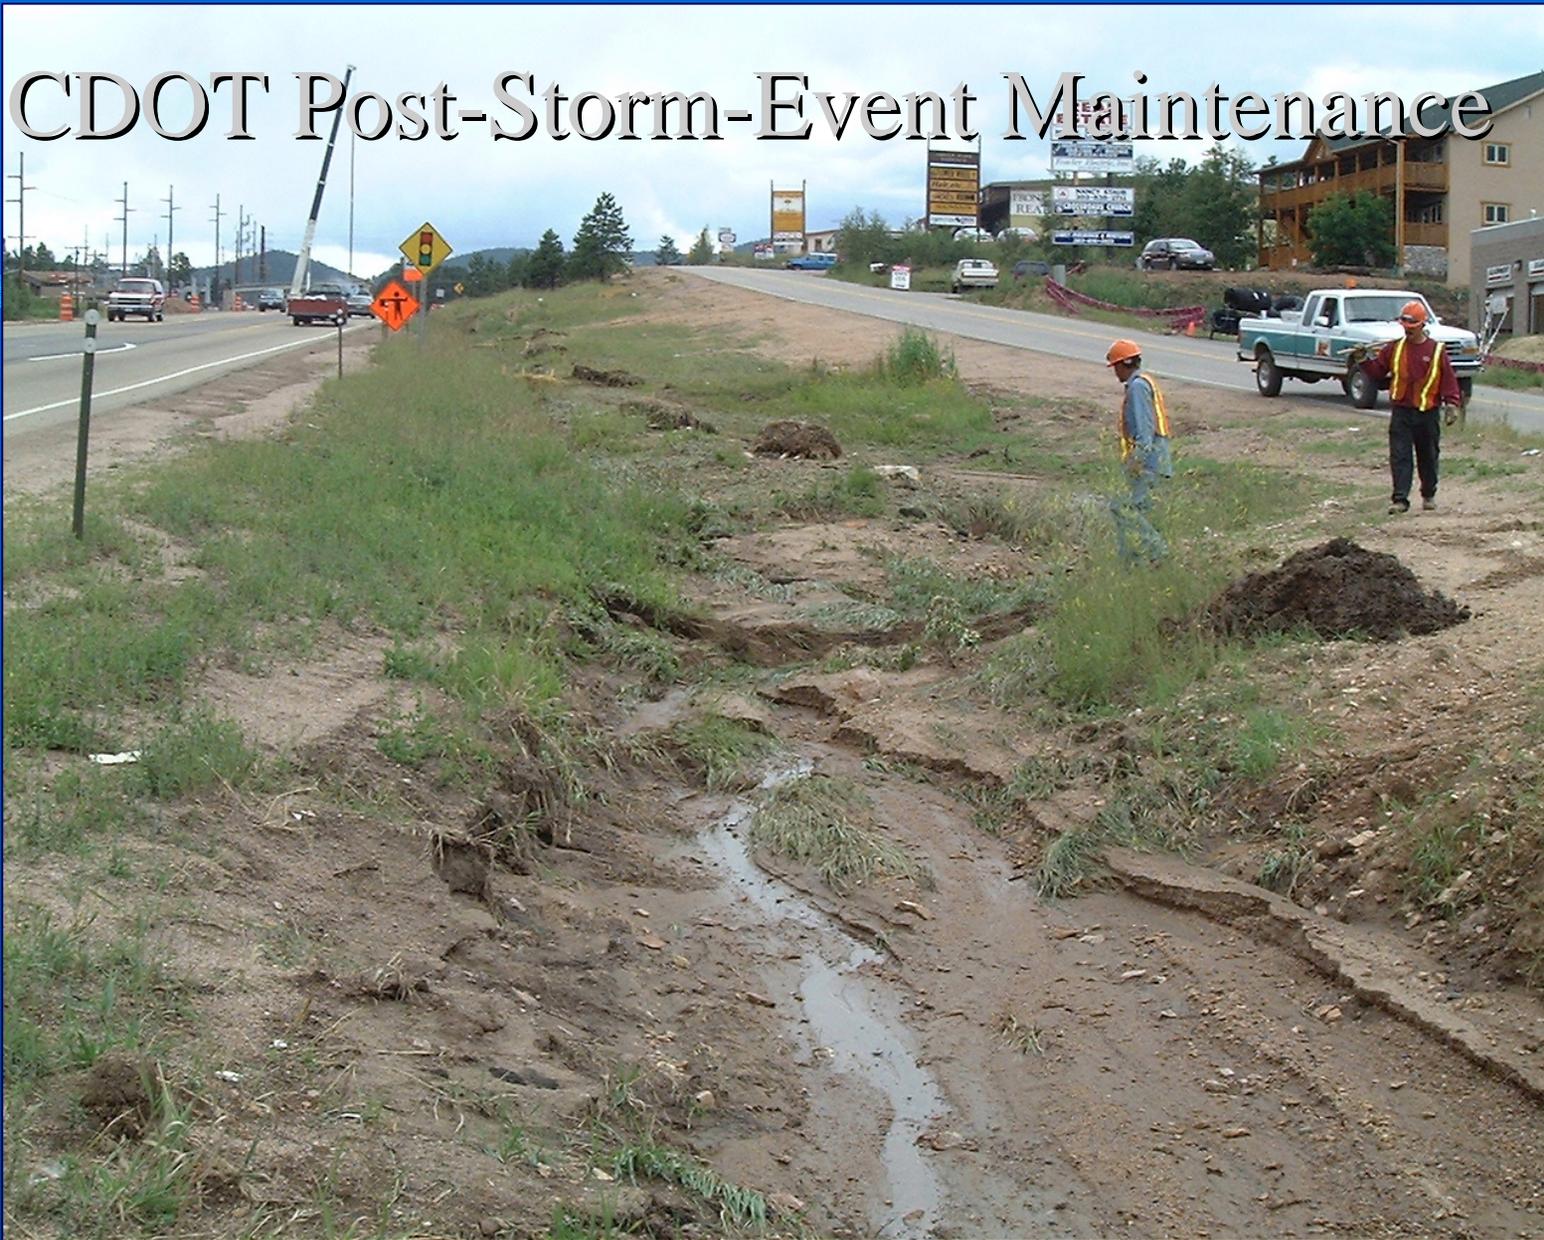
CDOT Post-Storm-Event Maintenance

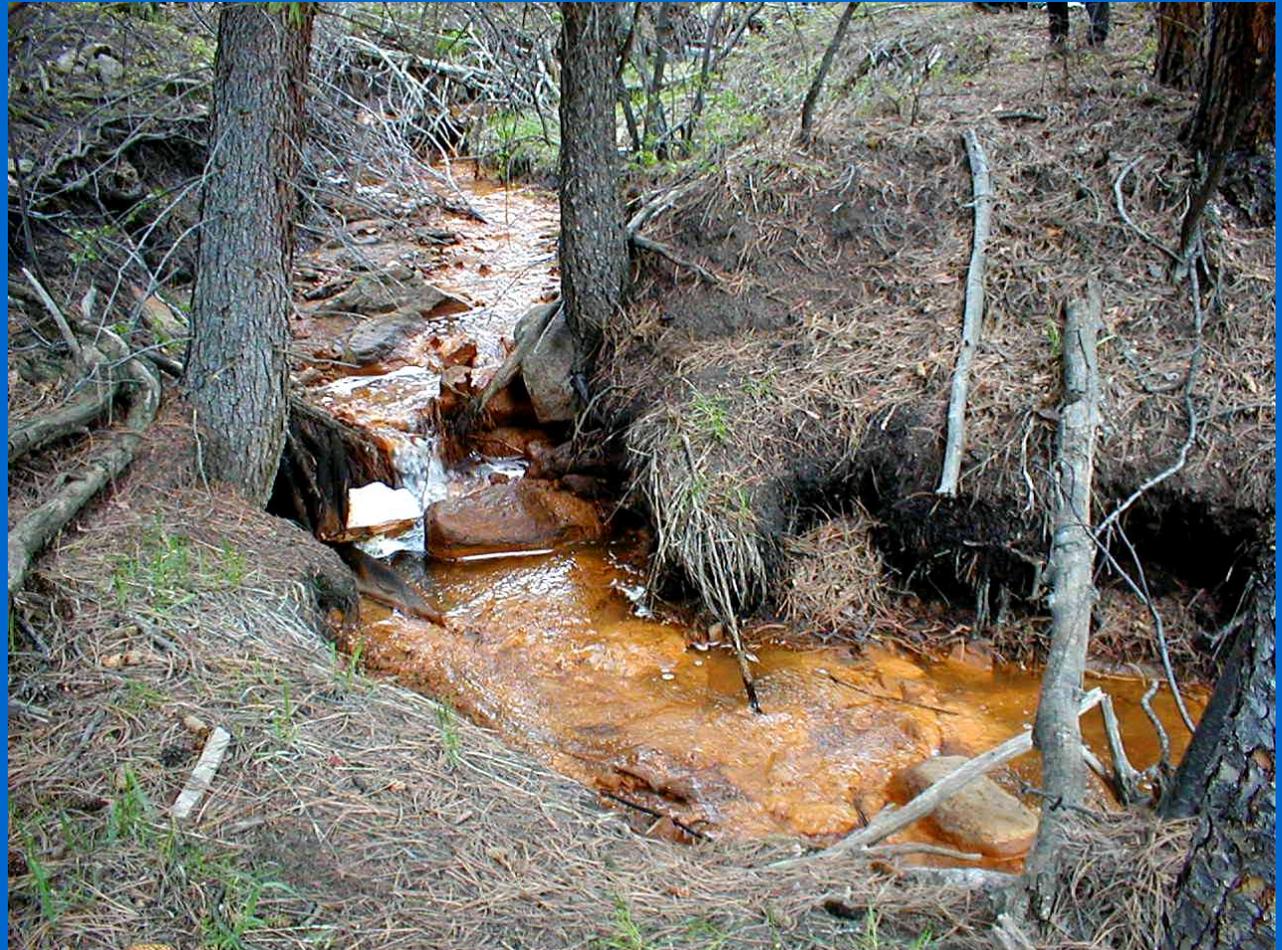
Iron-Oxide Precipitation, Windy Point Area -- 2003

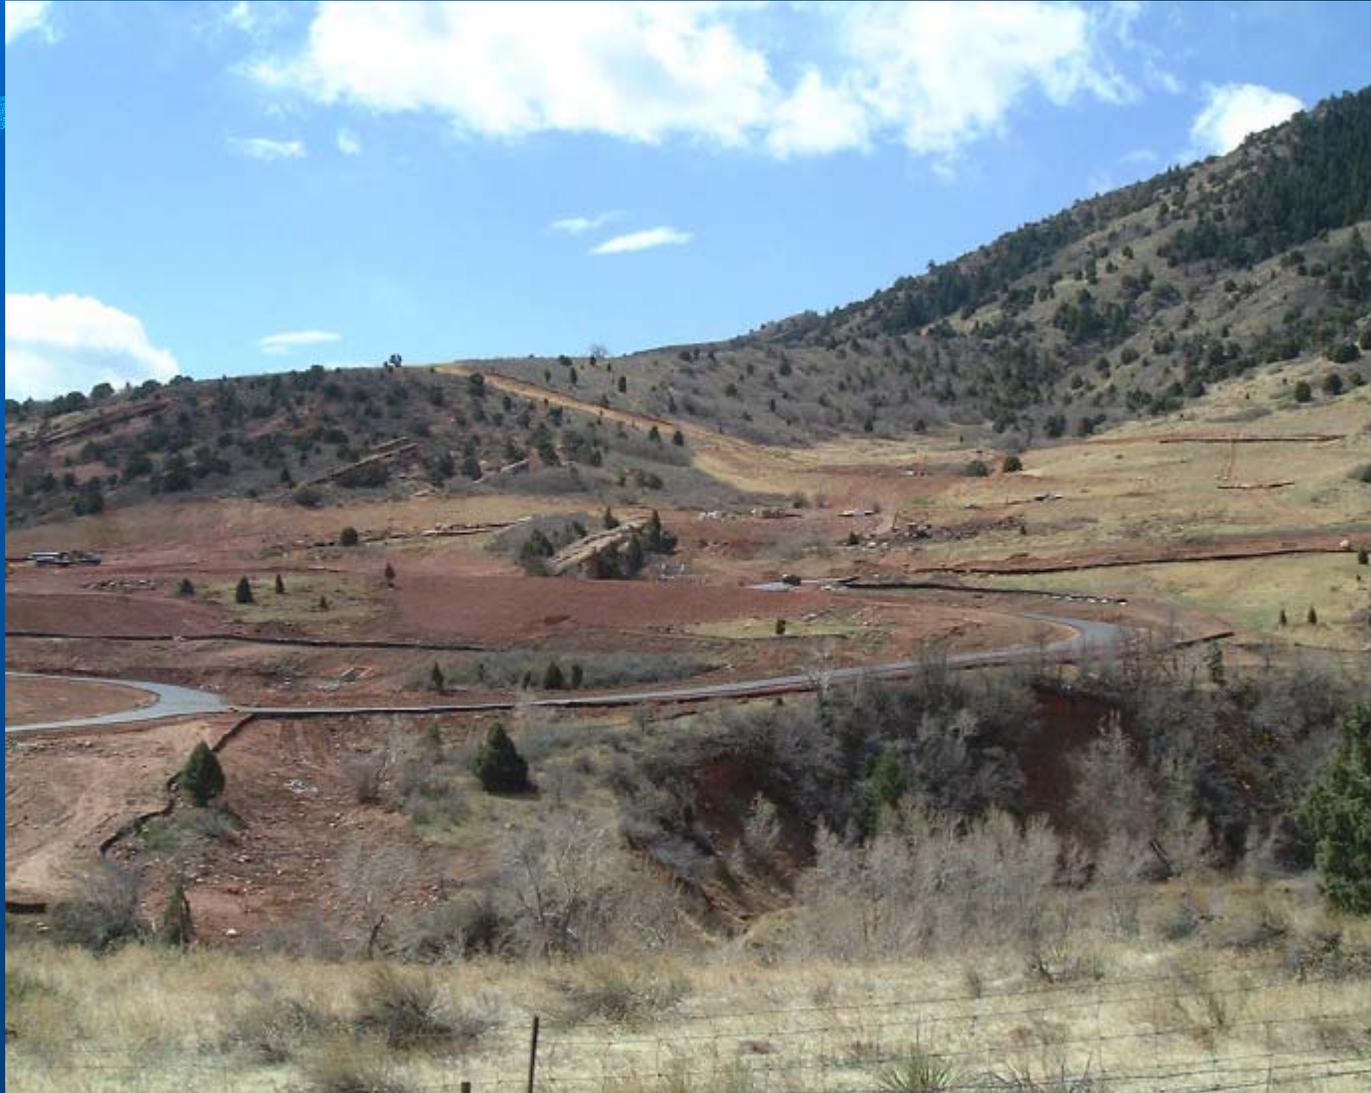
Land-Development Impacts Stream Sediments

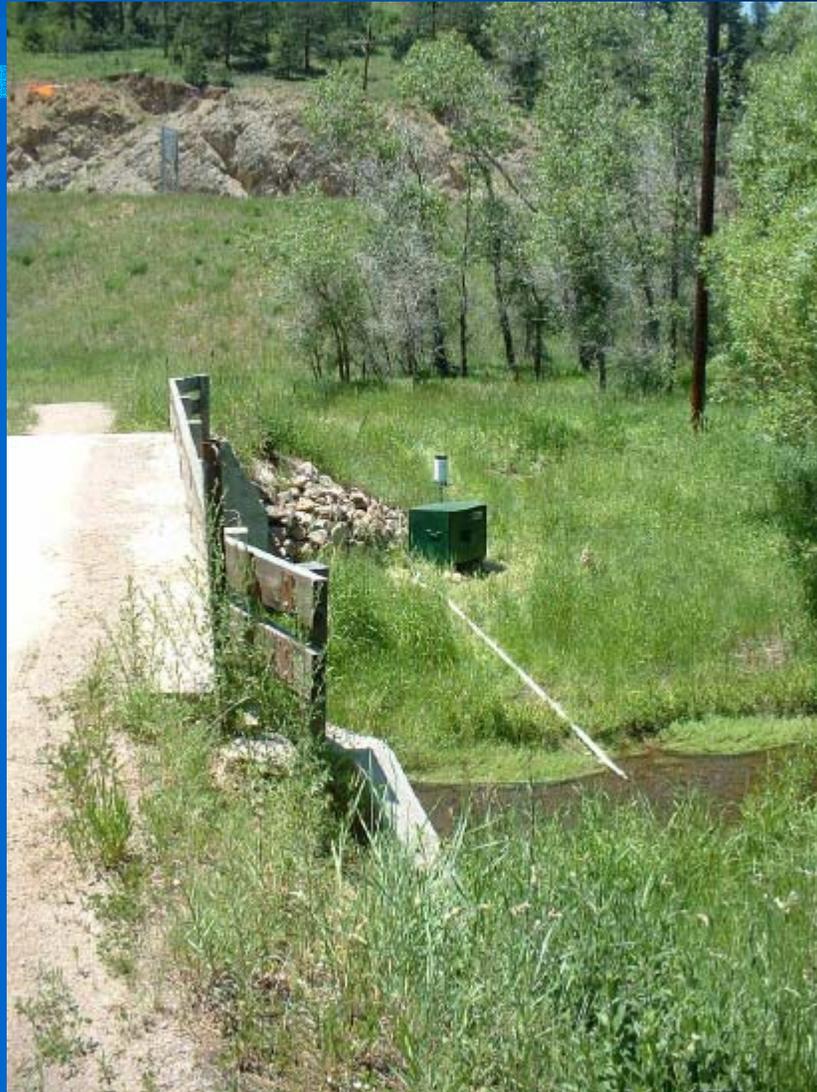
Use of Automatic-Sampling Instrumentation

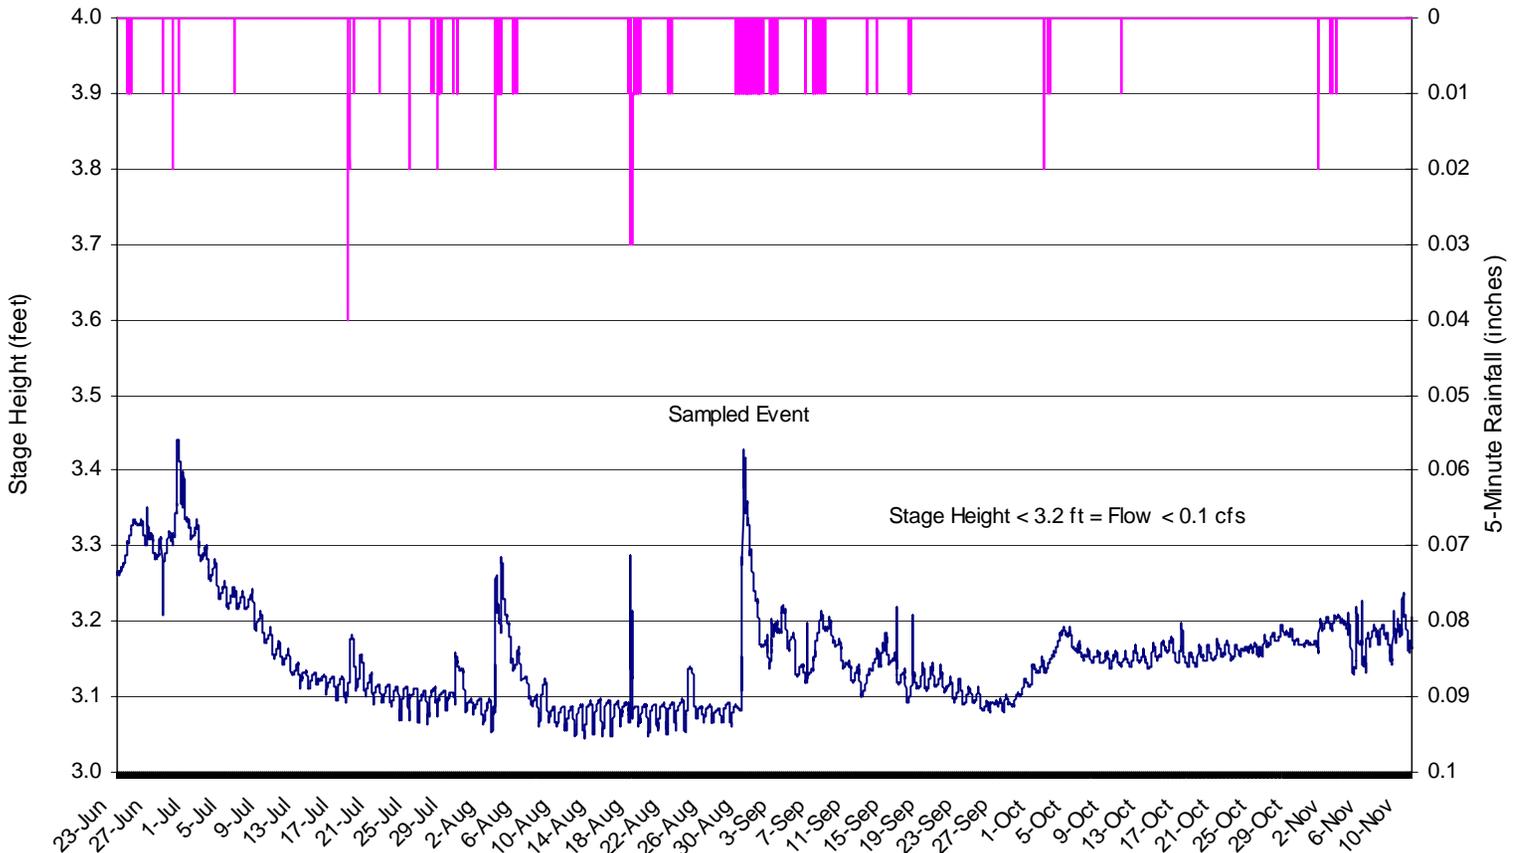
Storm-Event Sampling, 8/30/03

Figure 2a. Turkey Creek Station TC-3
June-November 2003 Stage Height and Rainfall
