Data Collection & Application Using a Modified Stream Visual Assessment Protocol

Authored by: Katie Giacalone, Greg Rusciano,
Ellen Fyock, Dr. Christopher Obropta

Presented by Katie Giacalone
RCE Water Resources Program
May 20, 2008

2008 WEF National Monitoring Conference

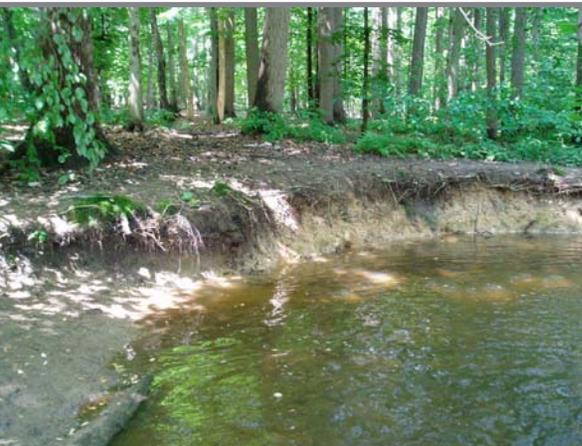
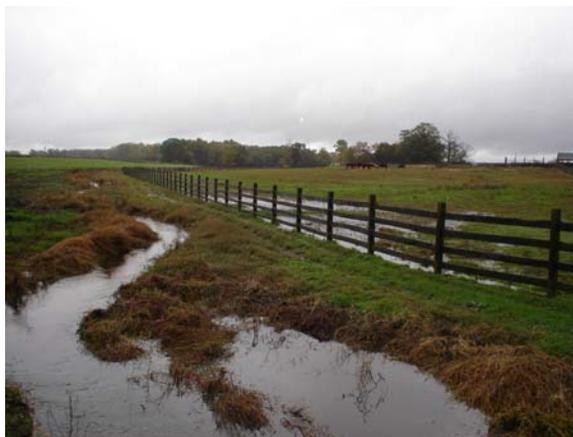
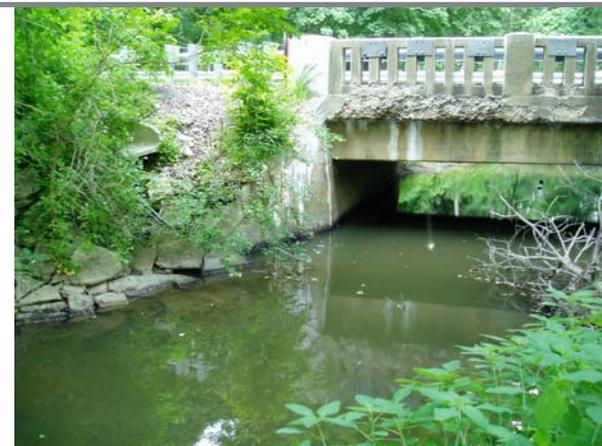
SVAP Elements

- **Channel Condition**
- **Hydrologic Alteration**
- **Riparian Zone (L, R)**
- **Bank Stability (L, R)**
- **Water Appearance**
- **Nutrient Enrichment**
- **Barriers to Fish Movement**
- **Instream Fish Cover**
- **Pools**
- **Invertebrate Habitat**
- **Canopy Cover**
- **Manure Presence**
- **Riffle Embeddedness**
- **Macroinvertebrates Observed**

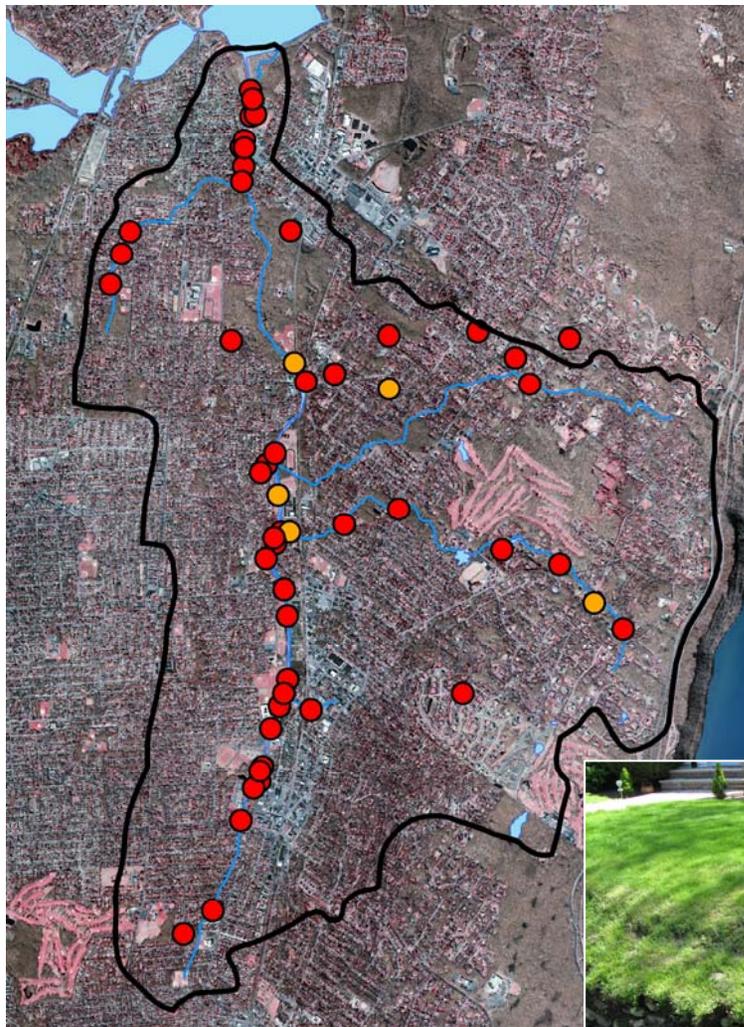
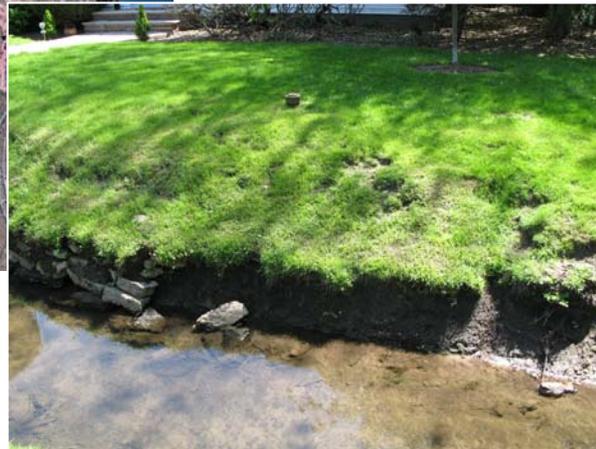
Tenakill Brook

- 9 mi², 9 river miles
- WMA 5 – the most densely populated WMA
- Addressing FC TMDL; TP data also above WQS
- 53 reaches assessed – 4.9 overall score (POOR)
- Sites identified with presence of manure – geese and pet waste management needed.

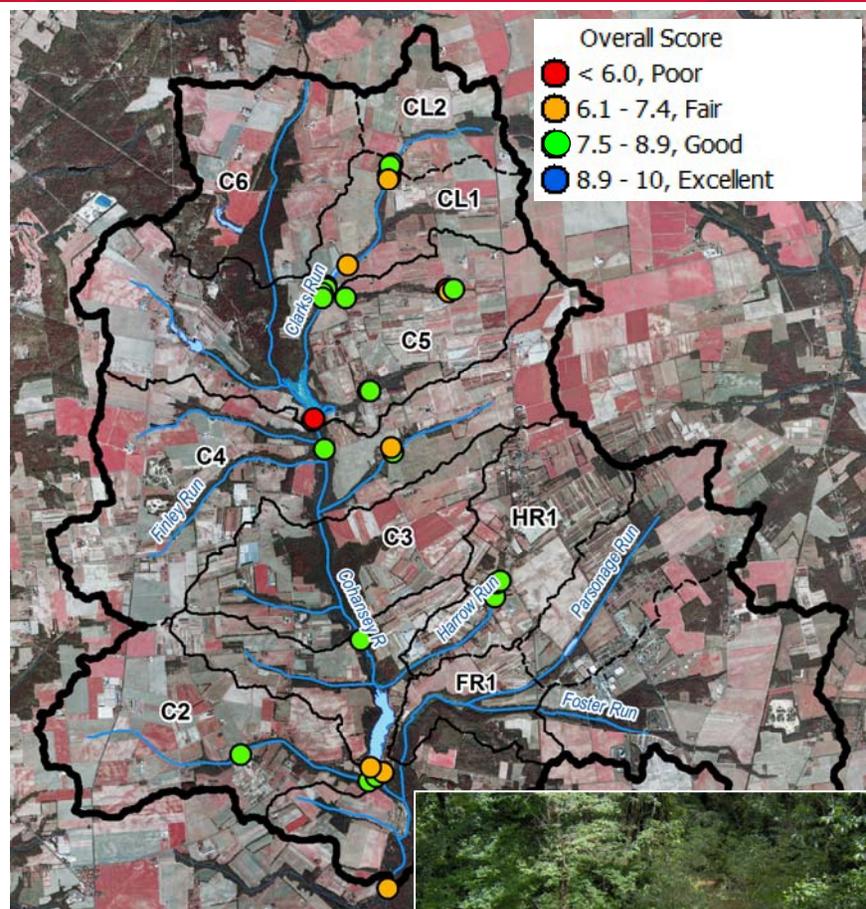
Upper Cohansey River

- 31 mi², 26 river miles
- 35 reaches assessed
- 86% Agriculture
- Addressing FC, TP TMDLs and aquatic life impairment
- Eroding stream banks, lack of riparian buffer, and water appearance scores are a focus
- Overall "GOOD"

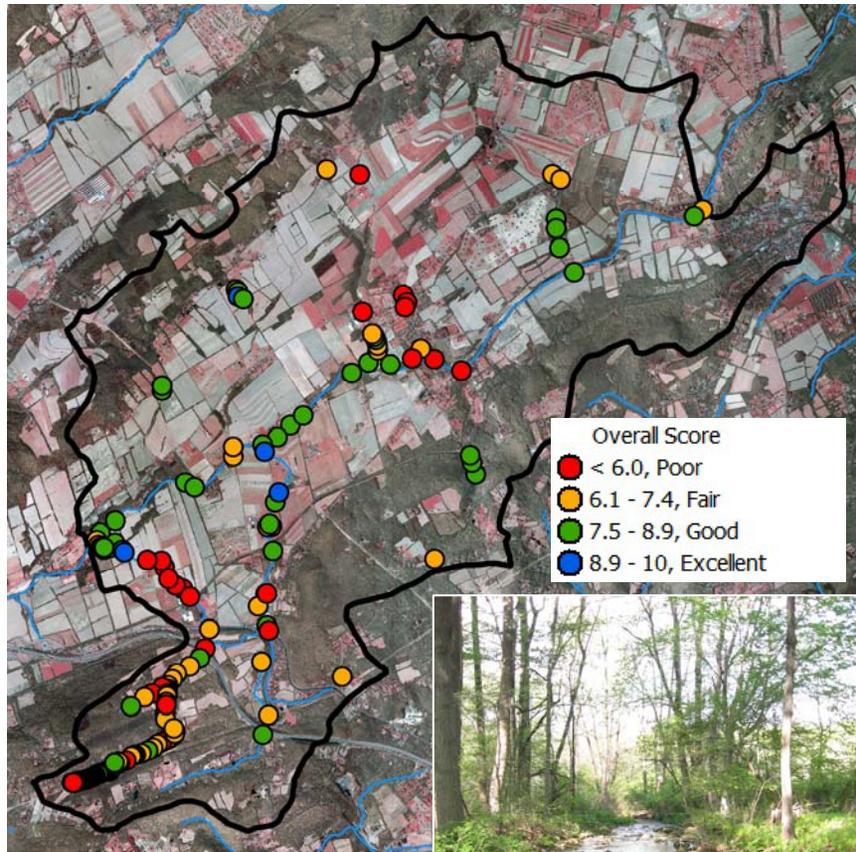
Musconetcong River

- 19 mi², 23 river miles
- 166 reaches assessed!
- Low and high gradient streams
- 45% Ag, 34% Forest
- EXCELLENT water appearance scores
- Pools and Barriers to Fish Movements were lowest scoring elements
- Opportunities for agricultural buffers documented as well as livestock and equine fencing

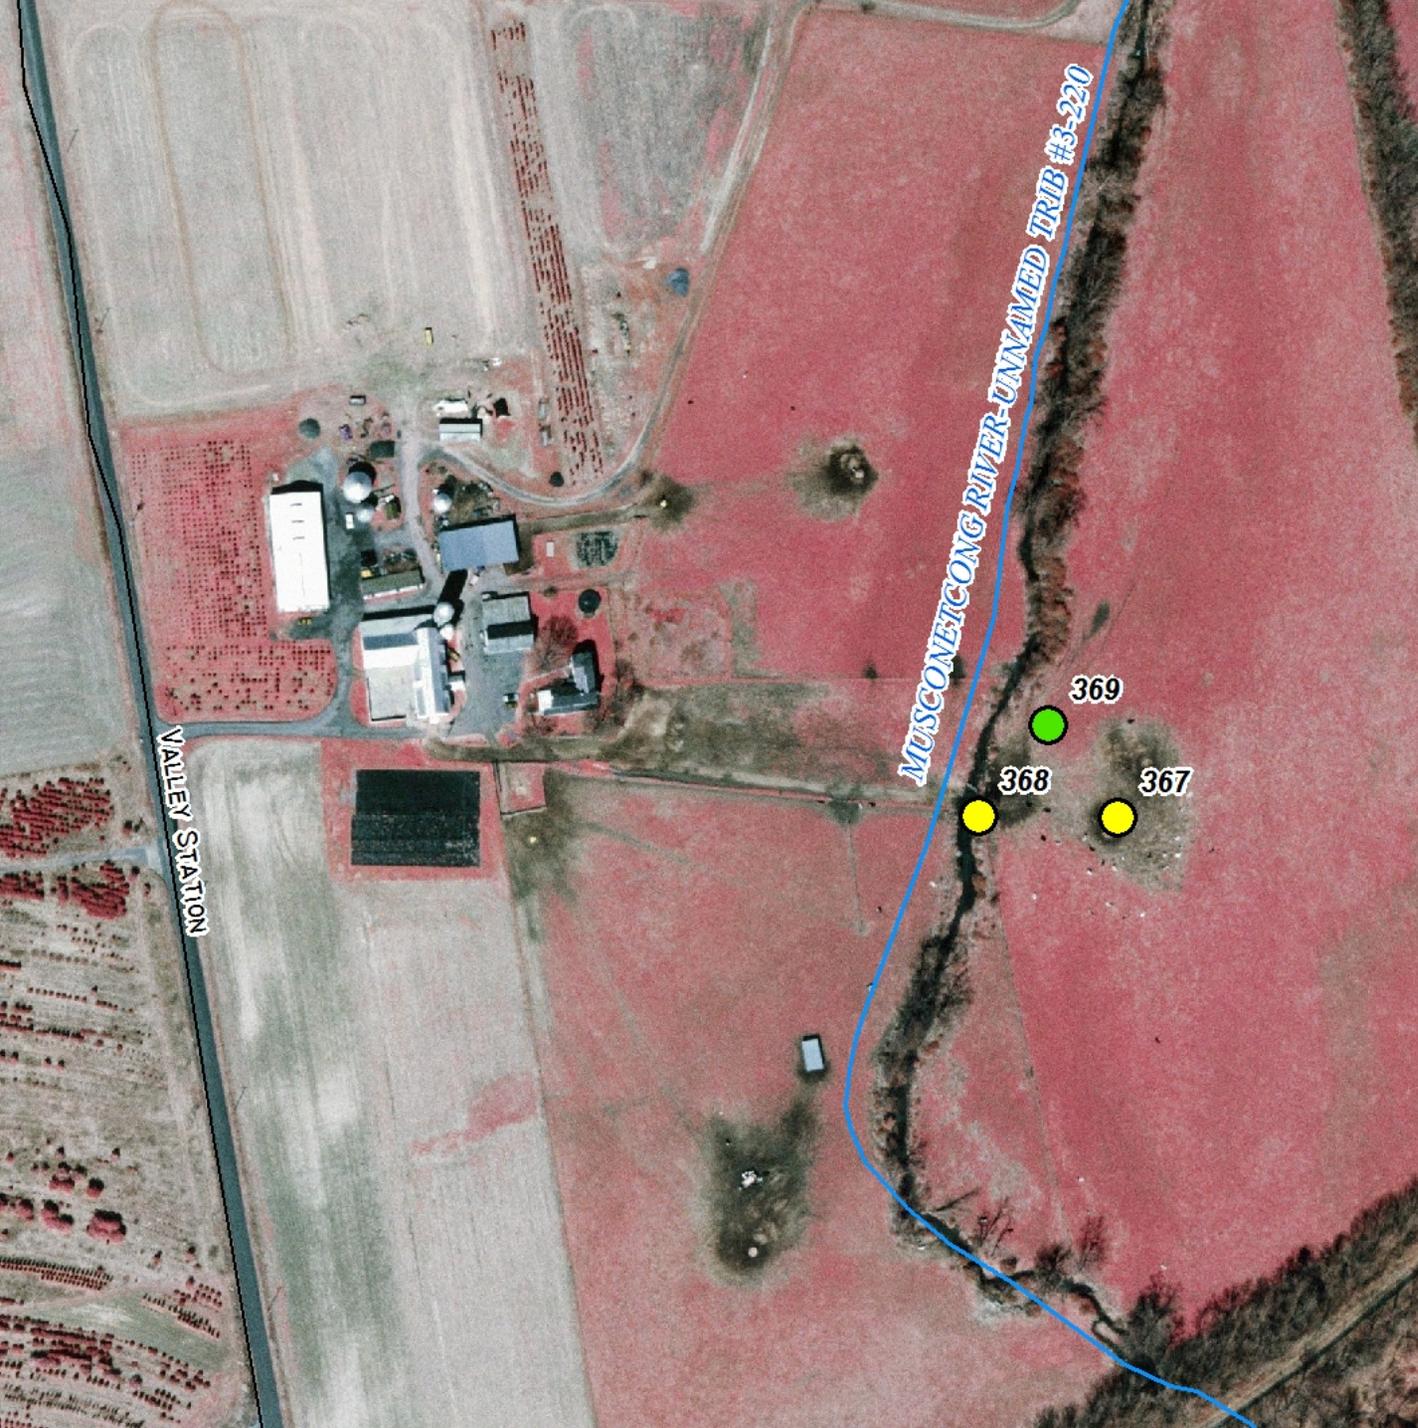
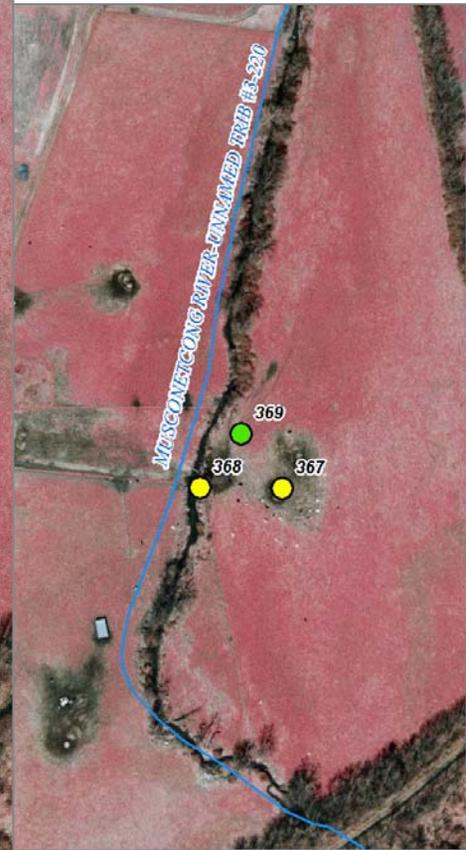
manure in stream
ge located in flood

of livestock access
e

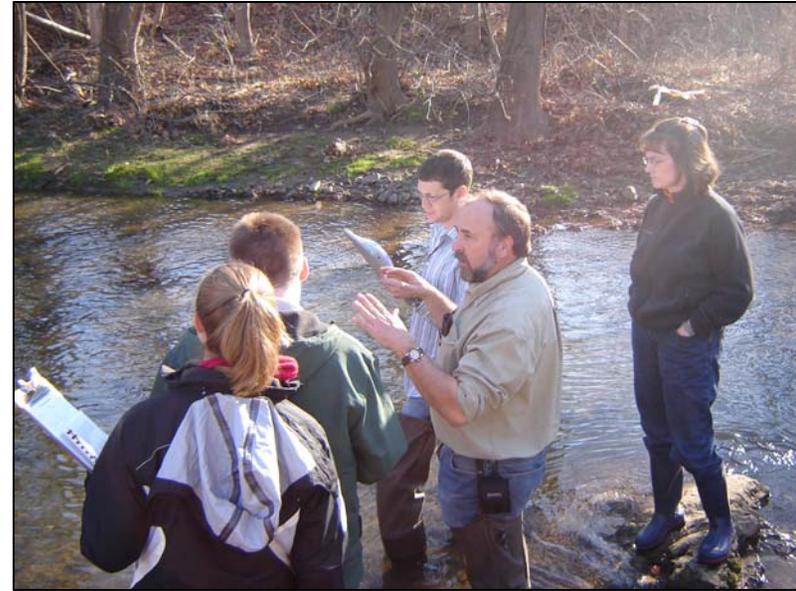
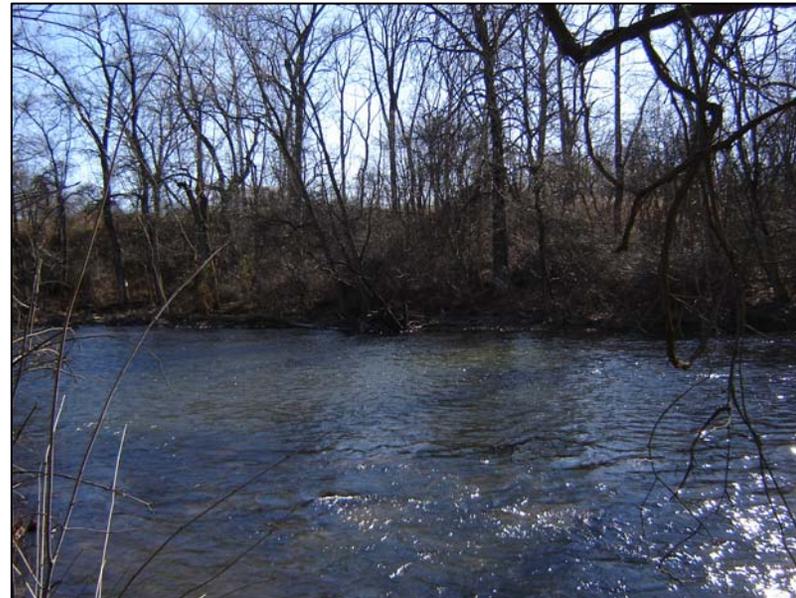
- Online database developed for ease of data entry storage.
- Data downloaded as spreadsheet and GIS point file.
