Measuring Reservoir Drawdown Effects in Texas as Part of the 2012 National Lakes Assessment: A Pilot Study to Enhance National Methods

Surface Water Quality Monitoring Program
Texas Commission on Environmental Quality

May 2, 2012
8th National Water Monitoring Conference
Portland, OR

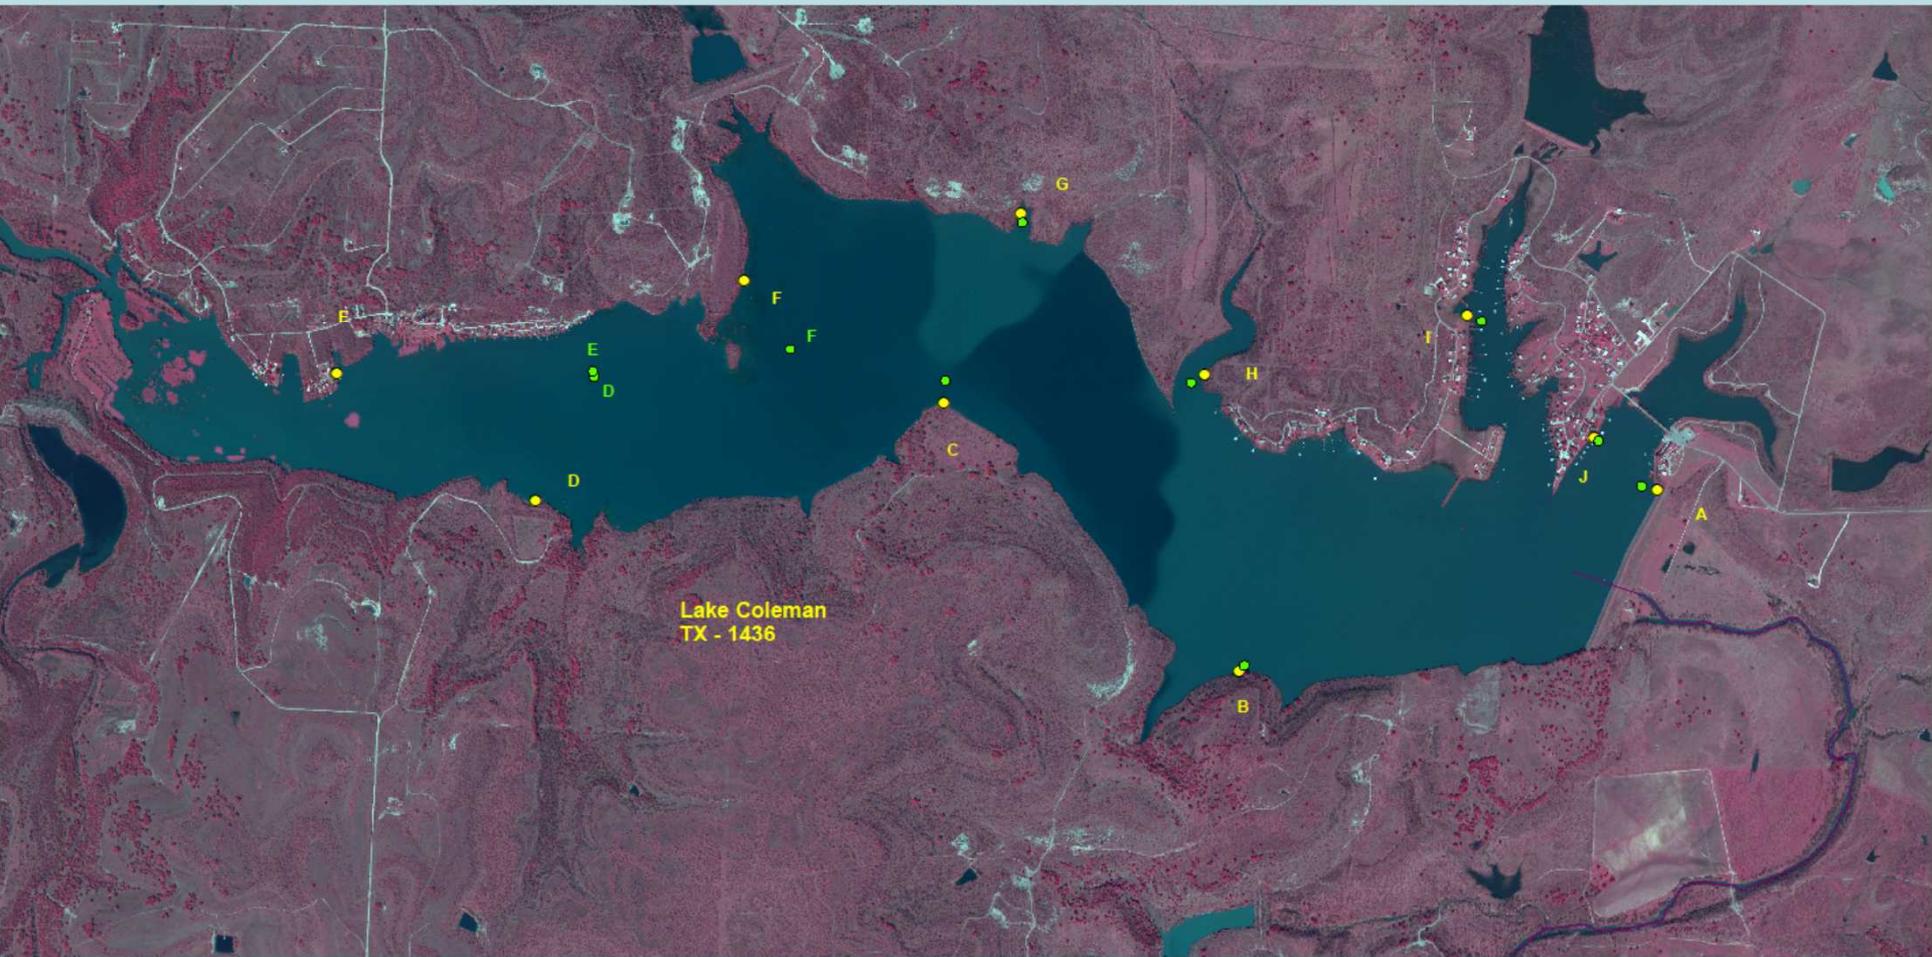
Map of Lake Coleman, Texas comparing selected sites from GIS (yellow) to location of sites that were accessible in the field (green)

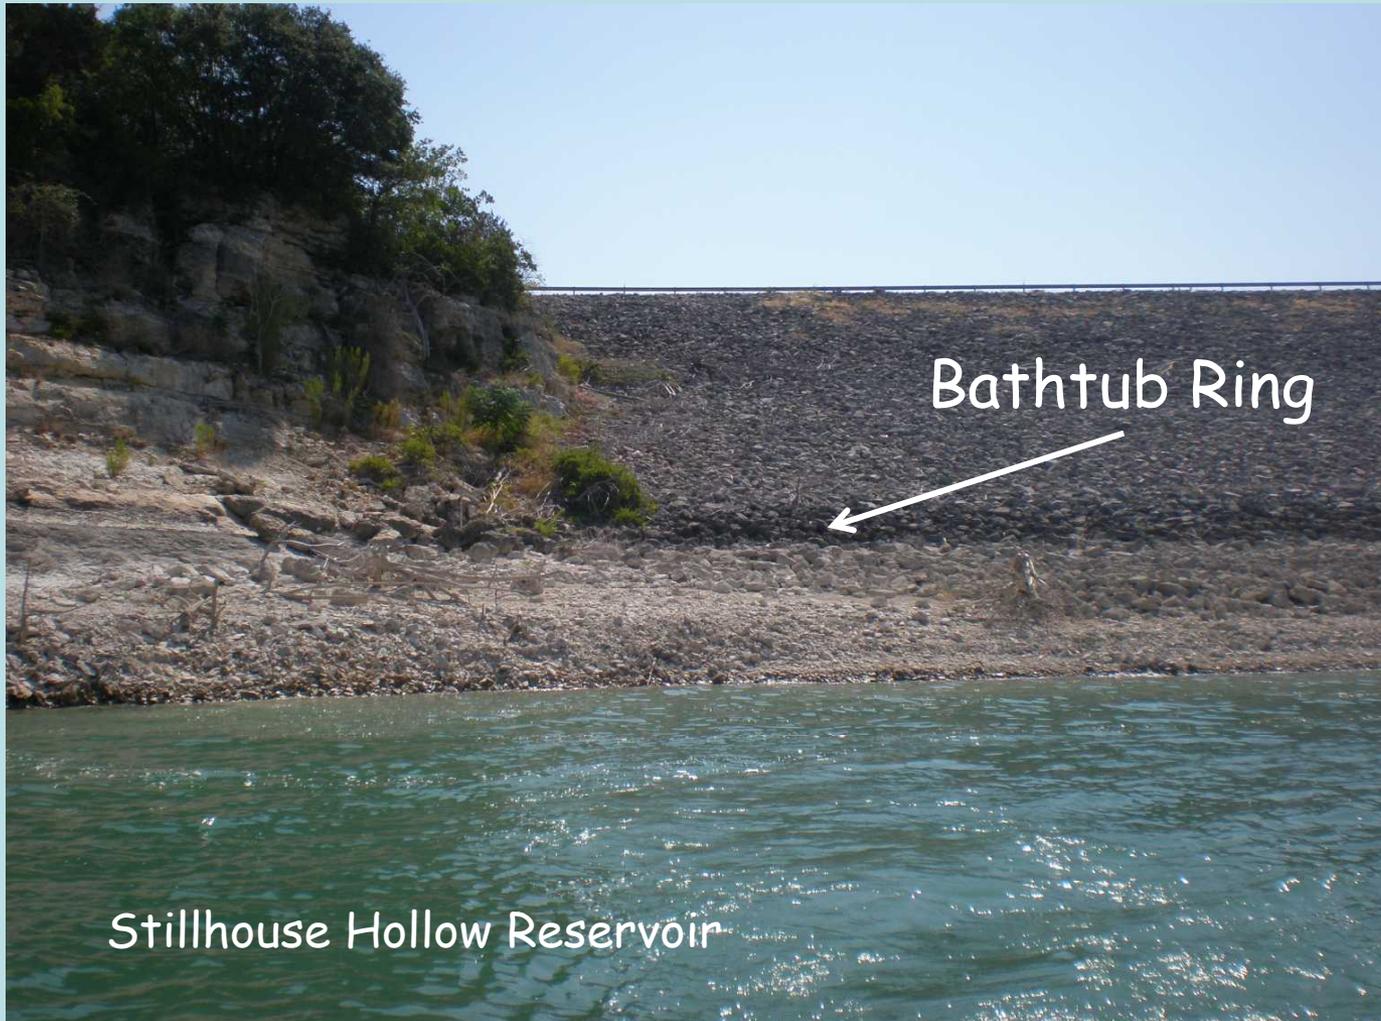
Stillhouse Hollow Reservoir

First evidence of drawdown or flooding is presence or absence of a "bathtub ring"

Bathtub Ring

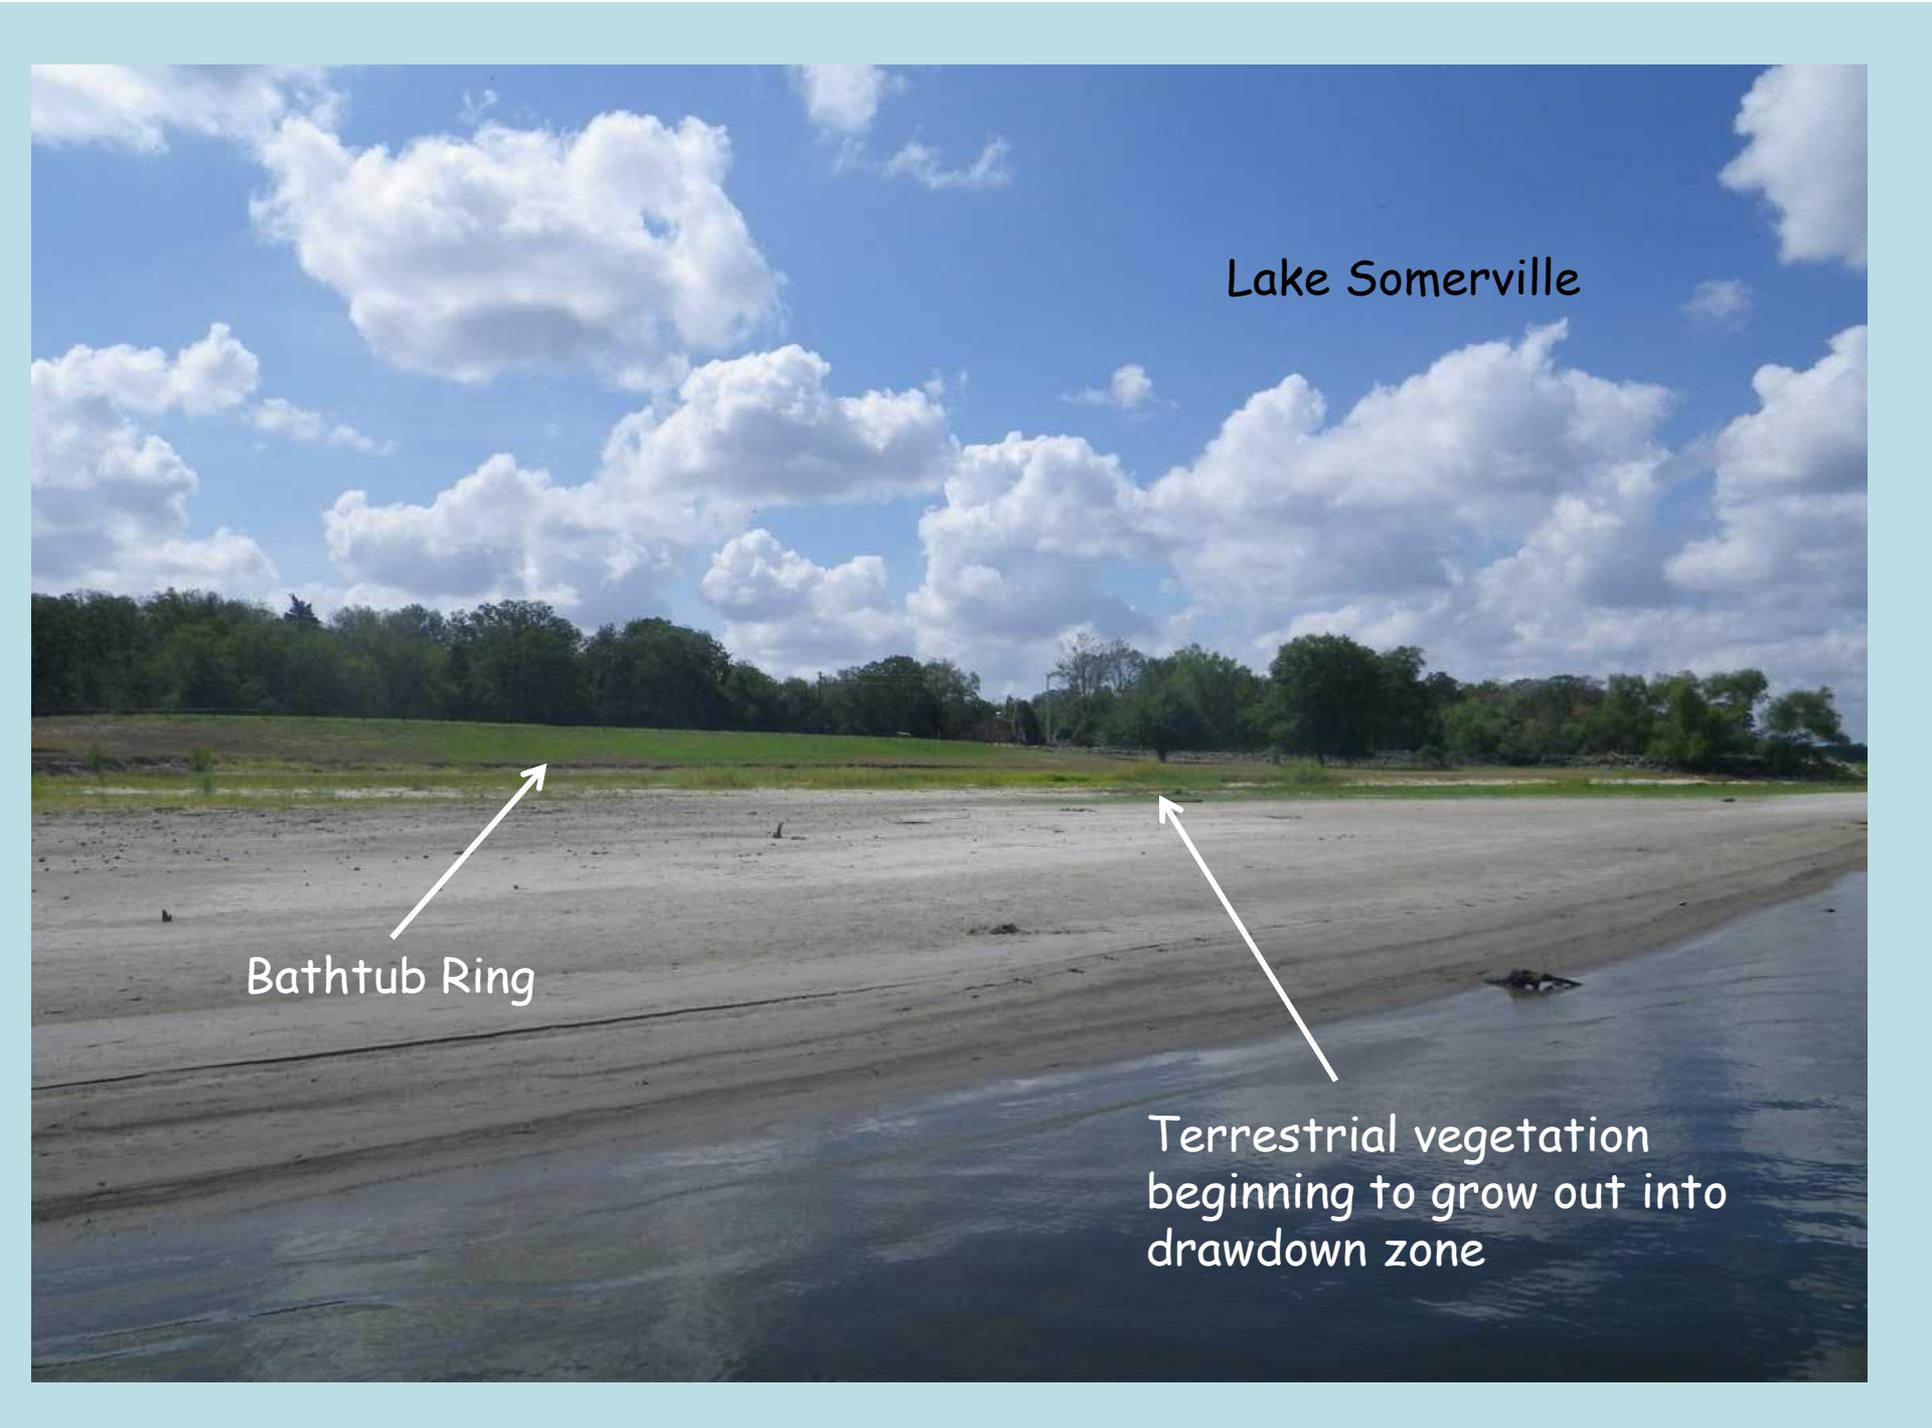
Lake Somerville

A photograph of a lake shoreline under a blue sky with white clouds. The foreground shows a sandy beach with a dark, wet area near the water's edge. A line of green grass and low vegetation is visible in the middle ground, and a dense line of trees is in the background. Two white arrows point from text labels to specific features in the landscape.

Bathtub Ring

Terrestrial vegetation
beginning to grow out into
drawdown zone

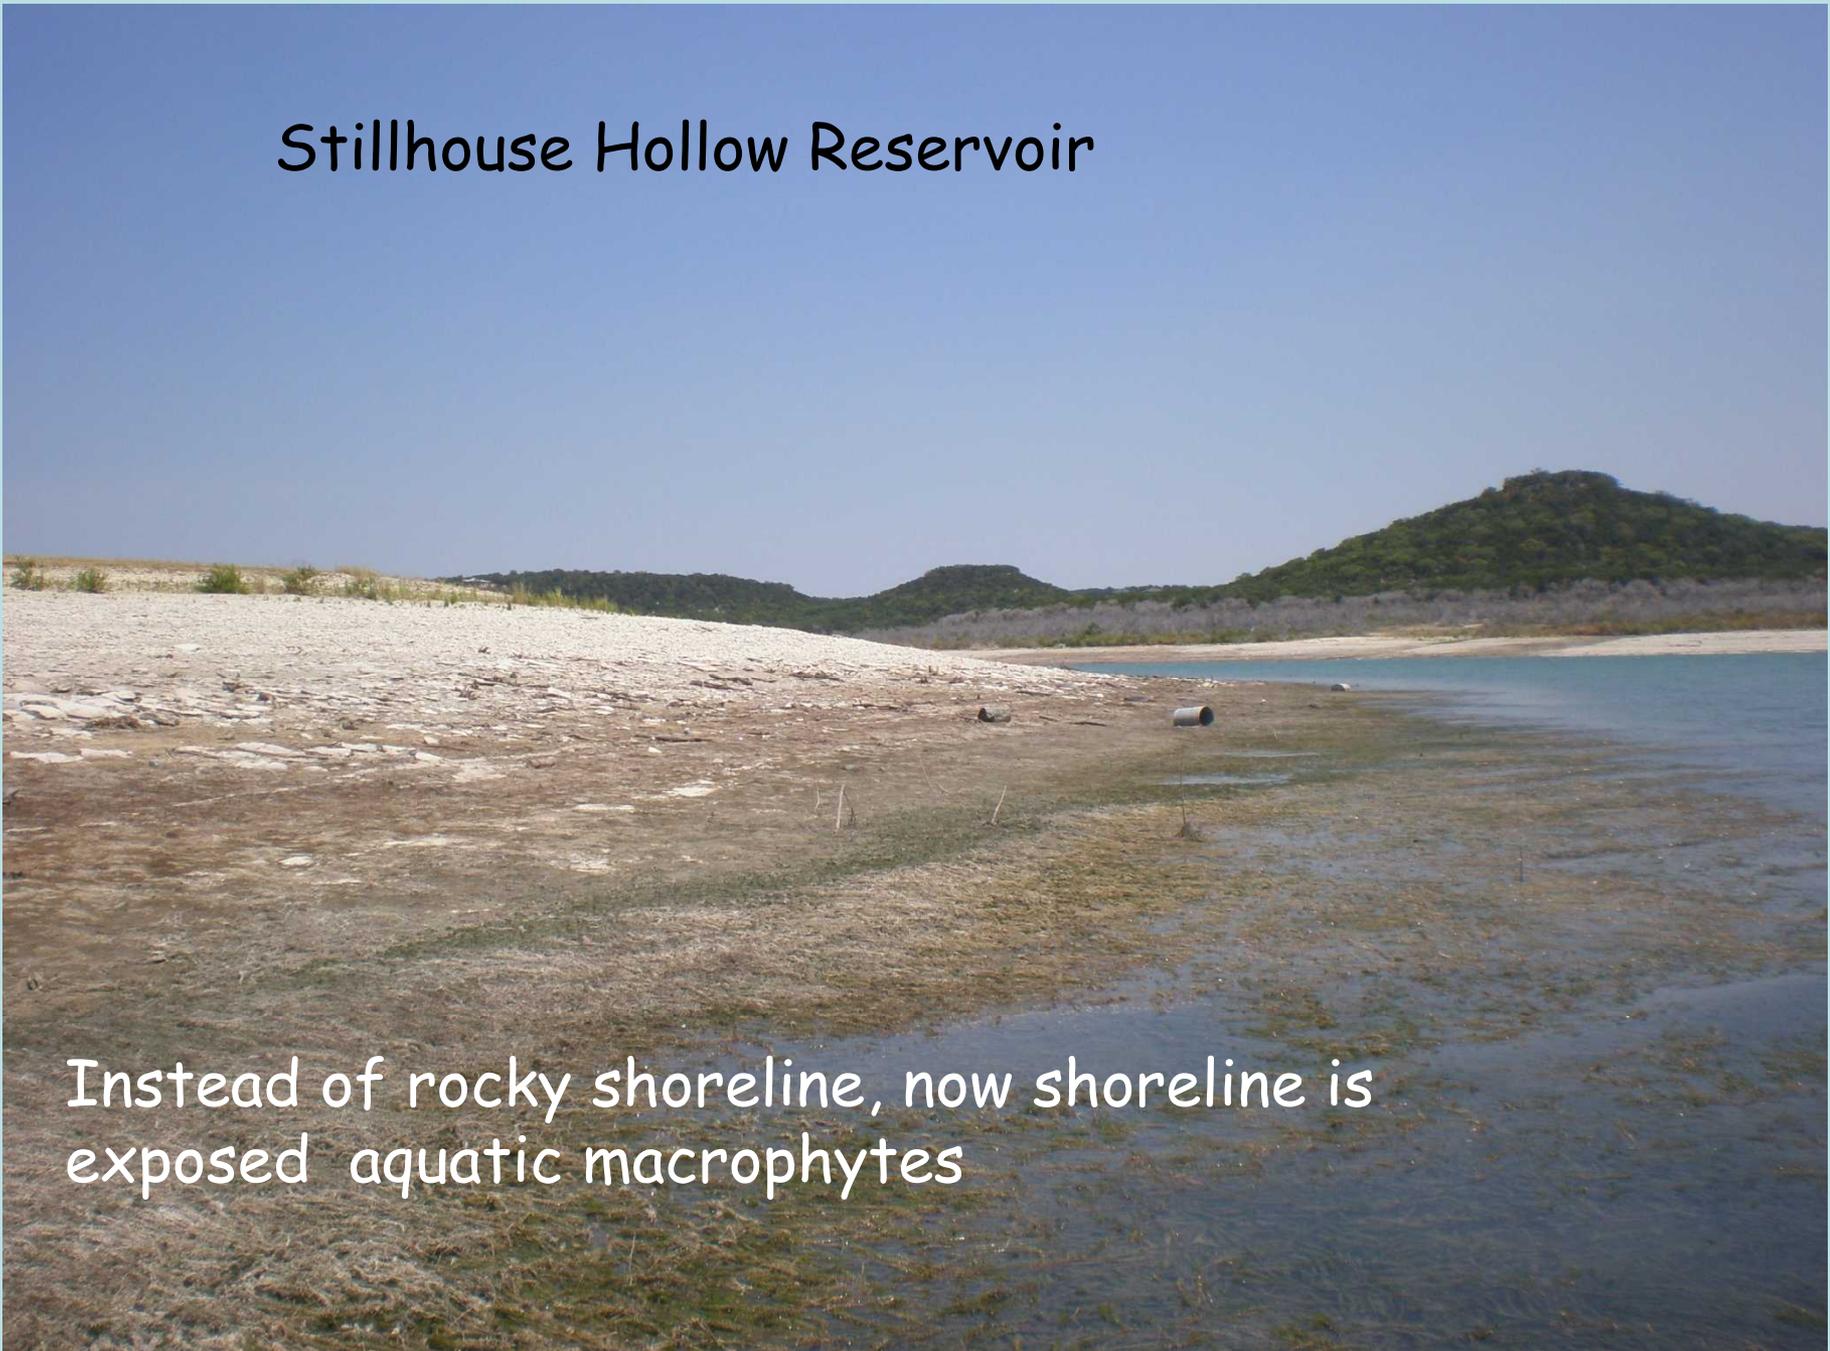
Stillhouse Hollow Reservoir

Instead of rocky shoreline, now shoreline is exposed aquatic macrophytes

- Exposed elements such as aquatic macrophytes, pier pilings, boulders, and woody debris are no longer available in littoral zone for fish habitat
- True riparian zone now far from shoreline and may no longer provide adequate buffer from run-off
- Exposed substrate sediments in drawdown zone may be eroded by wind or rain causing future changes in shoreline vegetation composition

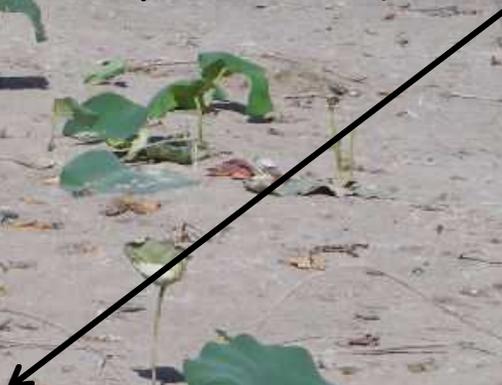
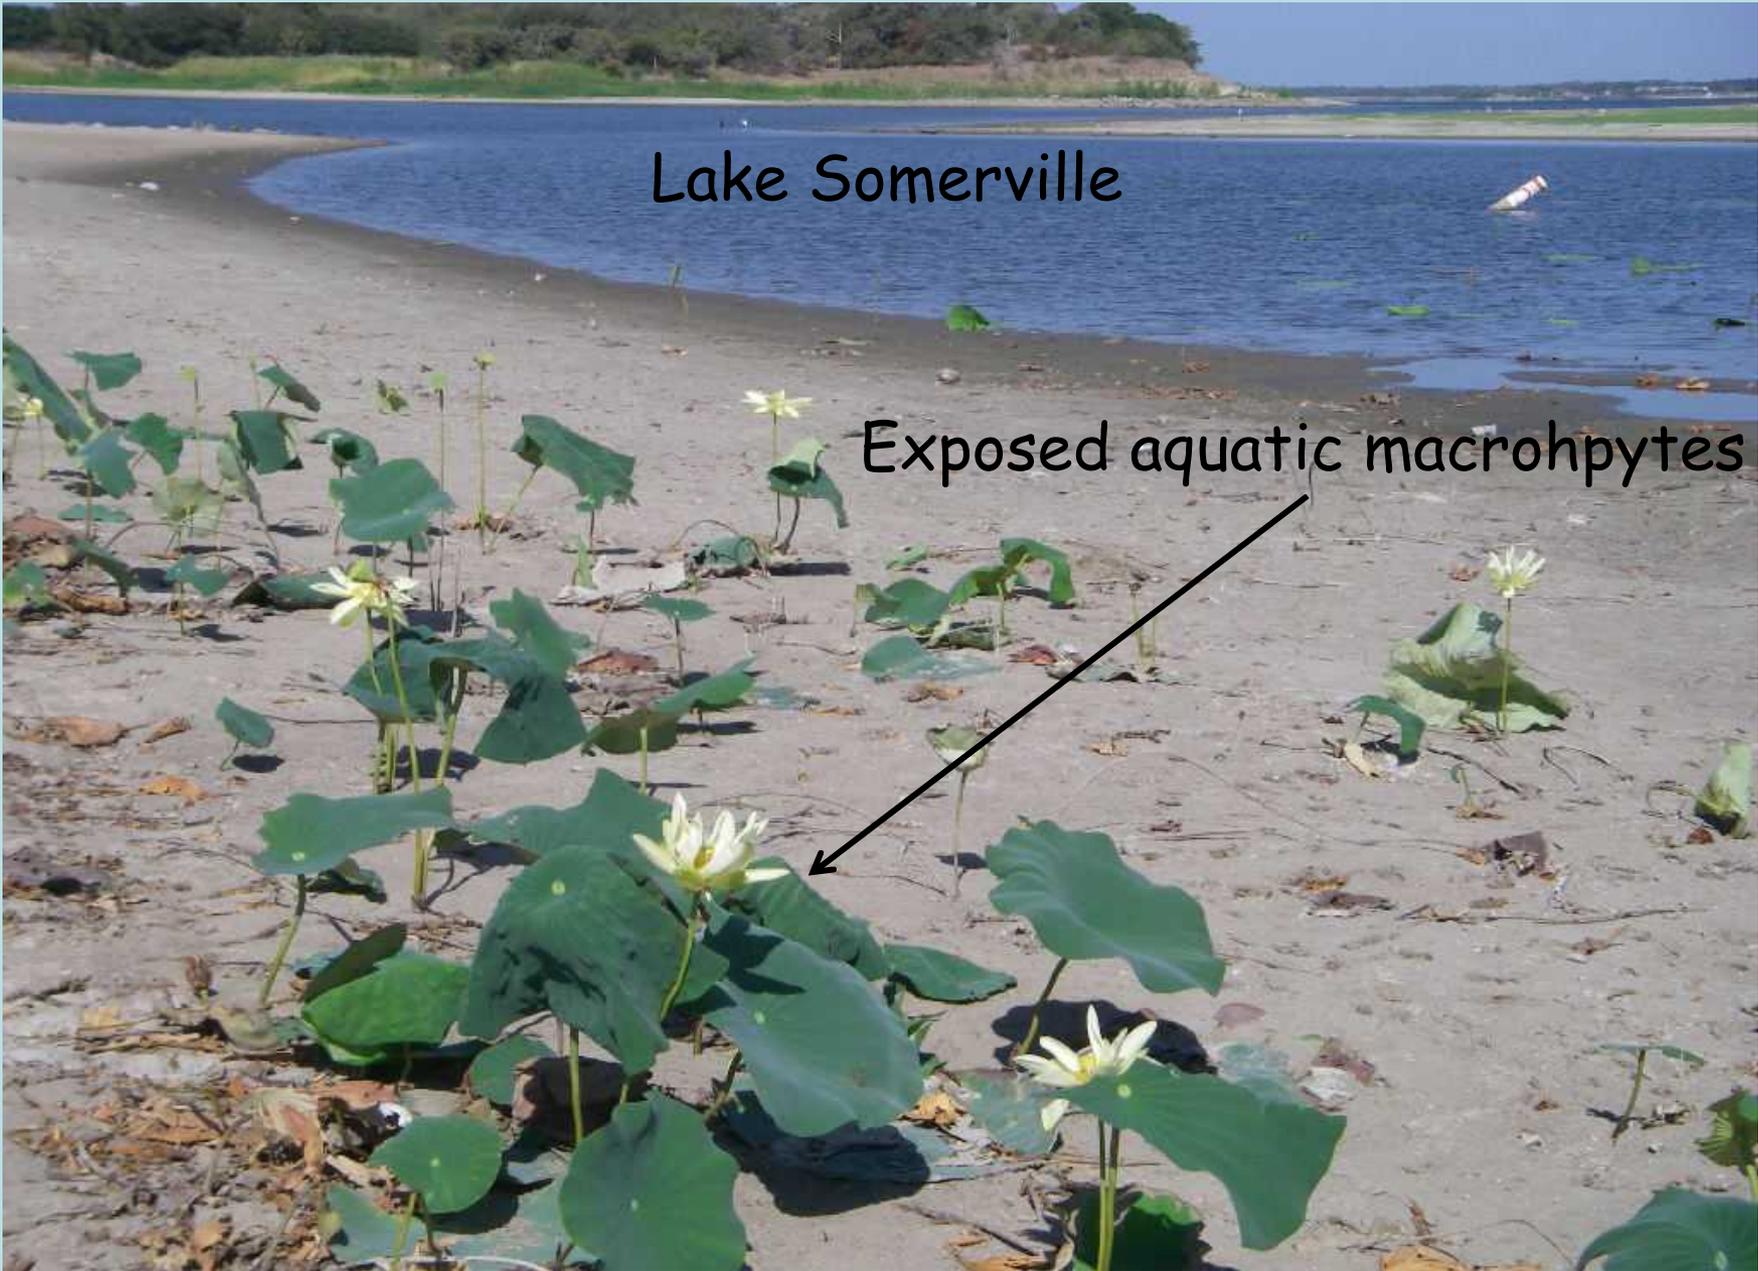
Lake Somerville

Exposed aquatic macrophytes

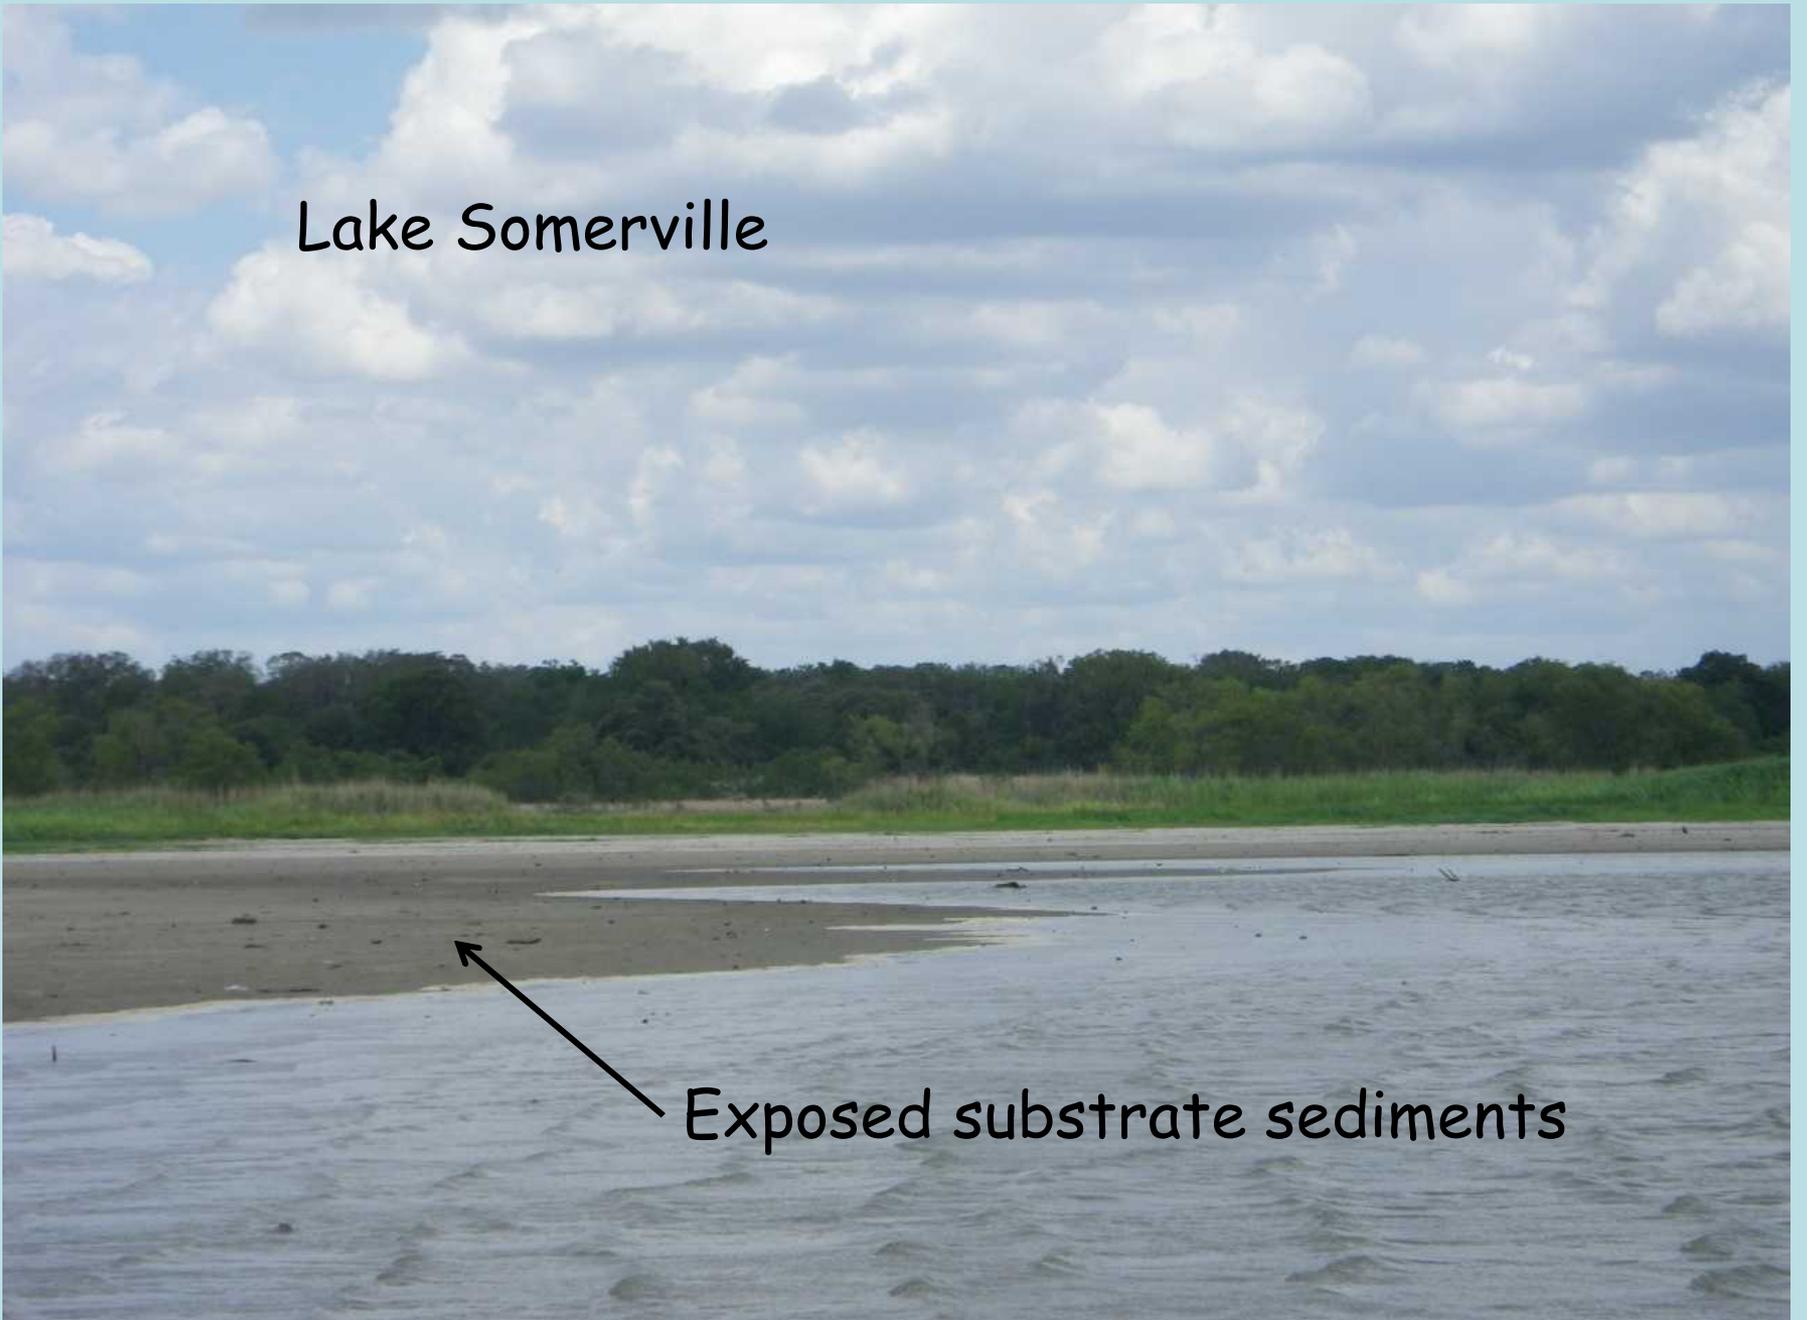
Lake Somerville

Exposed substrate sediments

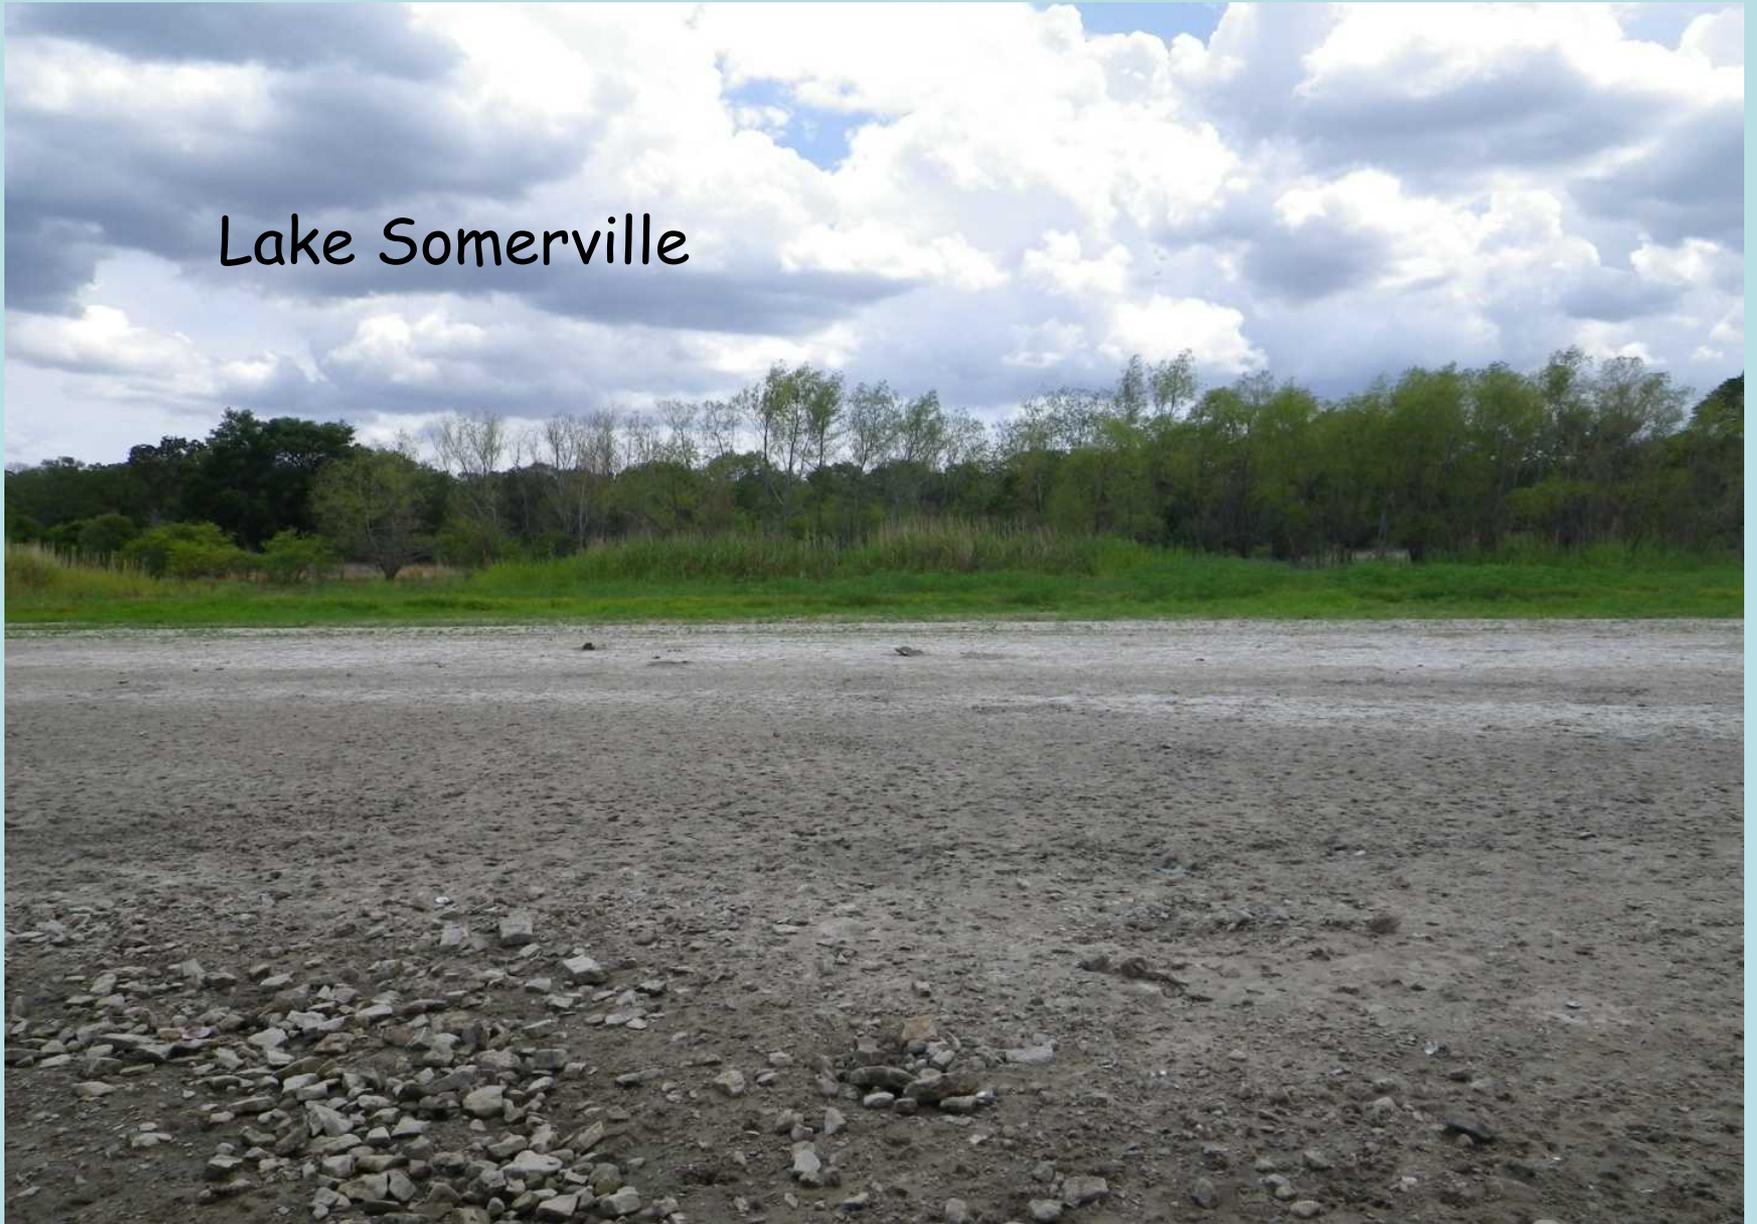
Lake Somerville

When steep shorelines are exposed, scouring is much more likely during heavy rain events

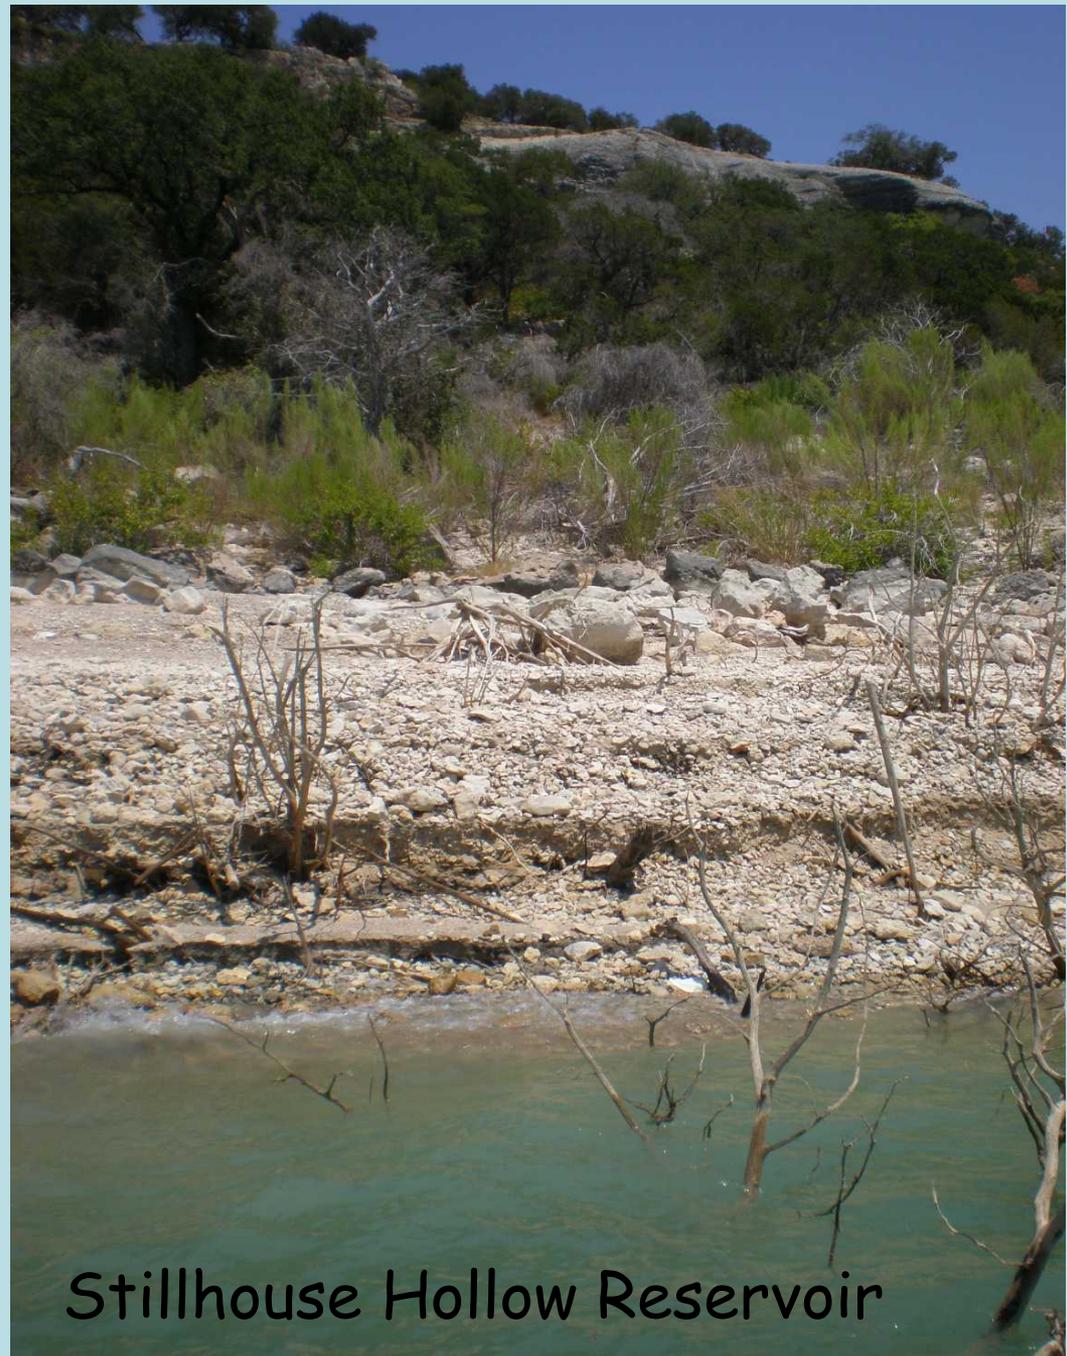
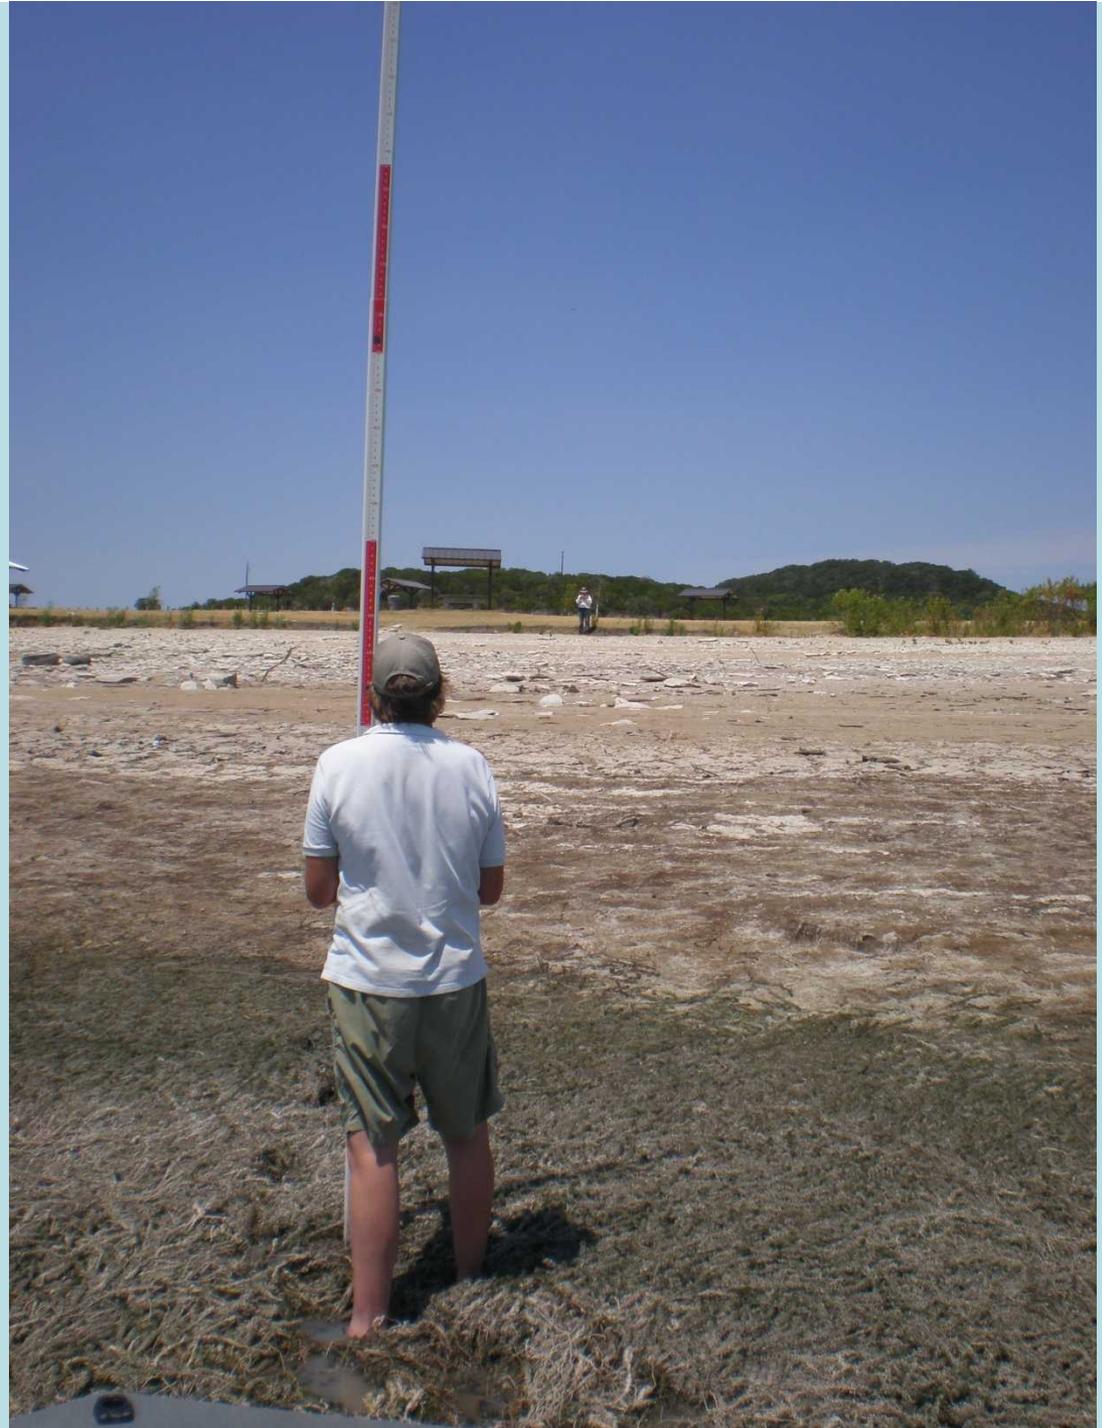
Stillhouse Hollow Reservoir

Measuring drawdown distance and elevation

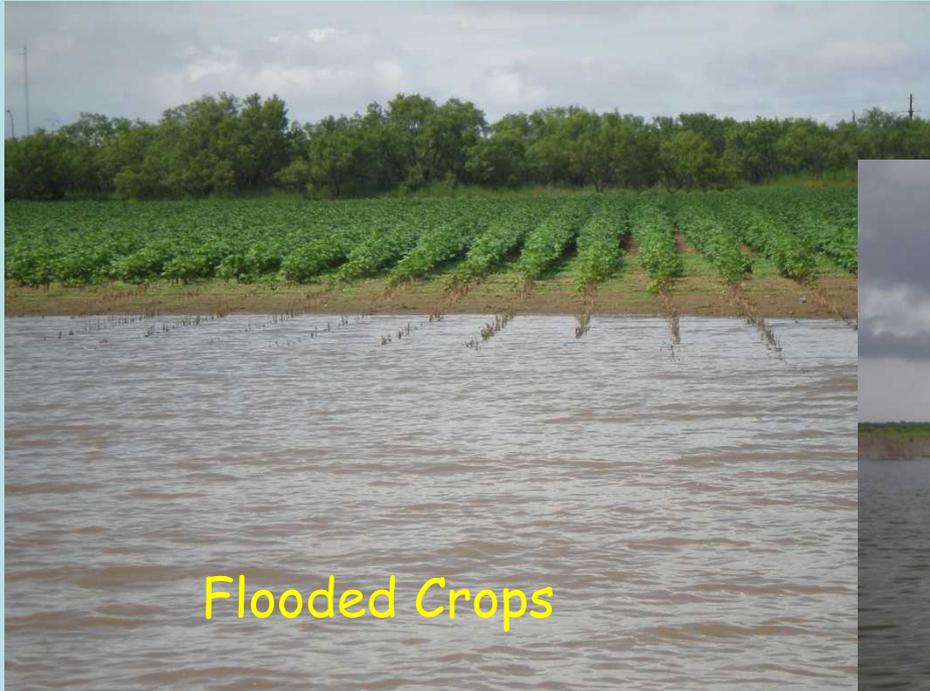
Flooded Crops

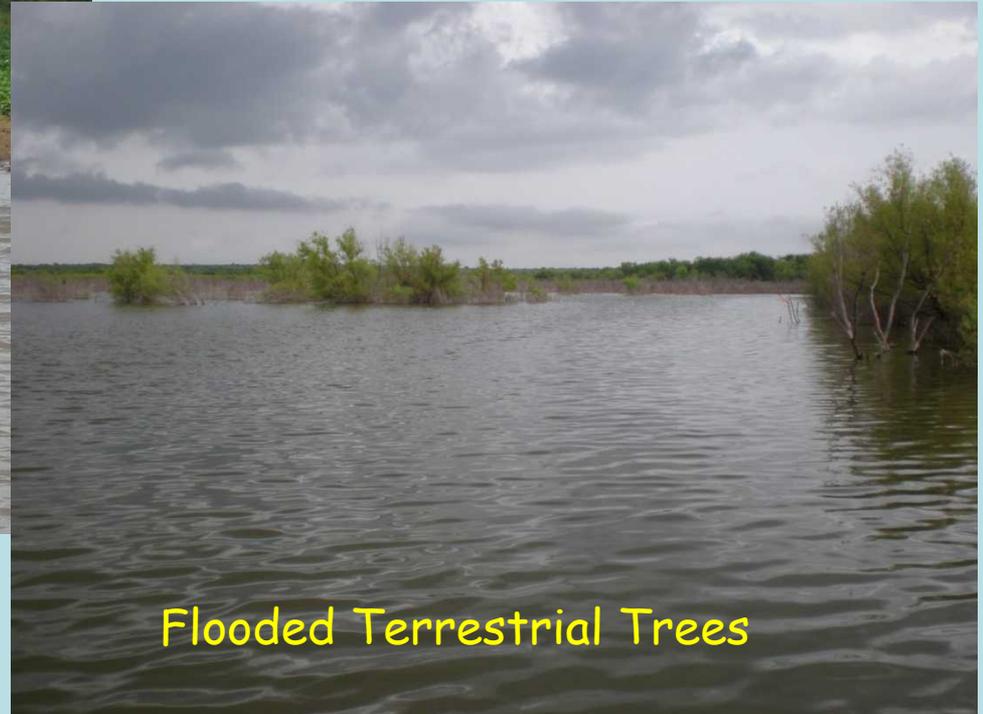
Miller Creek Reservoir in north Texas

Flooded Terrestrial Trees

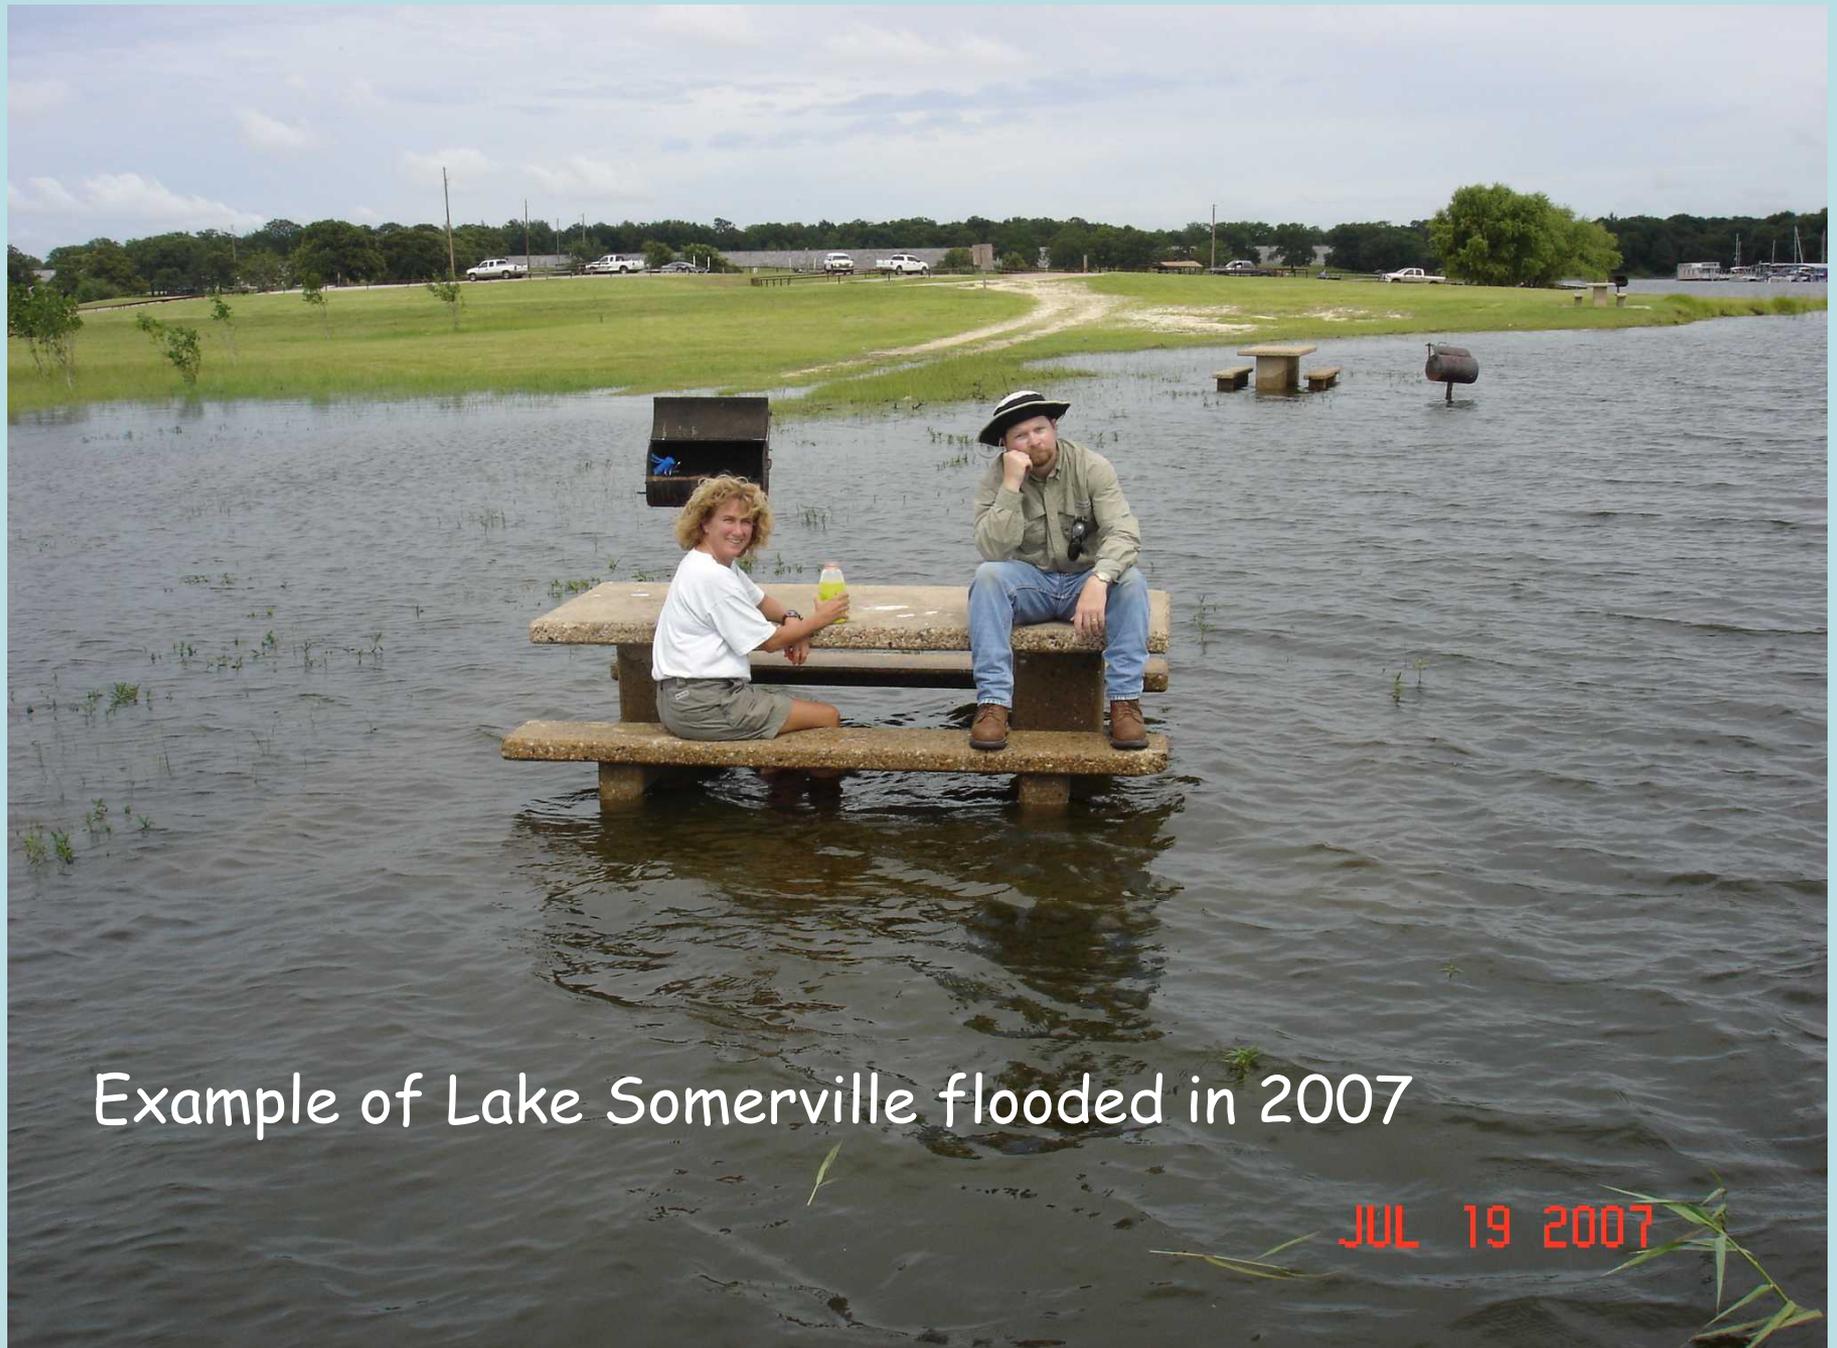
Many lakes were flooded in 2007 due to summer rains across Texas

Example of Lake Somerville flooded in 2007
