Measuring Reservoir Drawdown Effects in Texas as Part of the 2012 National Lakes Assessment: A Pilot Study to Enhance National Methods

Surface Water Quality Monitoring Program
Texas Commission on Environmental Quality

May 2, 2012
8th National Water Monitoring Conference
Portland, OR

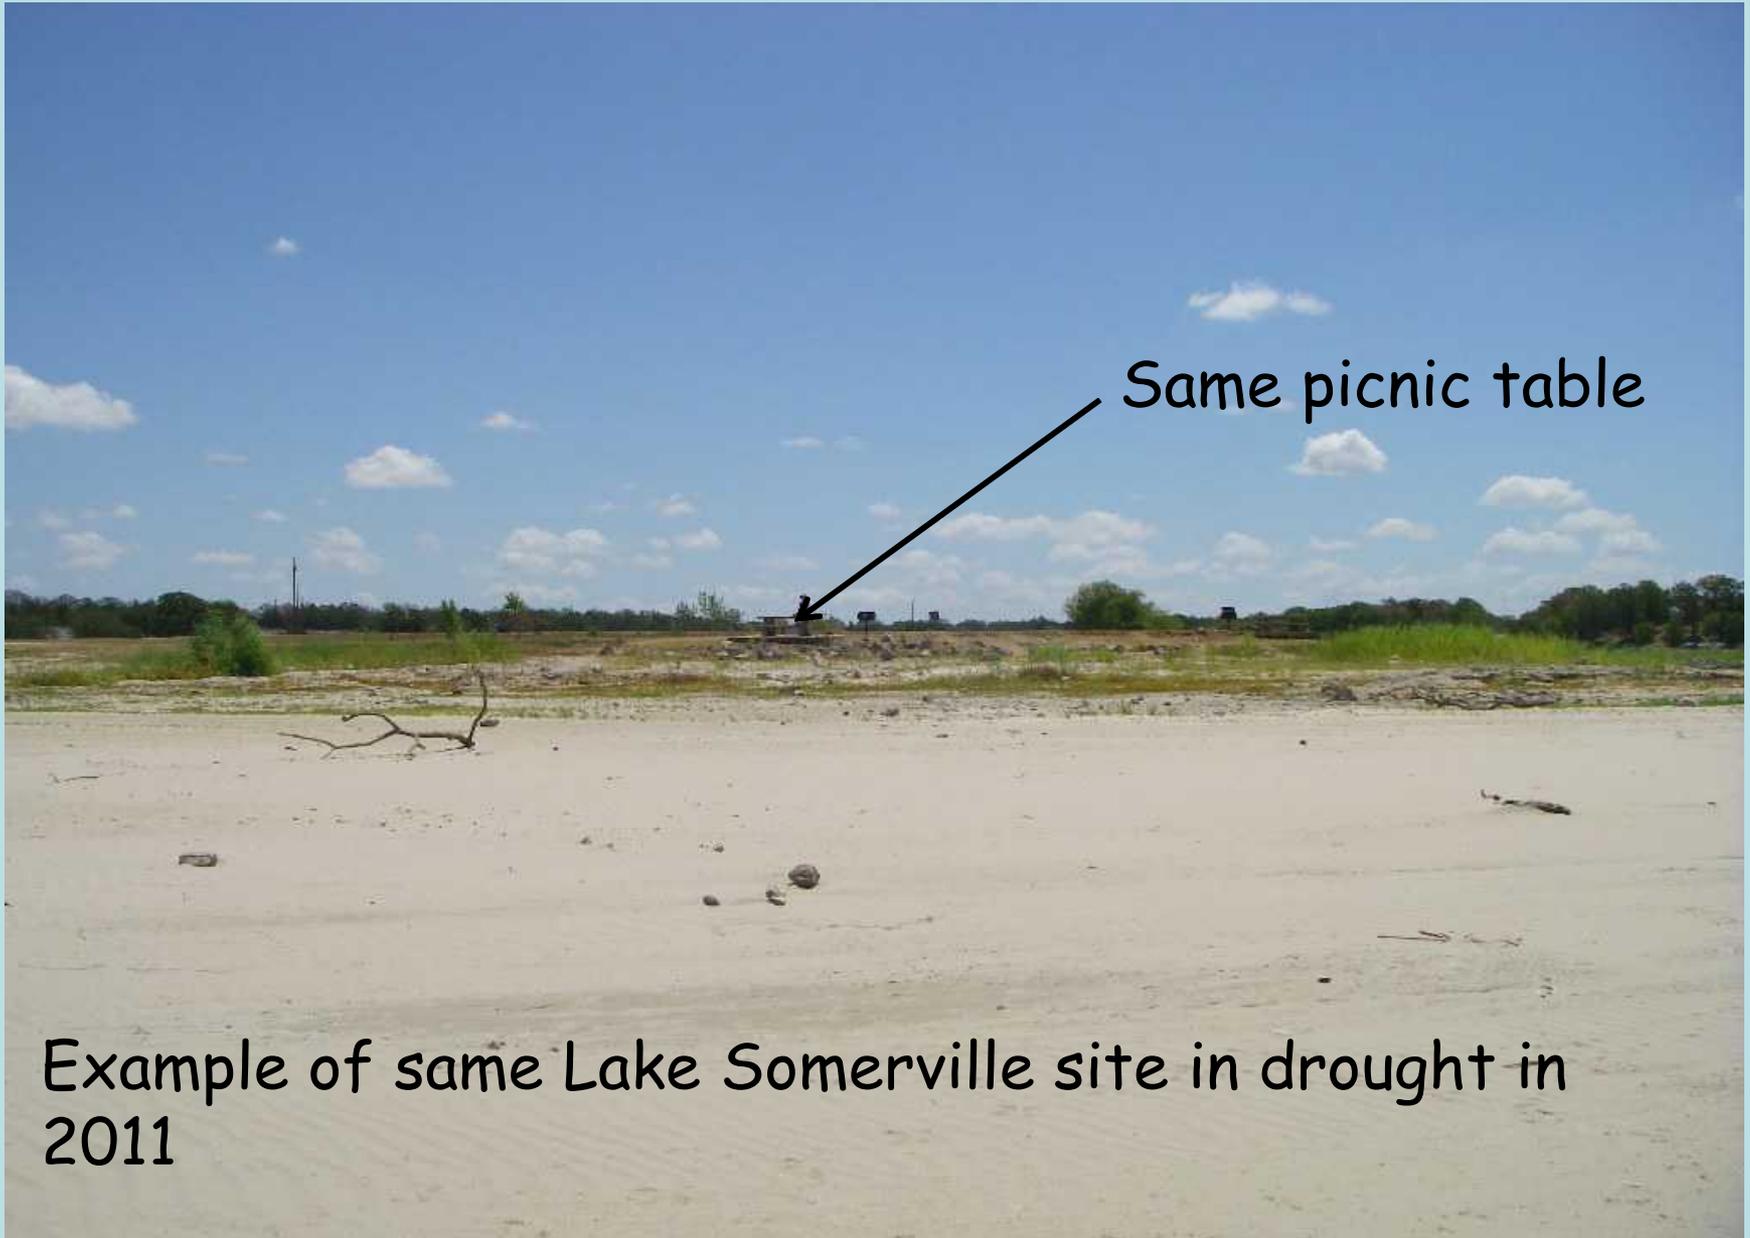
Same picnic table

Example of same Lake Somerville site in drought in 2011

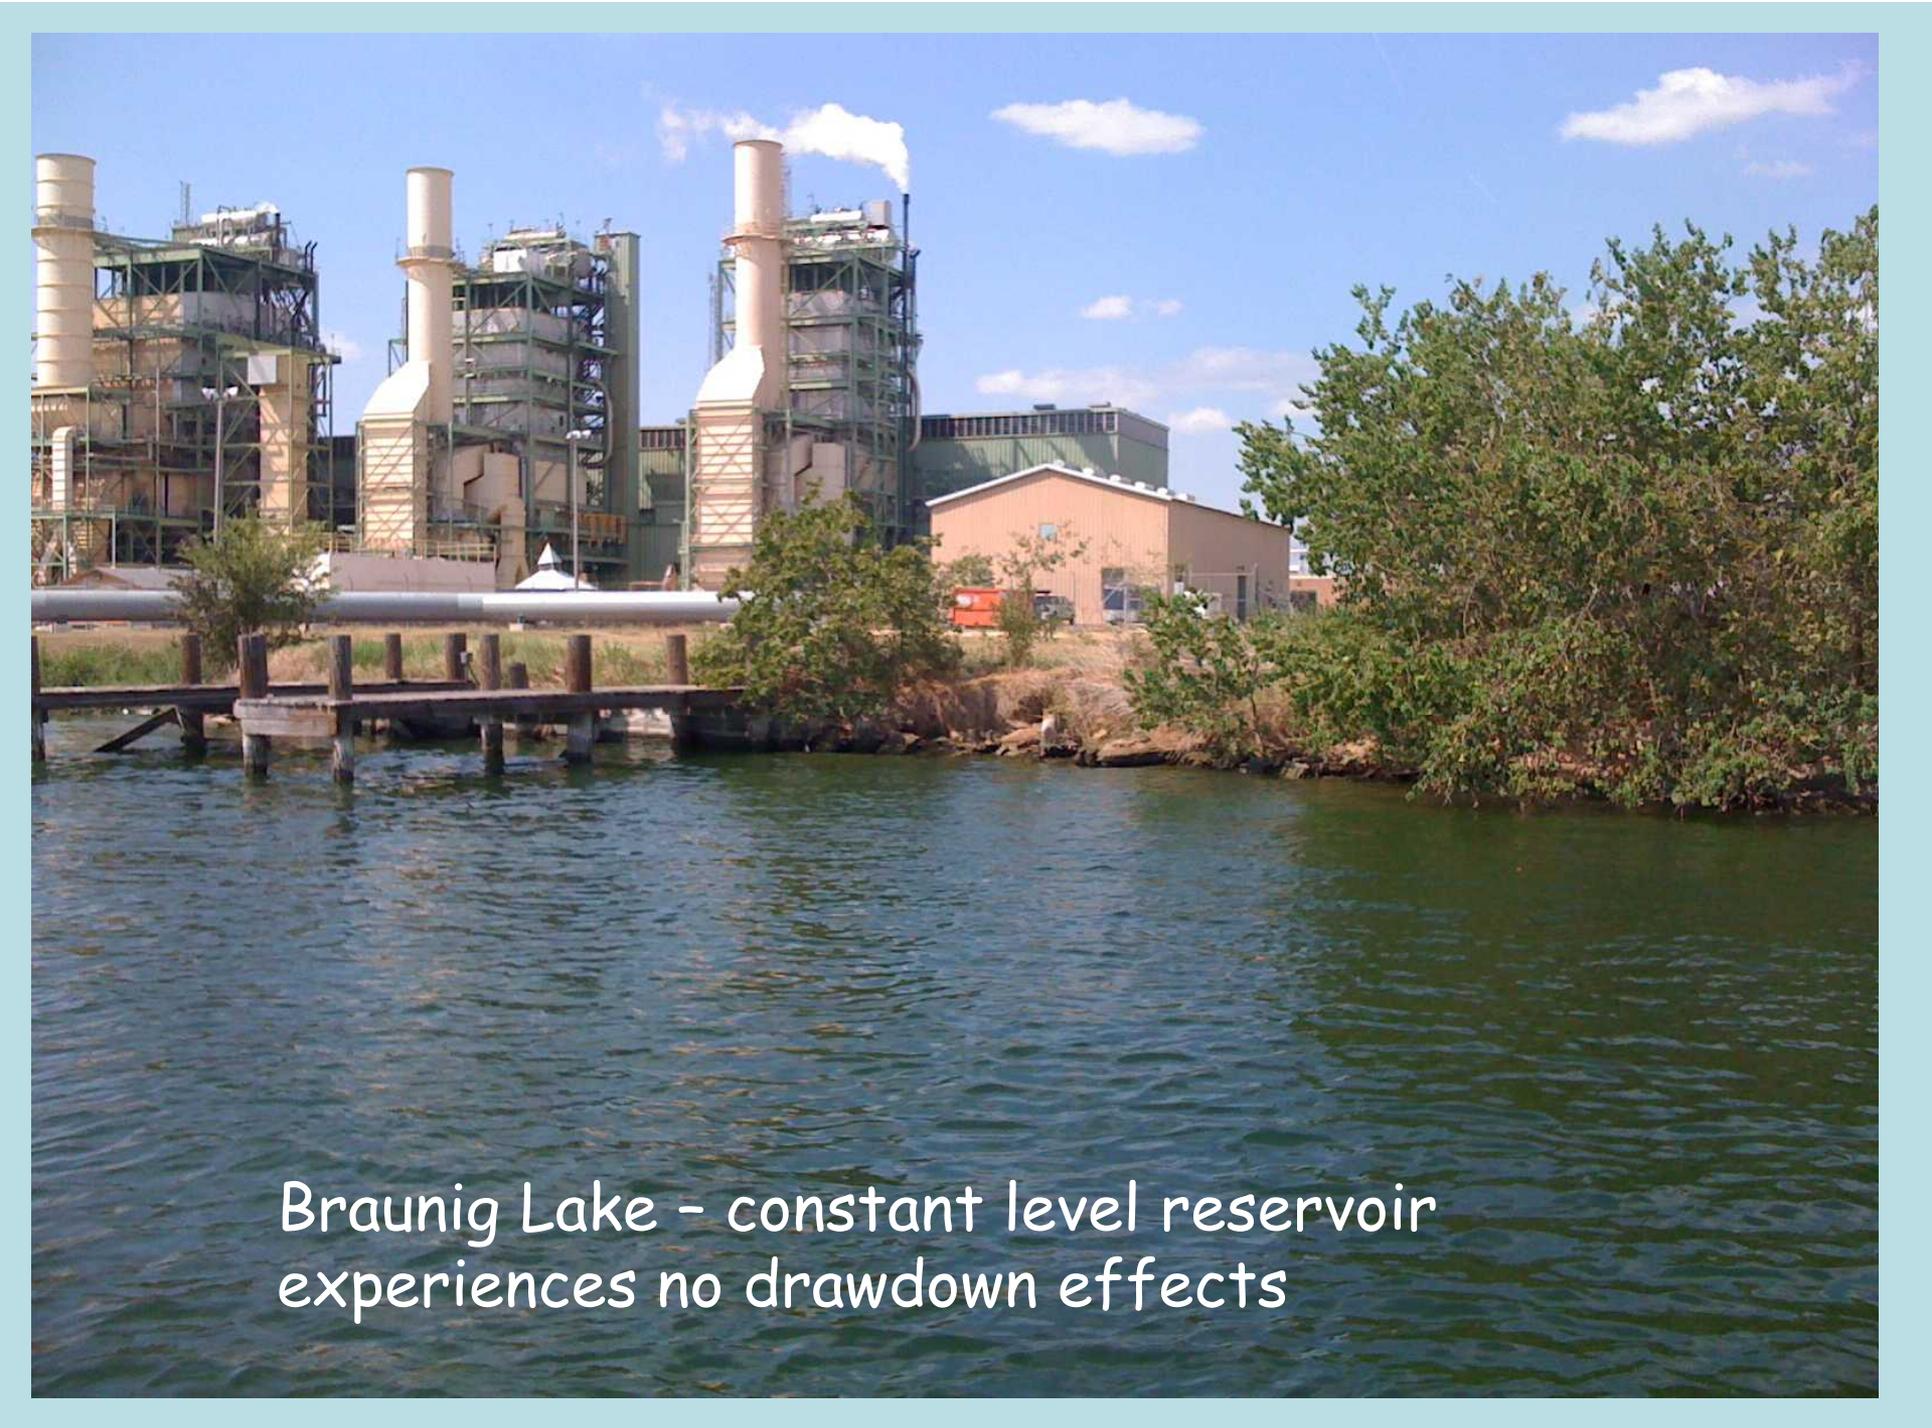
Braunig Lake - constant level reservoir
experiences no drawdown effects

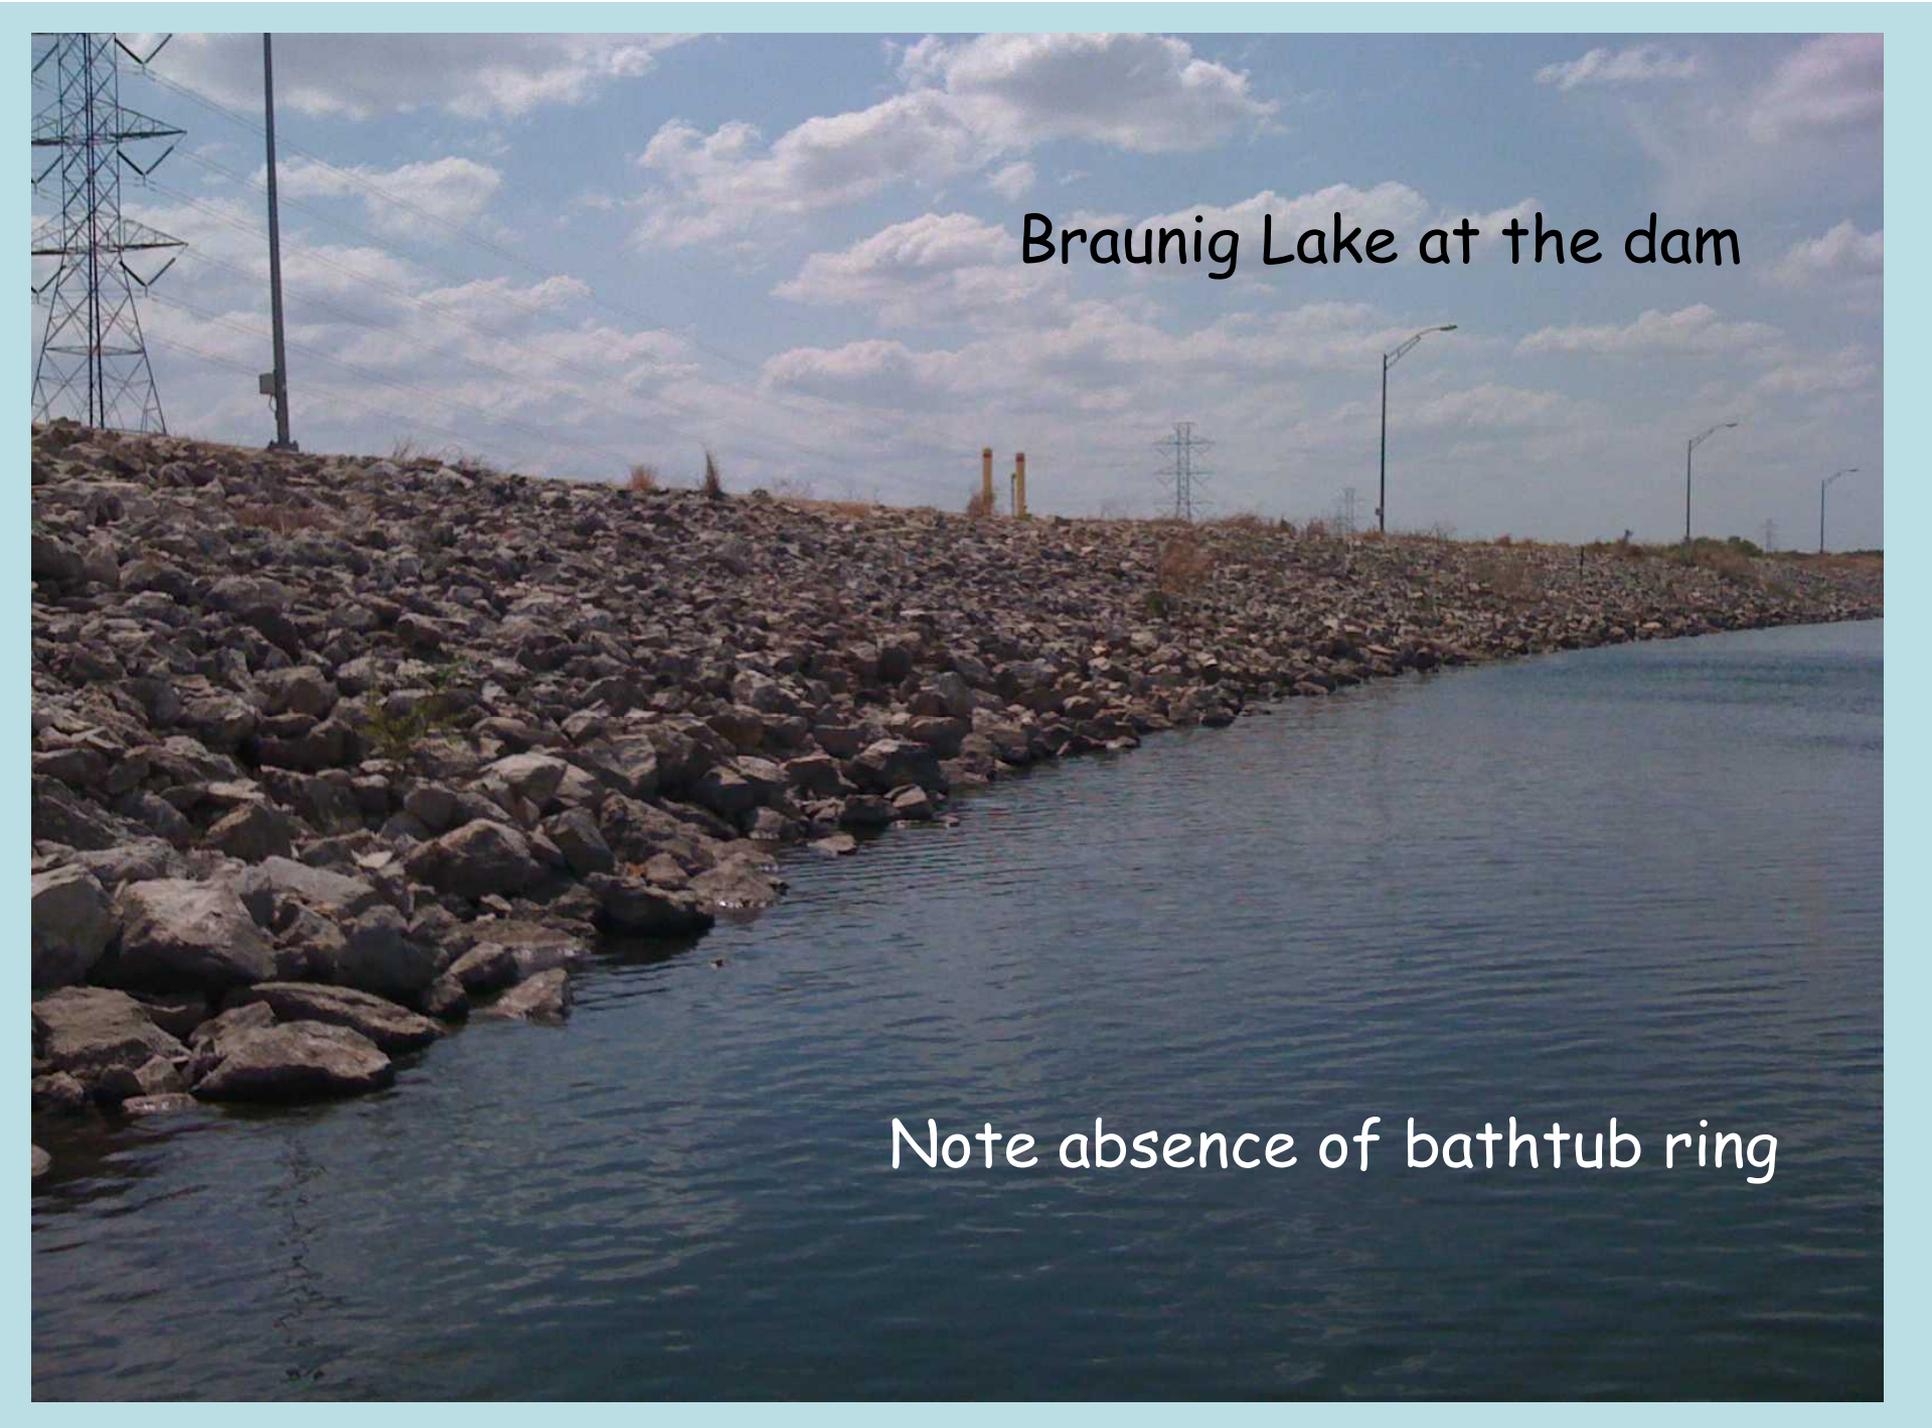
Braunig Lake at the dam

A photograph of a dam structure made of large grey rocks, with a body of water (Braunig Lake) in the foreground. The sky is blue with scattered white clouds. In the background, there are several high-voltage power line towers and a few streetlights. The water is dark blue and reflects the sky. The dam extends from the left side of the frame towards the right, curving slightly. The water is calm with some ripples. The overall scene is a typical view of a dam and its reservoir.

Note absence of bathtub ring

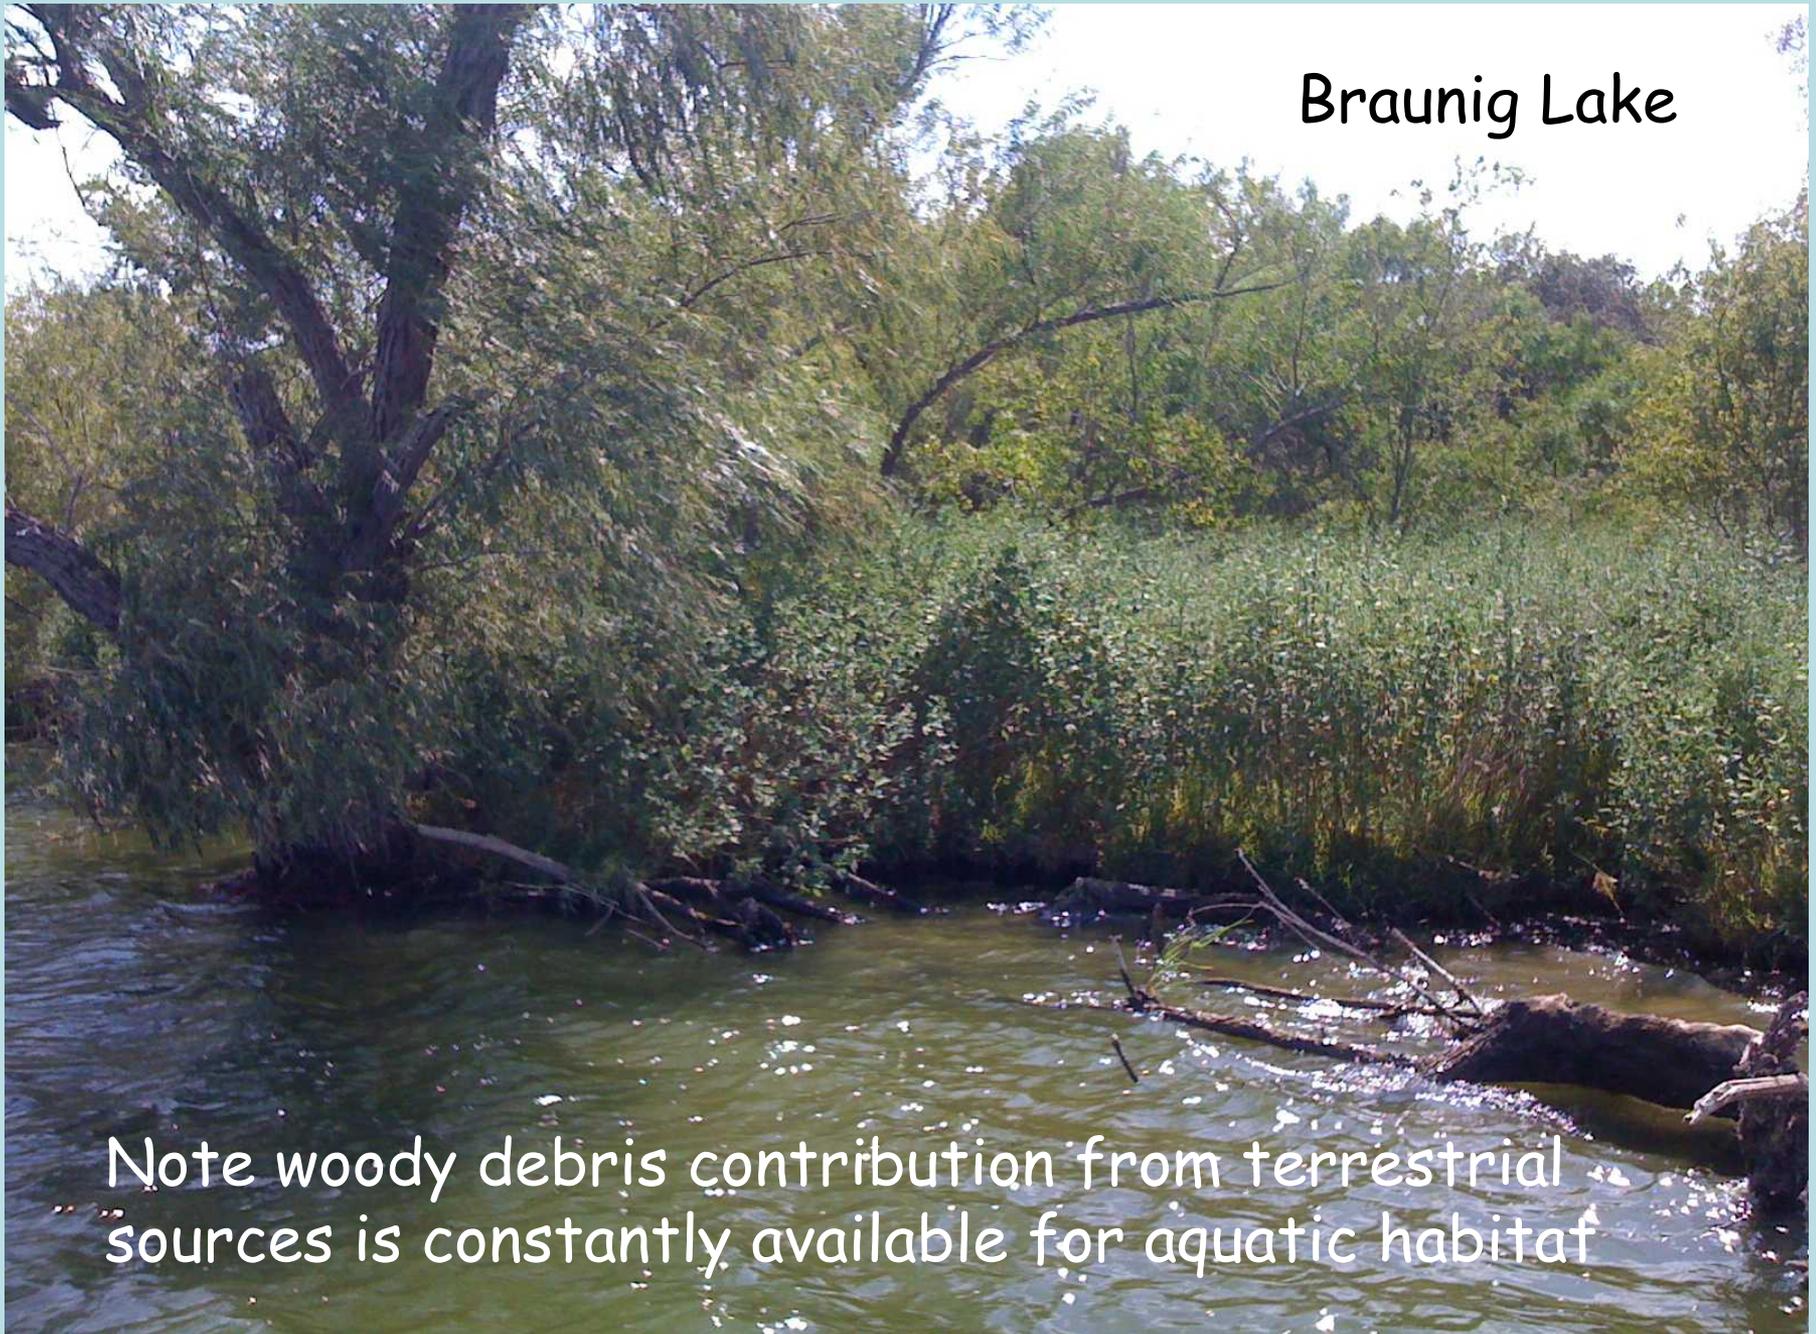
Braunig Lake

Note woody debris contribution from terrestrial sources is constantly available for aquatic habitat
