Grove EPA National Non-Point Pollution Monitoring Project

1. Floodwater detention
2. Sediment Transport
- 3. Nitrate Runoff**
- 4. Fishery enhancement**
5. Prairie/wetland complex

**BMP's to improve water quality in the Grove restoration
Prairie and Wetlands are 4+ years old in Phase 1 and 2.**

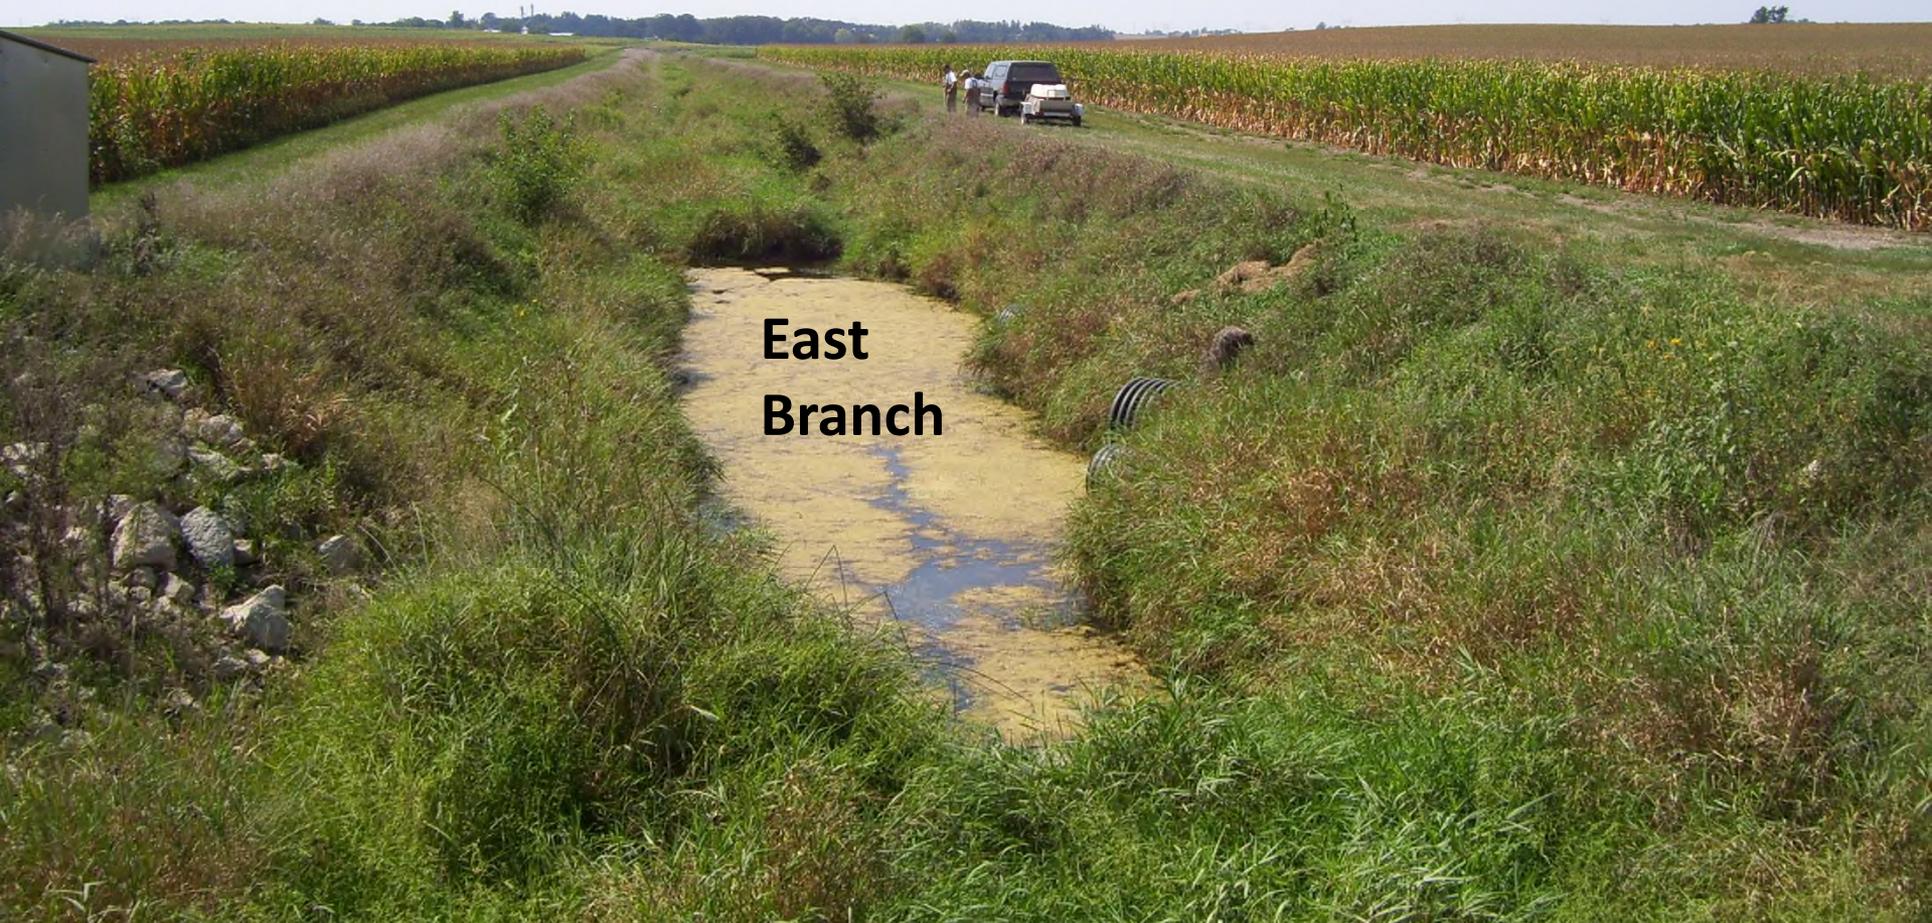
Before restoration at 2100 Rd , East Branch ditch revealed sedimentation, reed canary grass, and filamentatious algae

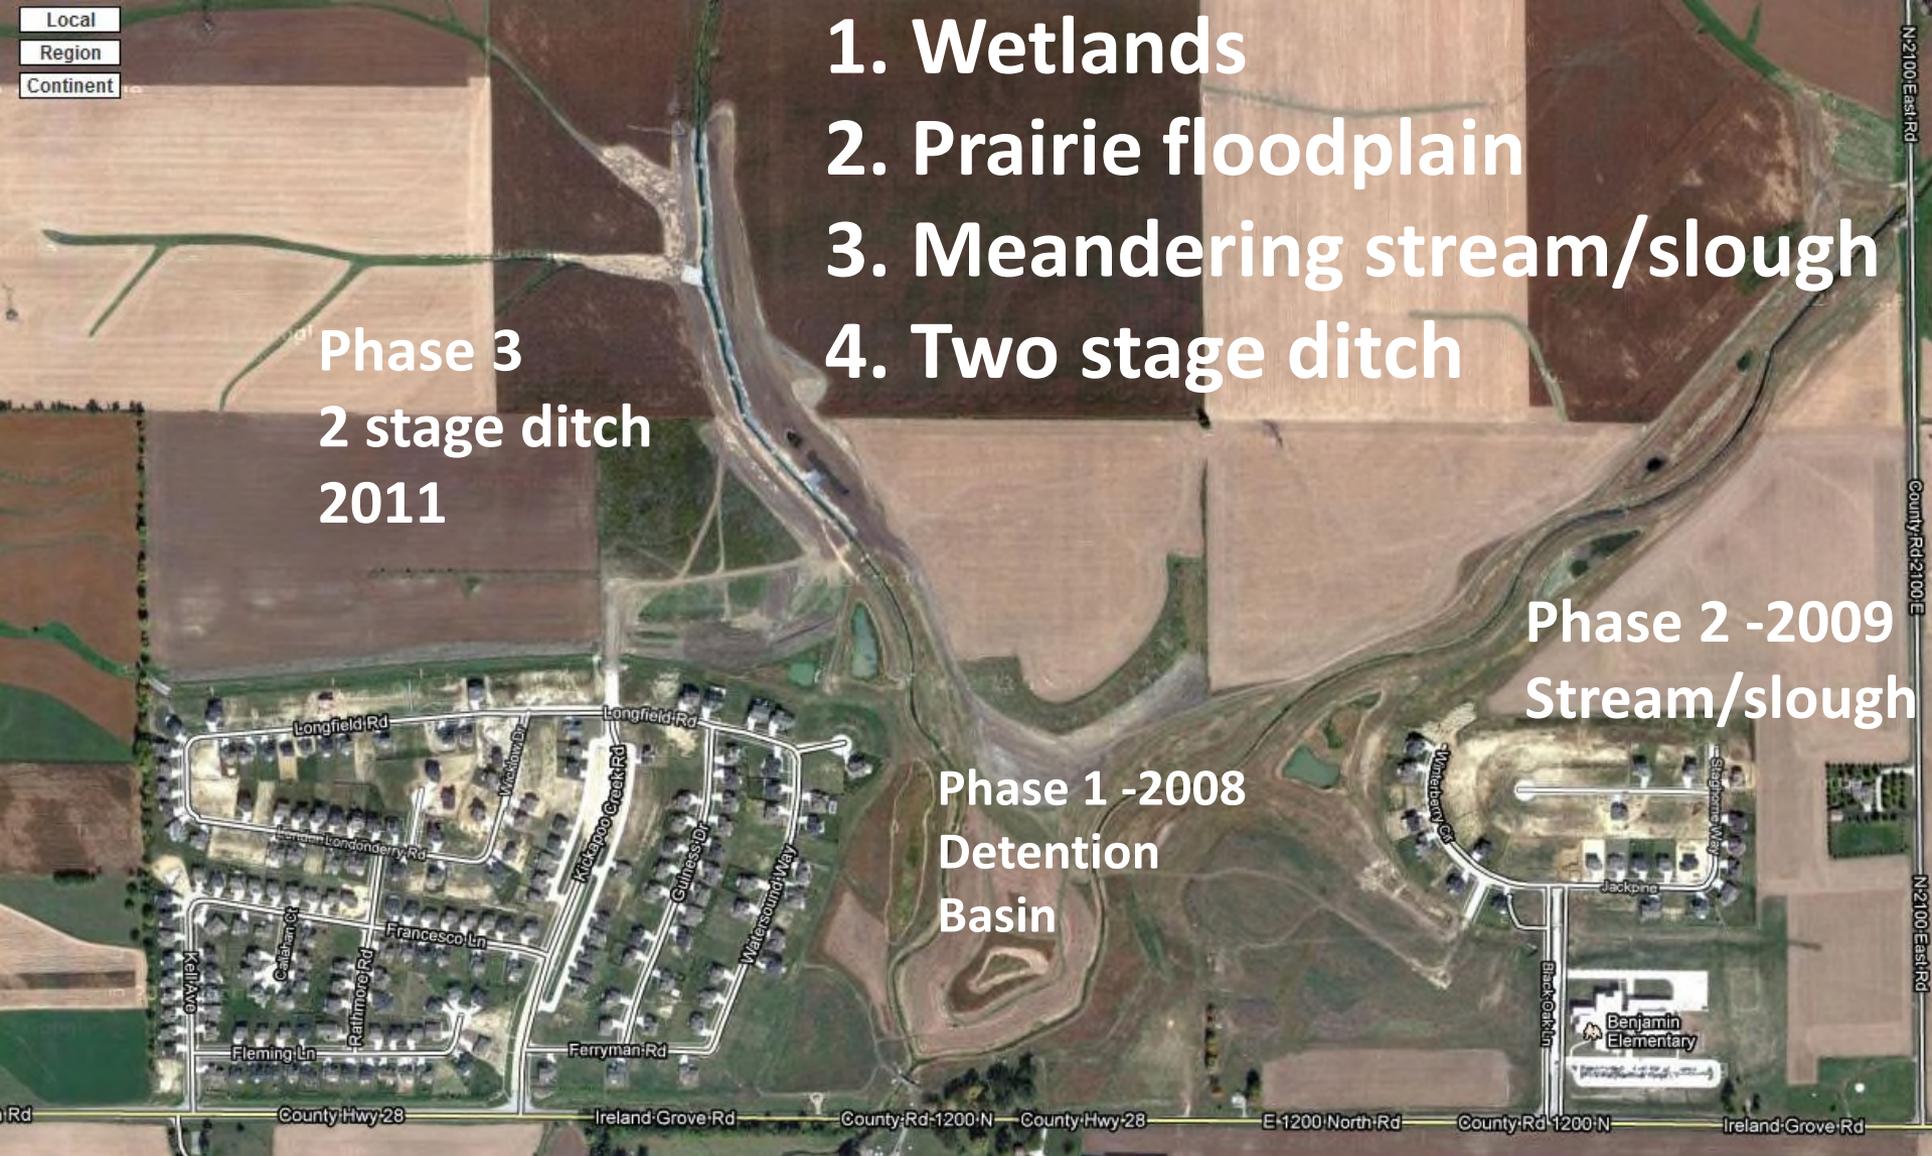
**East
Branch**

1. Wetlands
2. Prairie floodplain
3. Meandering stream/slough
4. Two stage ditch

Phase 3
2 stage ditch
2011

Phase 2 -2009
Stream/slough

Phase 1 -2008
Detention
Basin

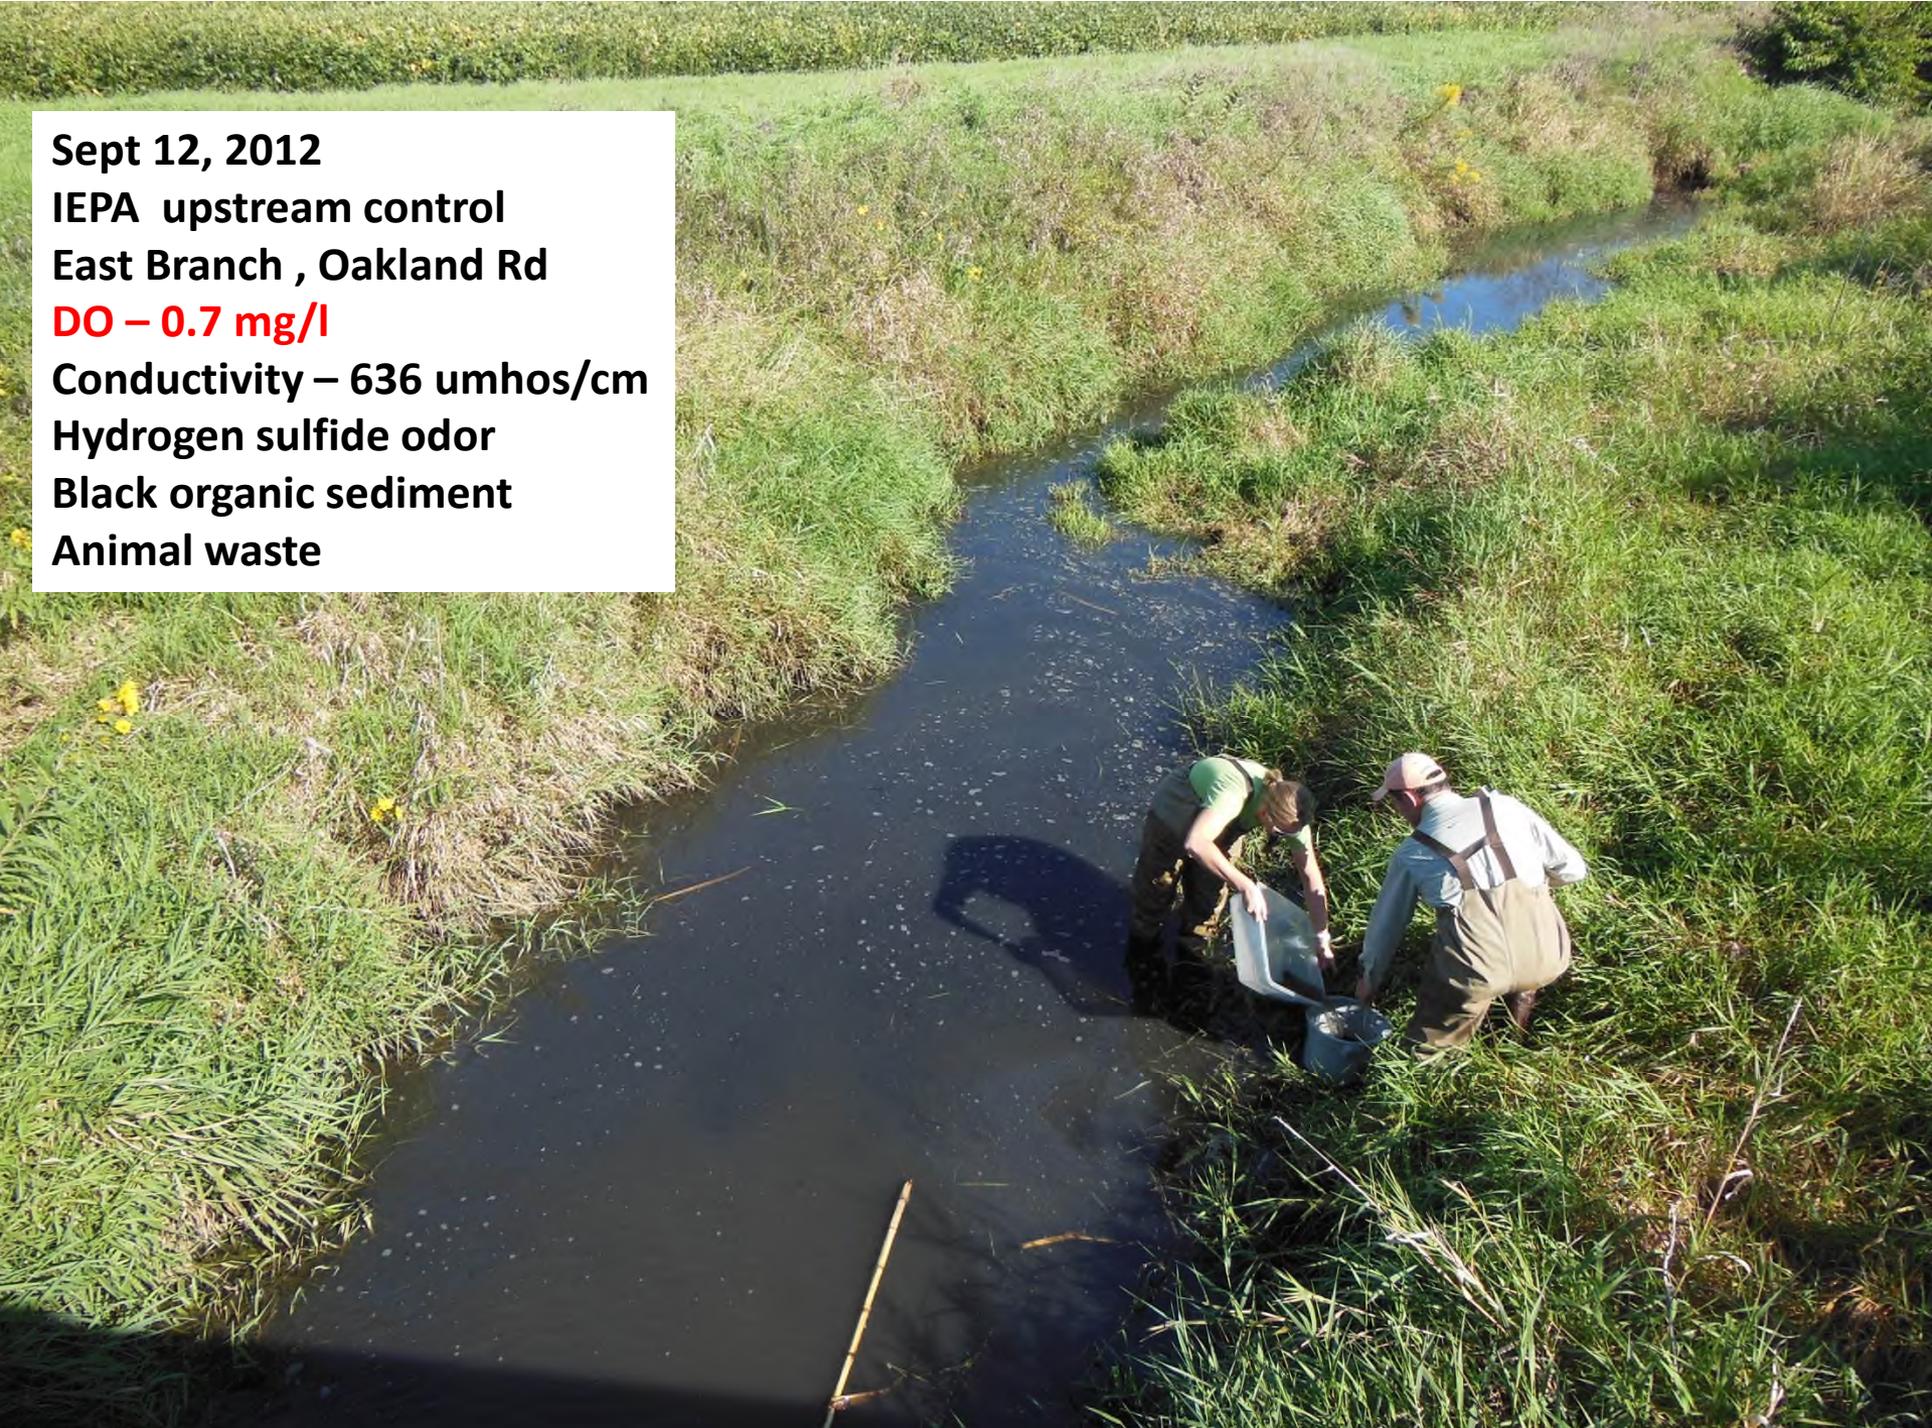
**IEPA upstream control
East Branch , Oakland Rd**

DO – 0.7 mg/l

Conductivity – 636 umhos/cm

Hydrogen sulfide odor

Black organic sediment

Animal waste

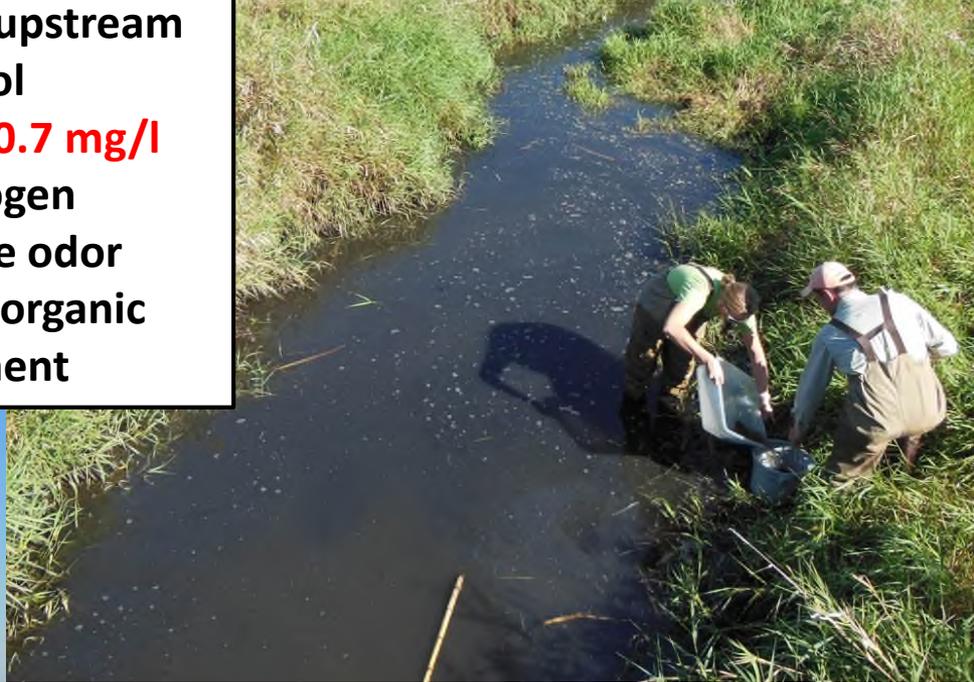
Control
DO - 0.7

DO 8.1

E8 riffle
DO 4.0

DO 7.0

E1 riffle
DO 6.8

IEPA field staff monitored dissolved oxygen in the Grove after the severe drought in early September 2012

East Branch control and two restoration sites

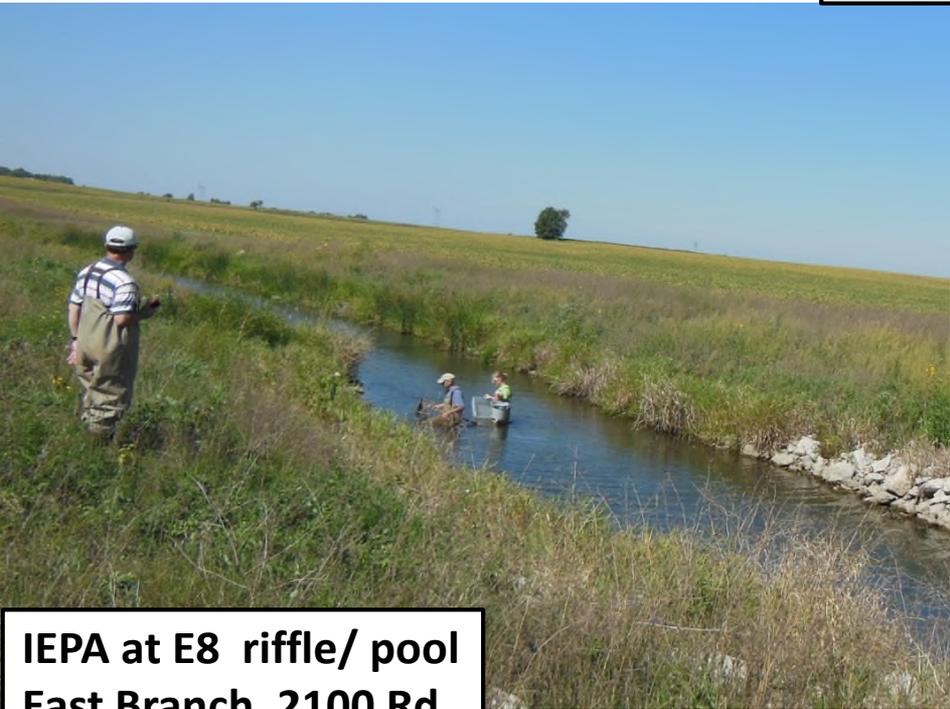
IEPA upstream
control
DO – 0.7 mg/l
Hydrogen
sulfide odor
Black organic
sediment

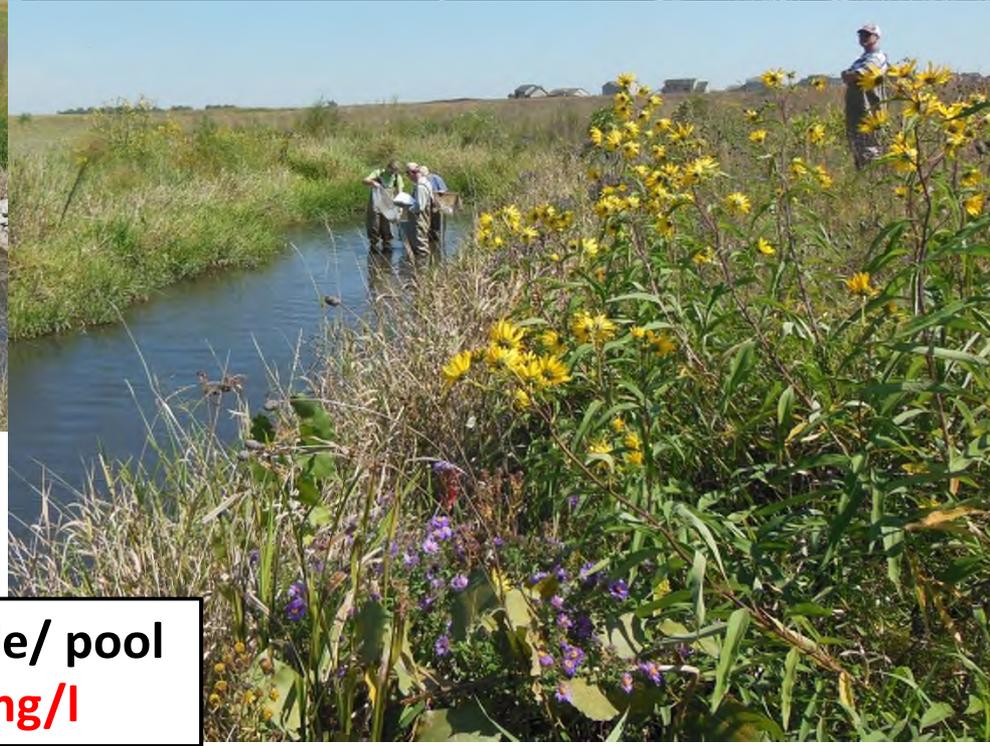
IEPA at E8 riffle/ pool
East Branch, 2100 Rd
DO – 4.0 mg/l

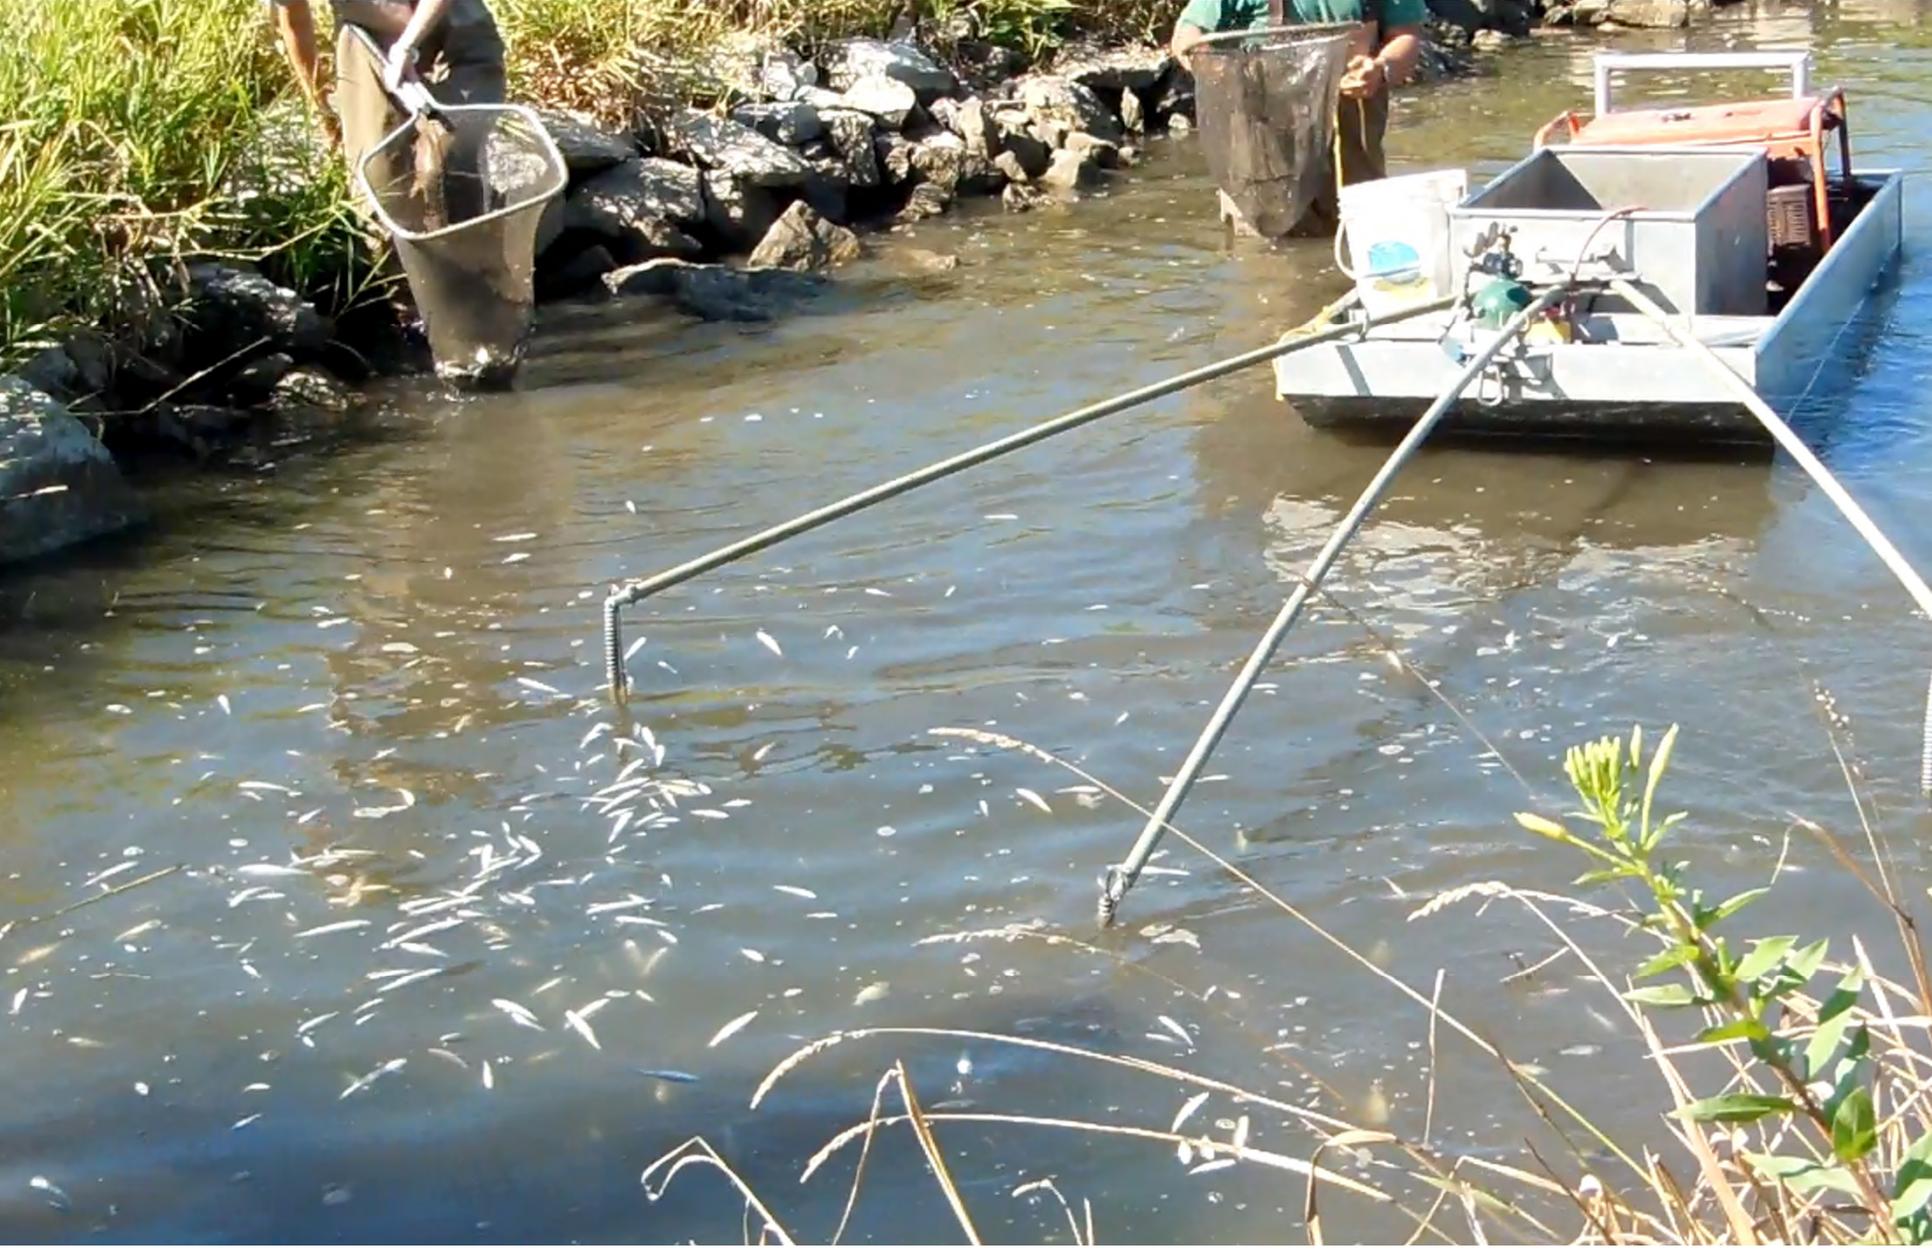
IEPA at E1 riffle/ pool
DO is 6.8 mg/l

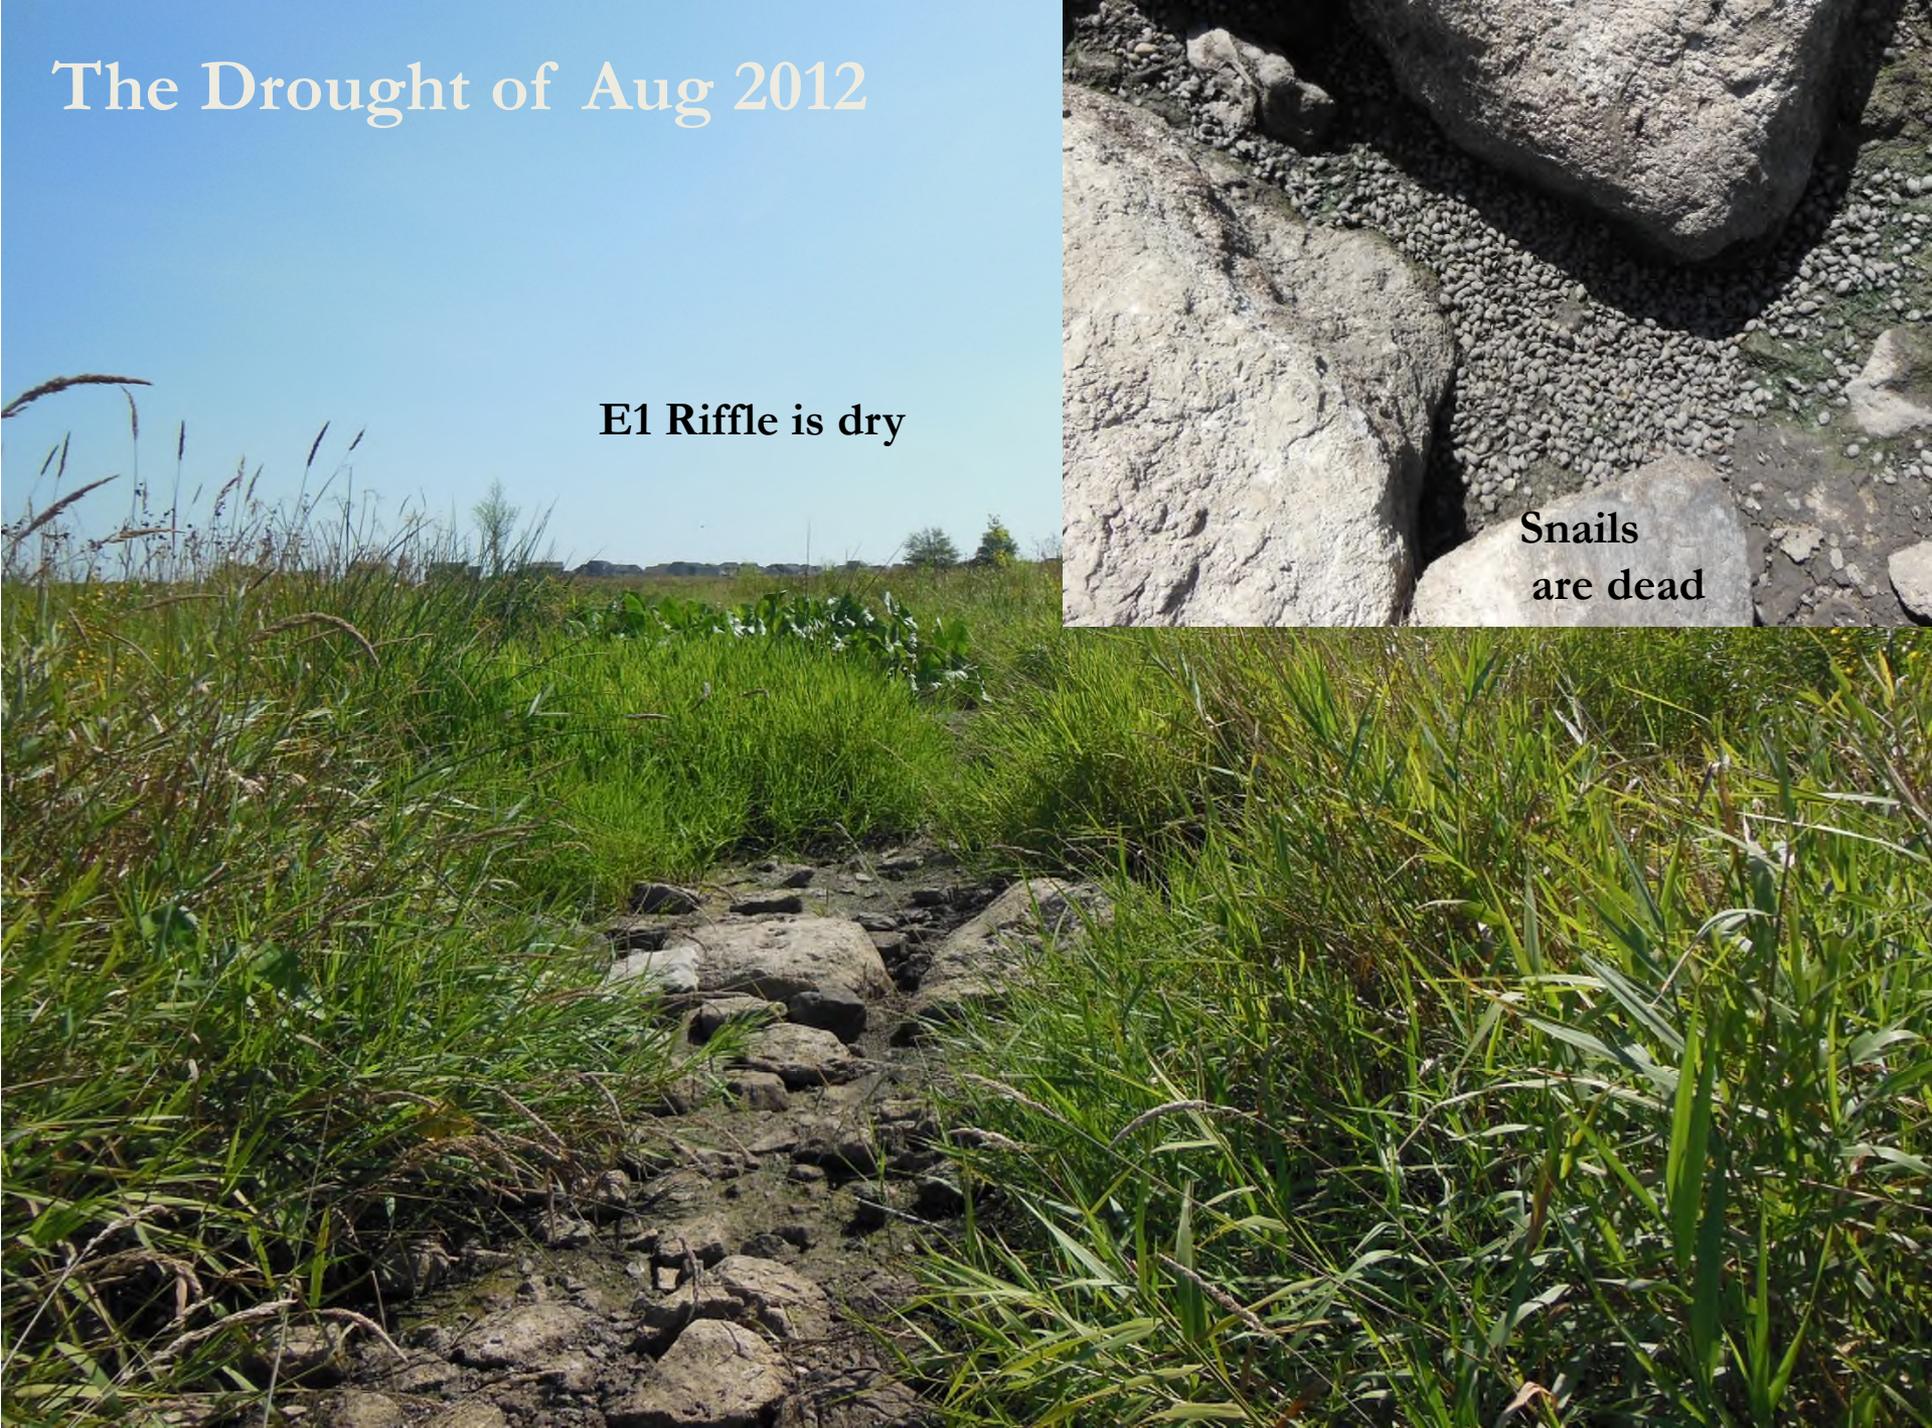
The Drought of Aug 2012

E1 Riffle is dry

**Snails
are dead**

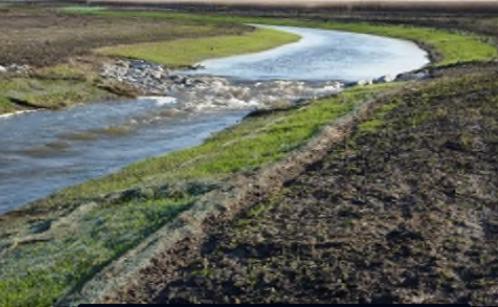
East Branch Upstream Treatment Site

High flows
scour deep hole

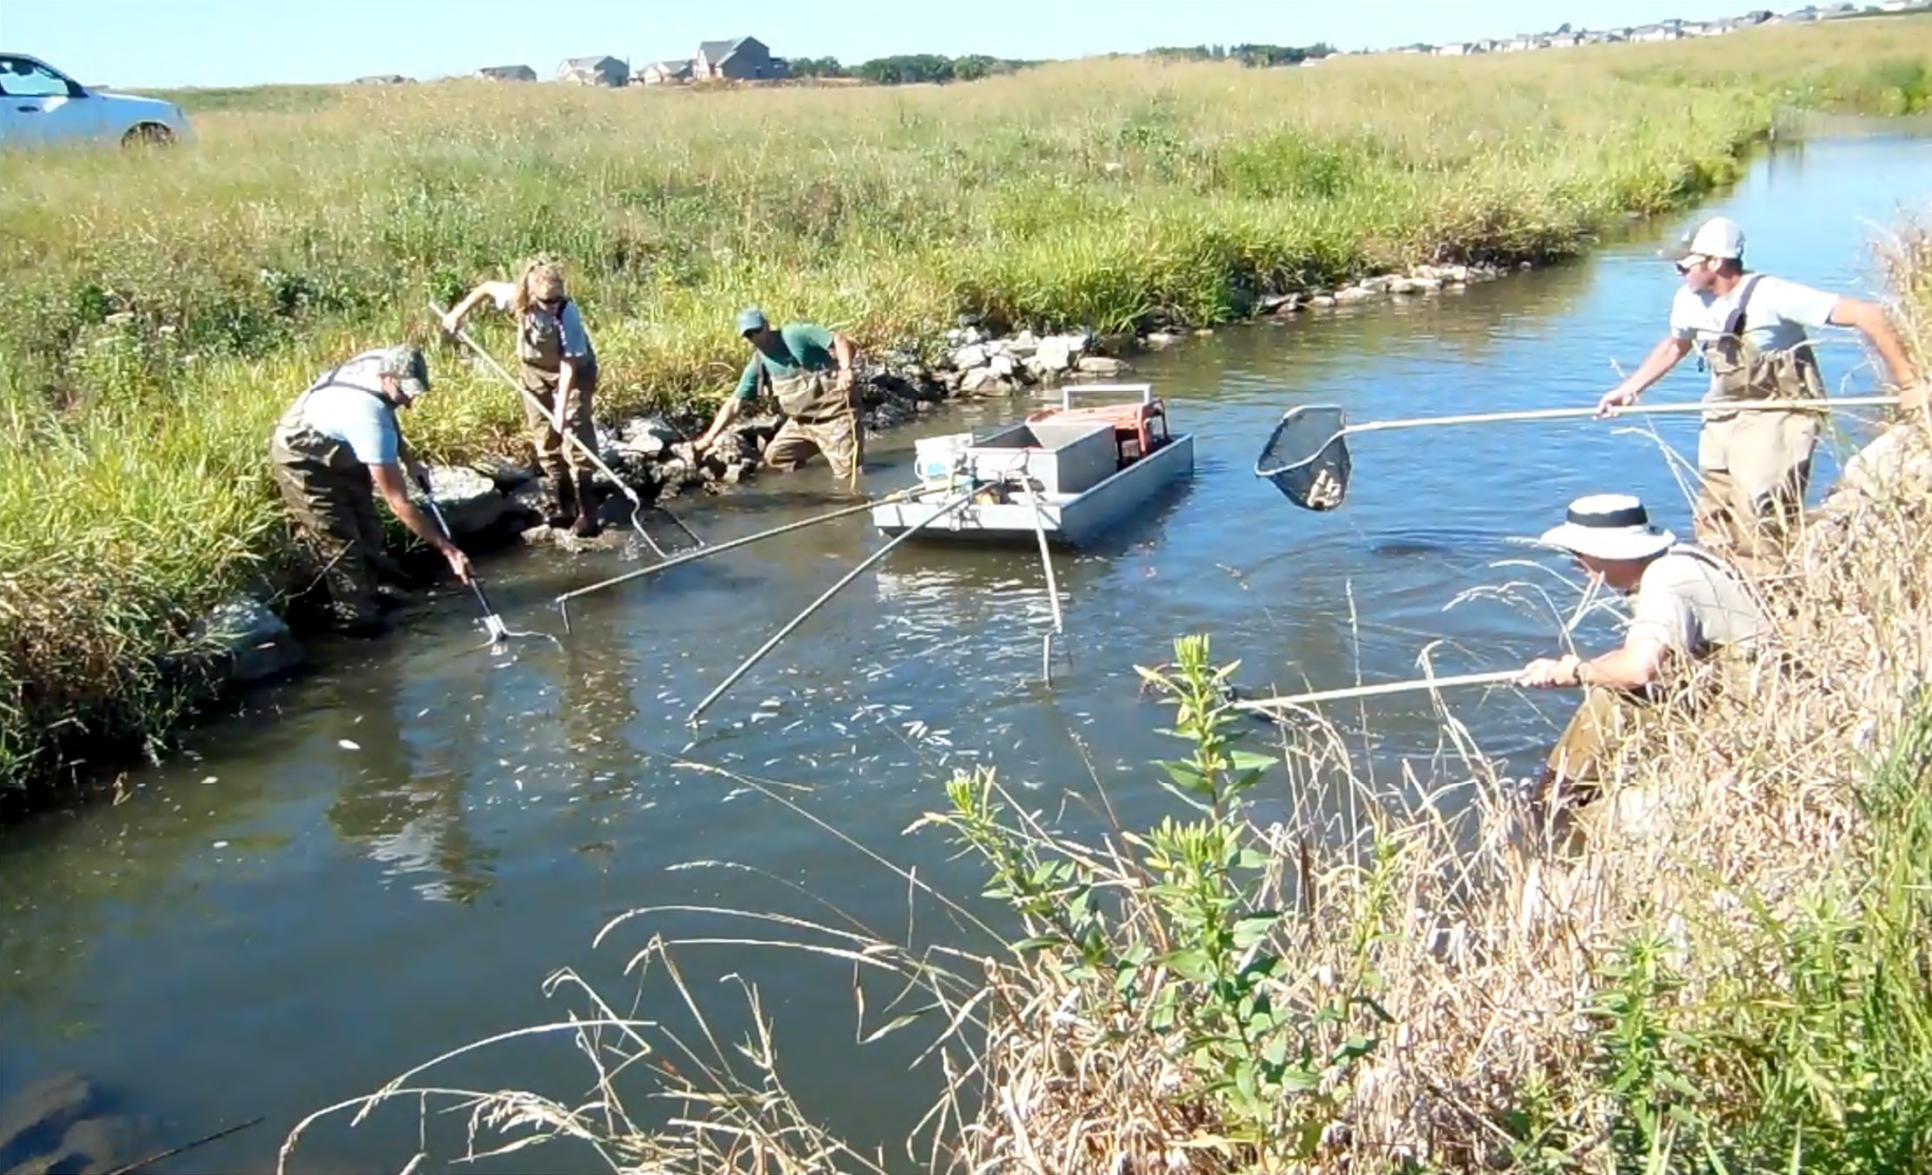
2012 drought did not affect fish in deeper pools

Population similarity
after restoration before restoration

Pre: 12.5 species
303.7 fish

During: 10 species
56 fish

After: 17.8 species
1232.7 fish

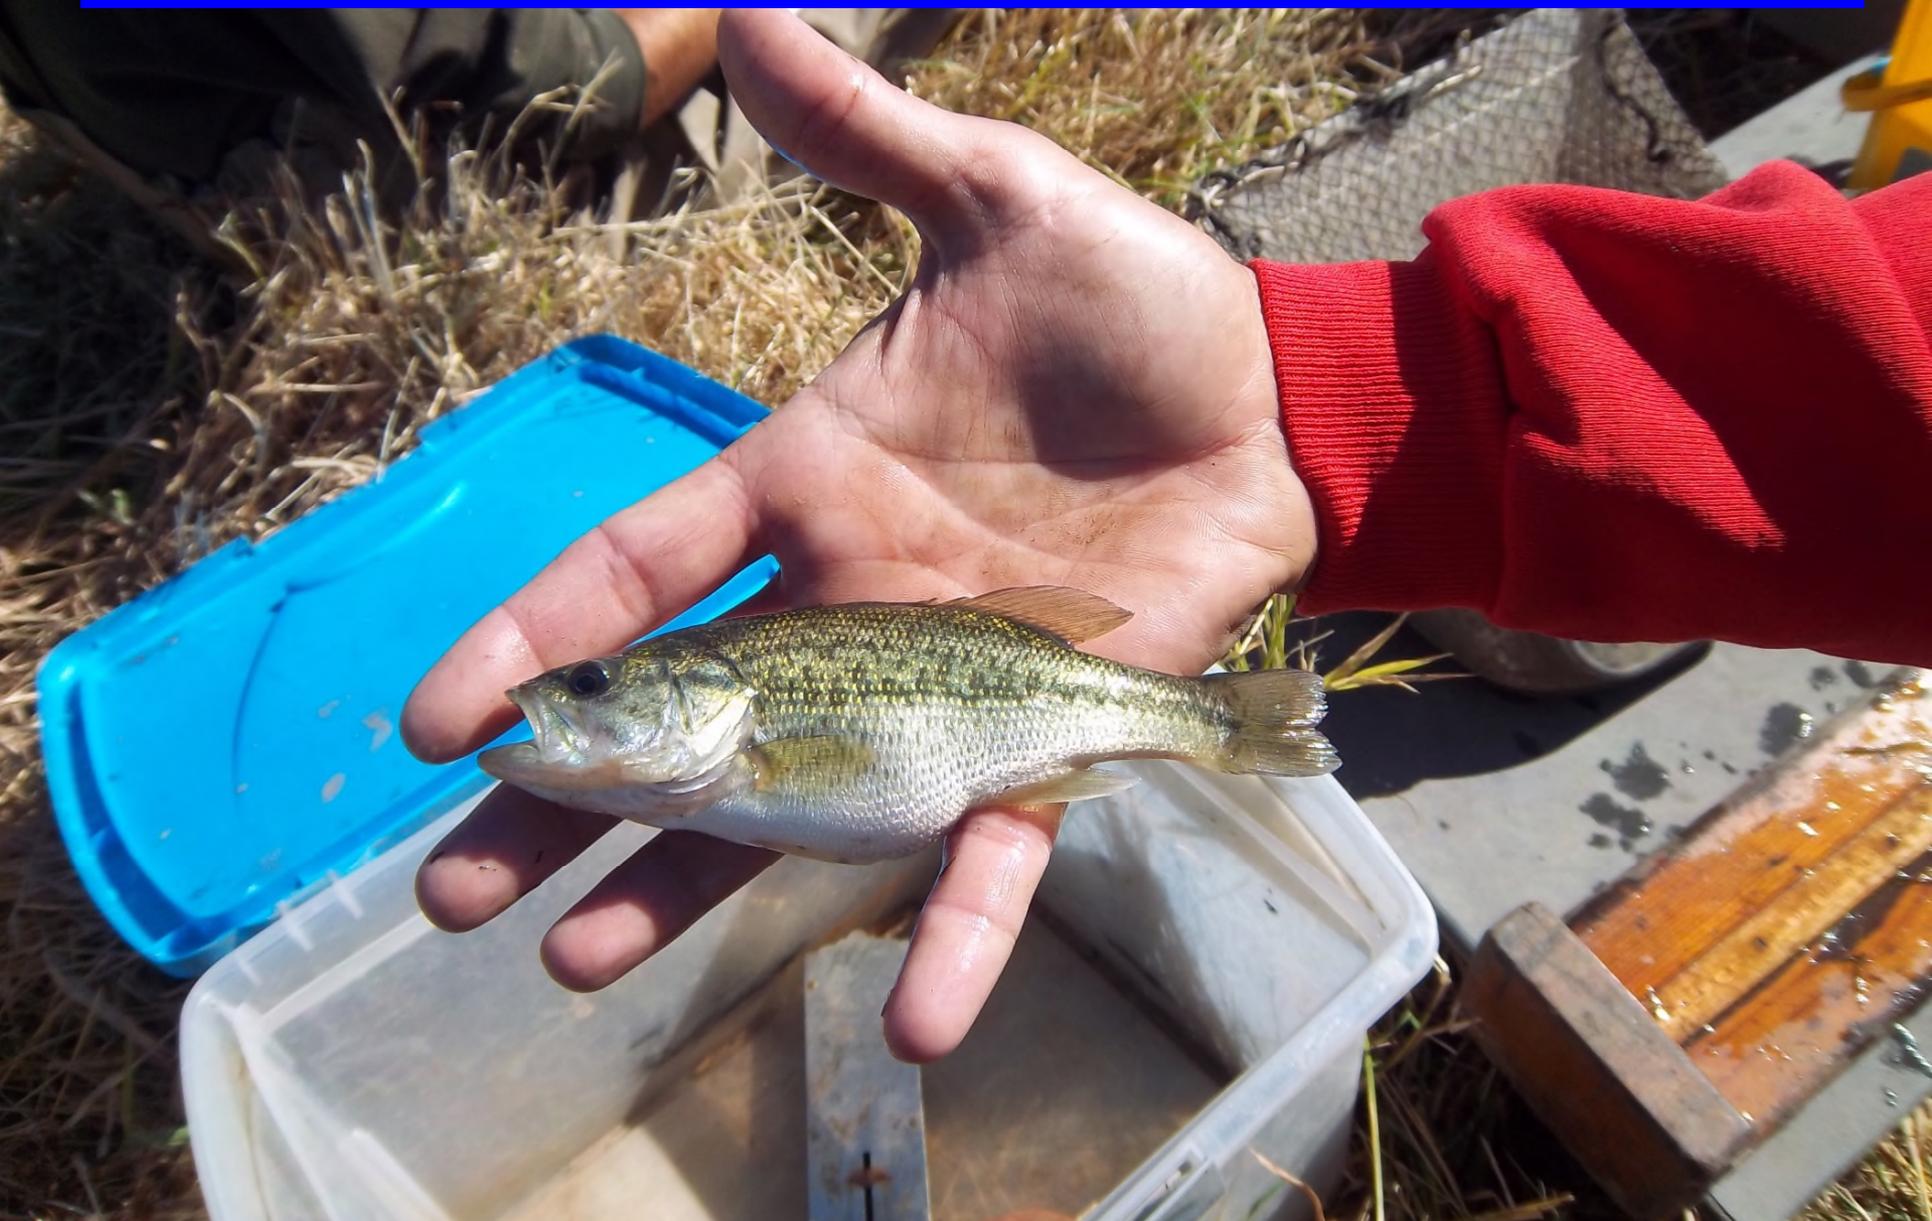
**In 2012 drought, E8 pool is deeper than staff are tall
– stay on steep banks below E8 riffle**

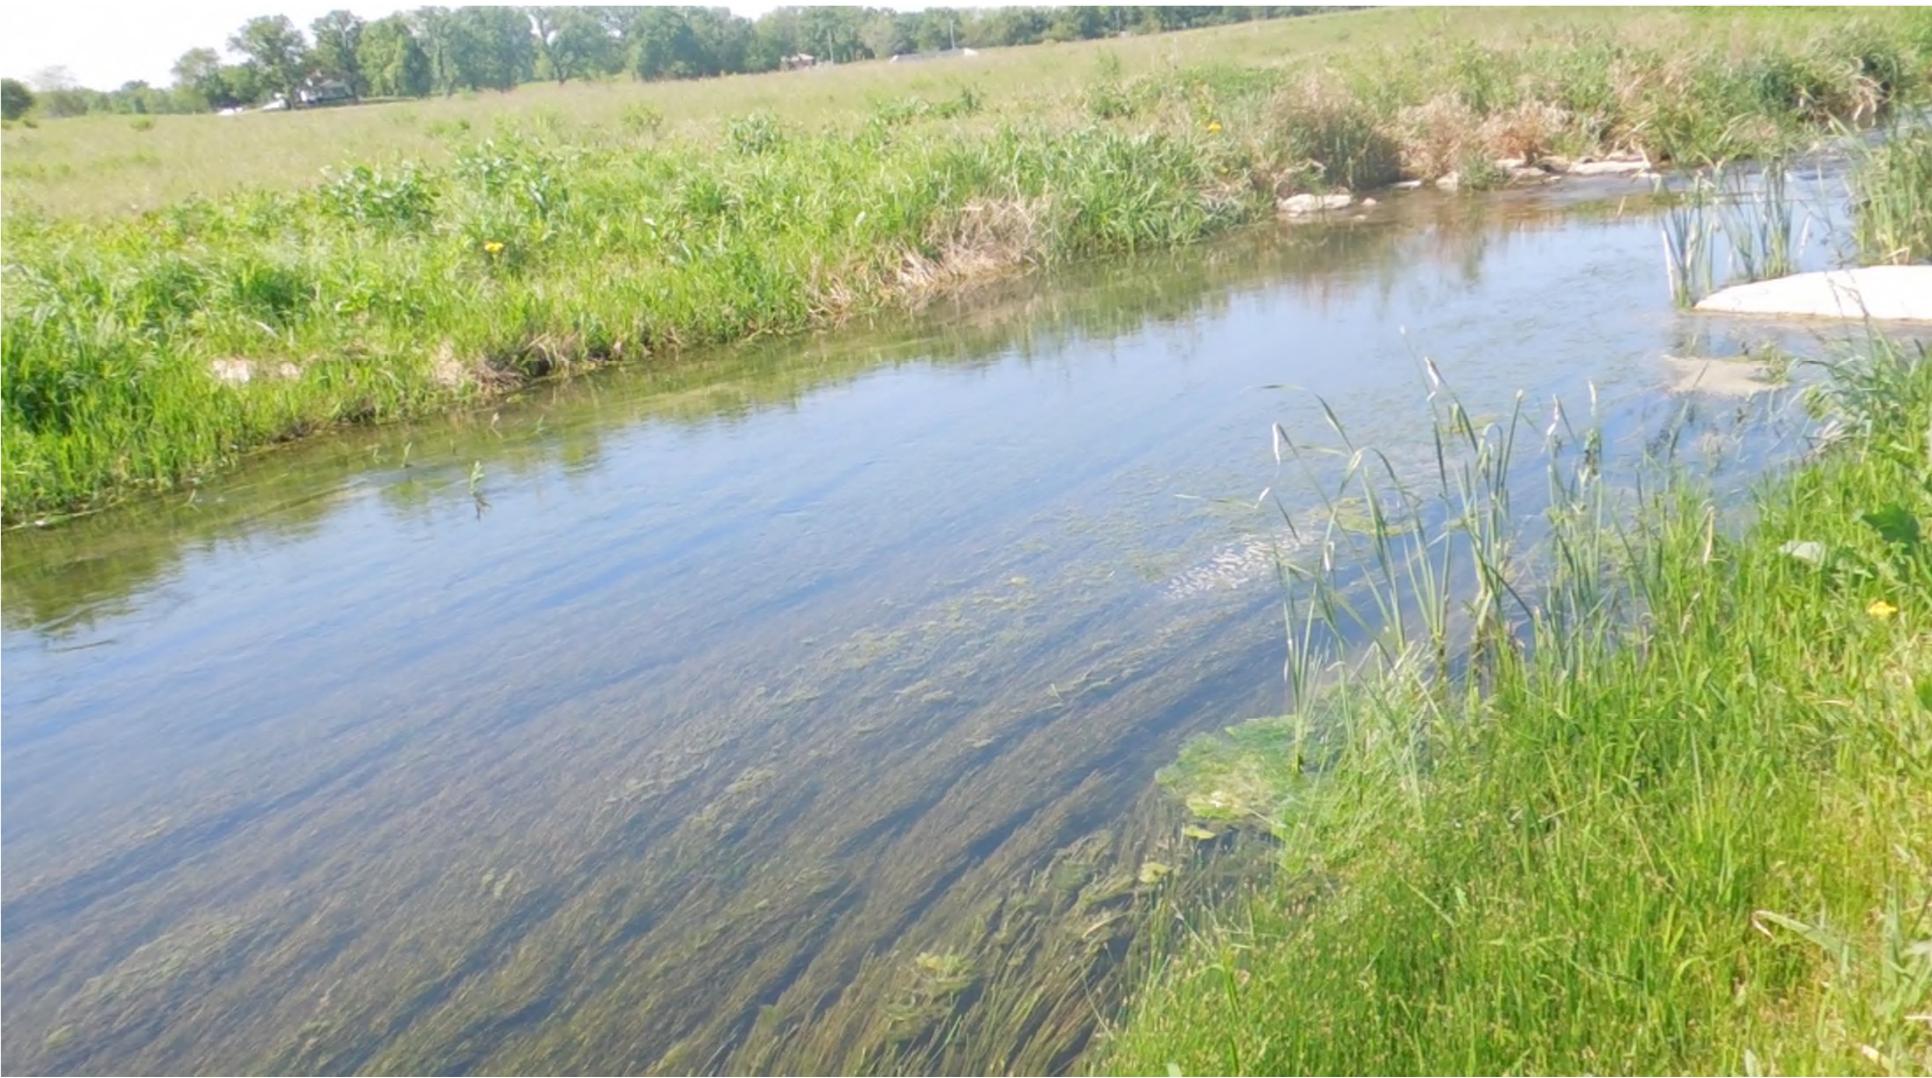
The aquatic vegetation in the Grove prairie slough improved water quality and provided plentiful forage

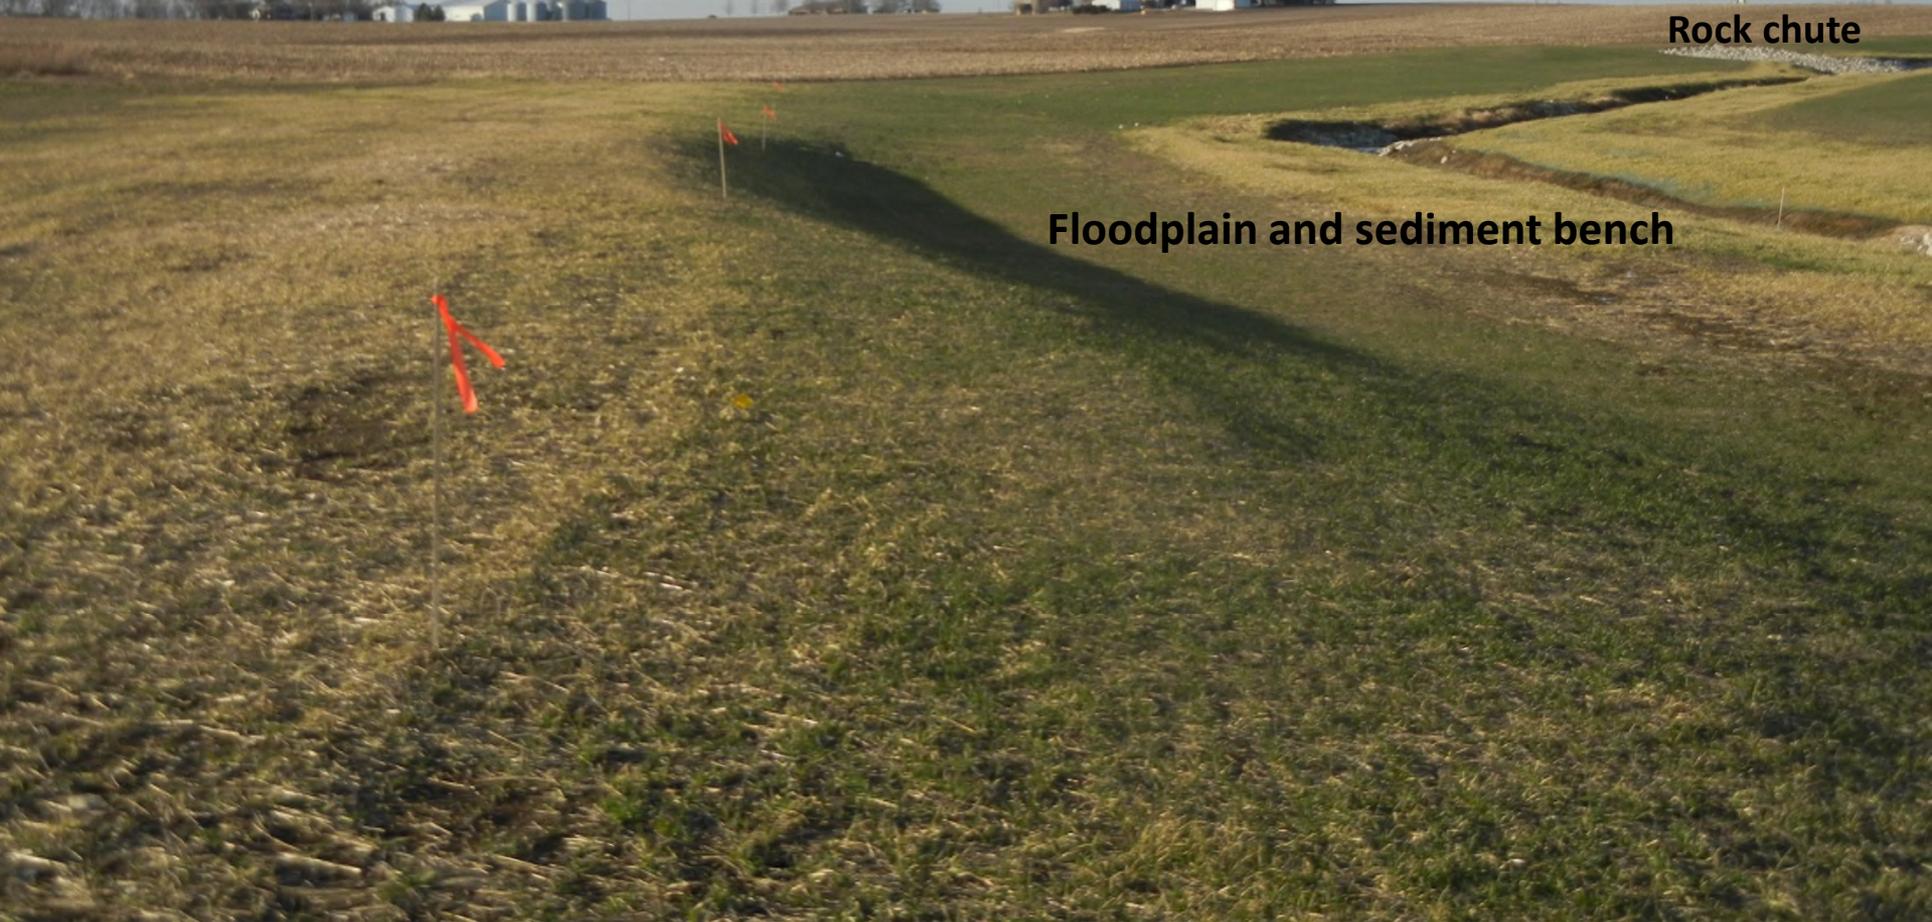
**Phase 3 -Two Stage Ditch
with 11 rock riffles**

Rock chute

Floodplain and sediment bench
