Grove EPA National Non-Point Pollution Monitoring Project

1. Floodwater detention
2. Sediment Transport
- 3. Nitrate Runoff**
- 4. Fishery enhancement**
5. Prairie/wetland complex

**BMP's to improve water quality in the Grove restoration
Prairie and Wetlands are 4+ years old in Phase 1 and 2.**

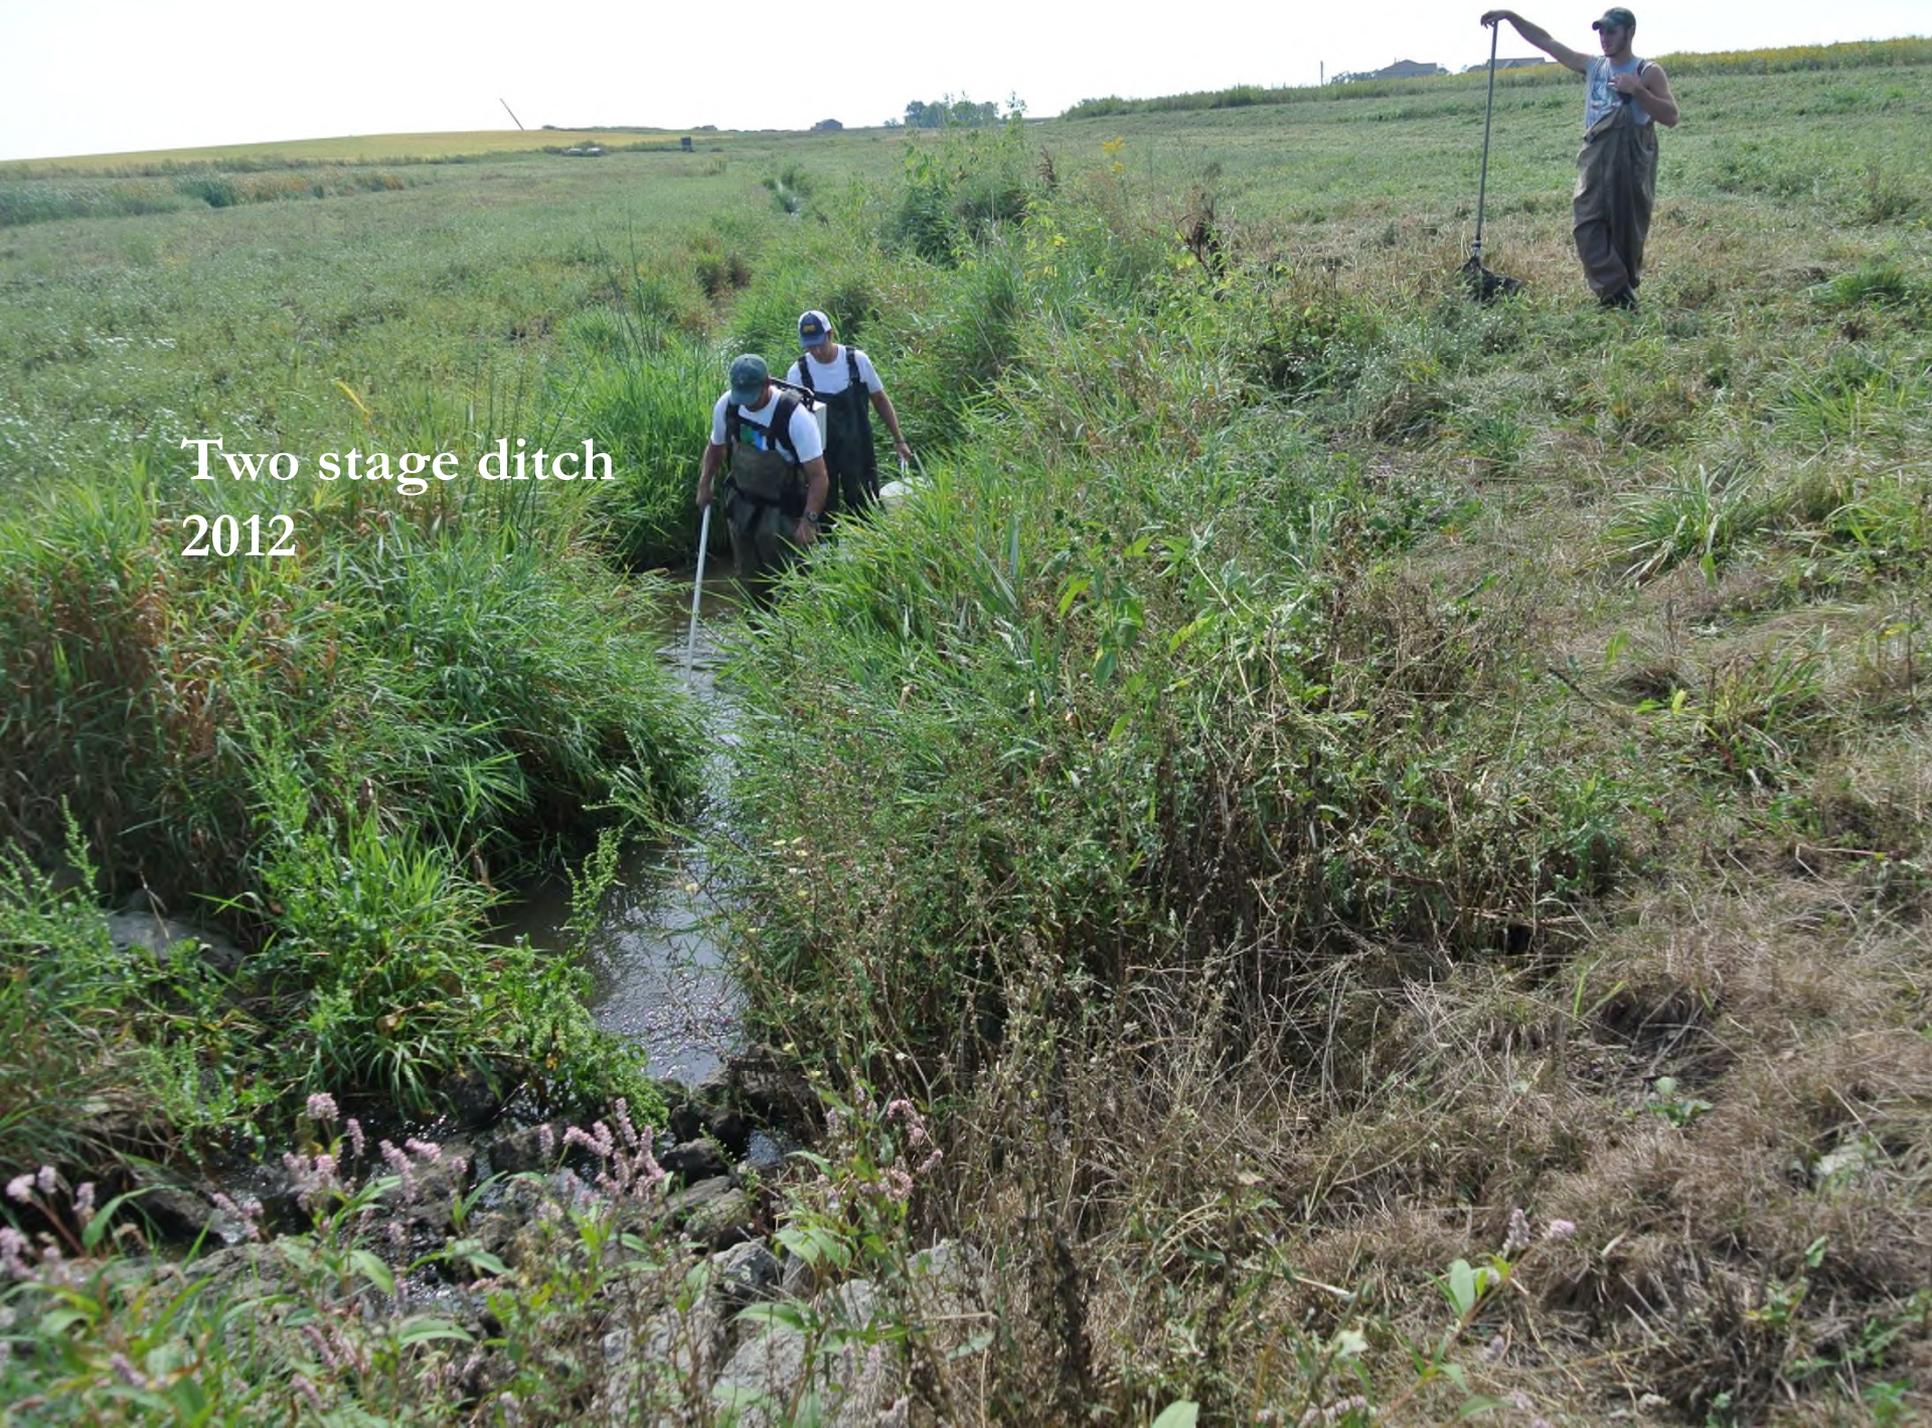
Two stage ditch
2012

Rowcrop fields adjacent to the lower end of the Grove two stage ditch

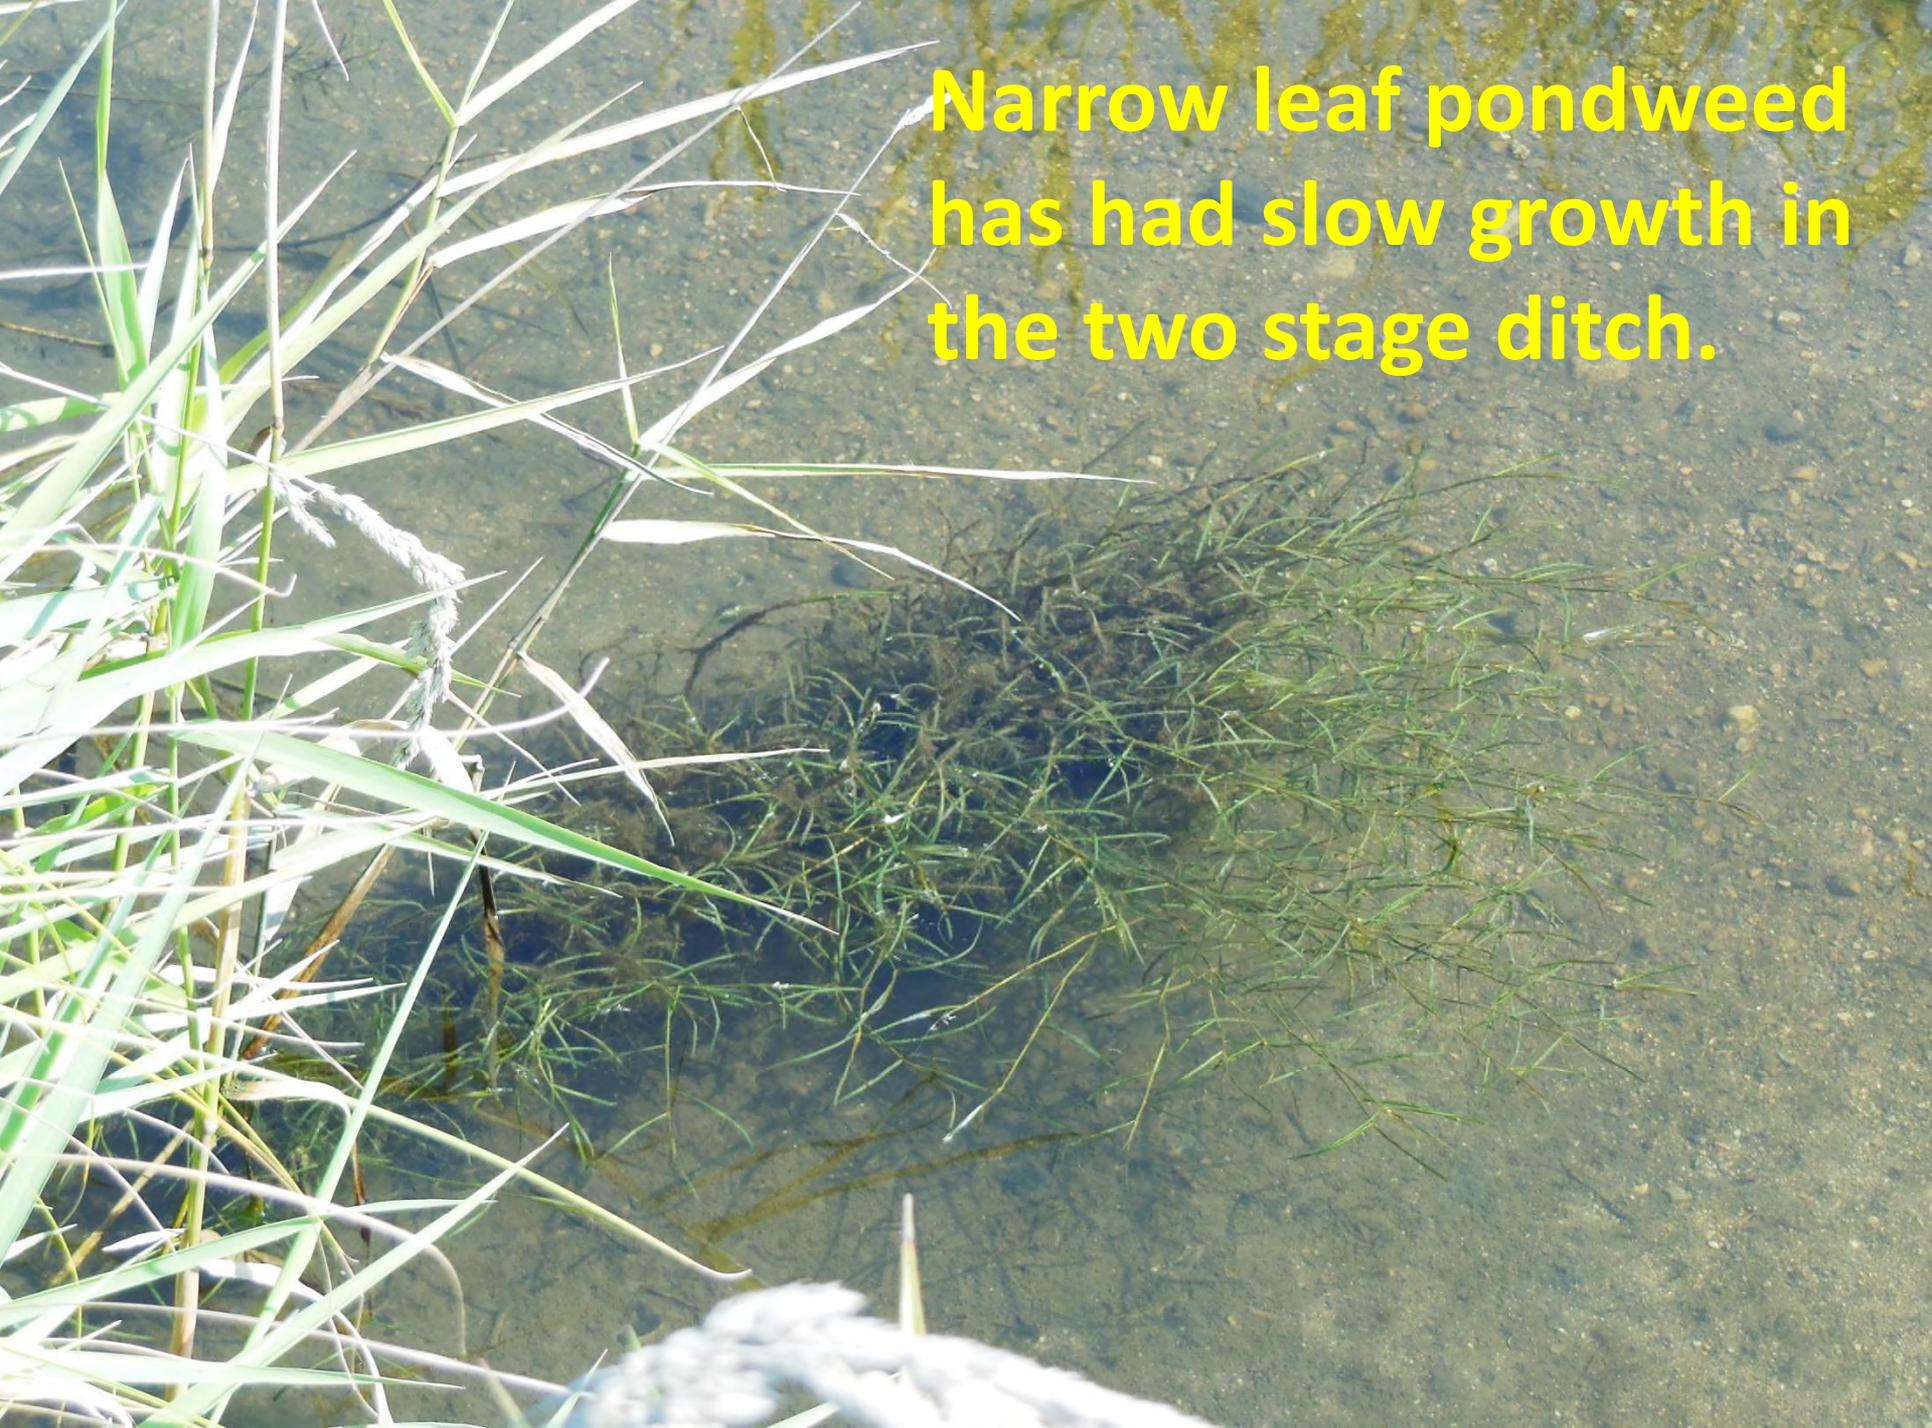
**Narrow leaf pondweed
has had slow growth in
the two stage ditch.**

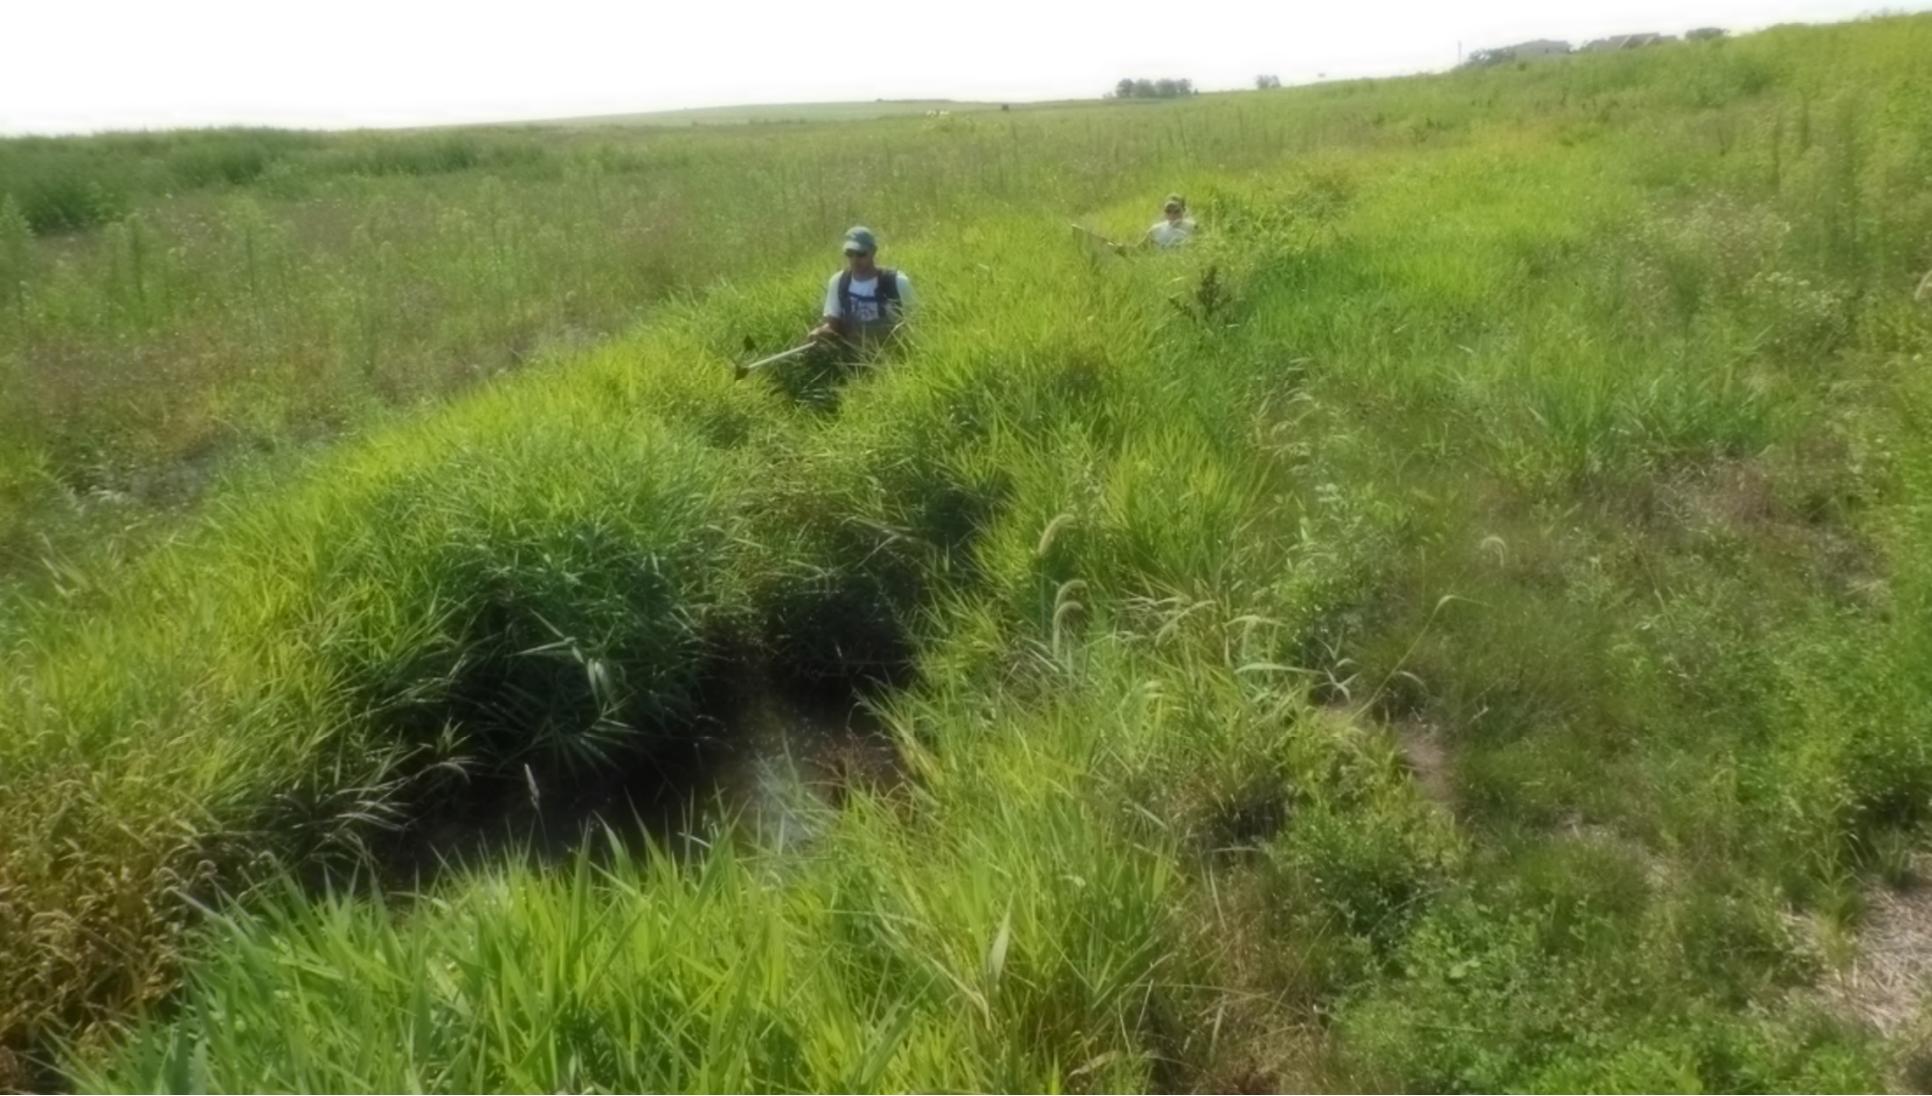
W10 fish riffle pool -- Two stage ditch
Too much shade In narrow original channel
