# Using Remote Sensing Tools to Target Stream Protection and Wastewater Treatment BMPs in Rural Kentucky

Catherine Carter, Peter Cada, Gregory D. Sousa, PE, and Barry Topping | Tetra Tech, Research Triangle Park NC | 919.485.8278  
 catherine.carter@tetrattech.com, peter.cada@tetrattech.com, gregory.sousa@tetrattech.com, barry.topping@tetrattech.com

For the Hinkston Creek Watershed CWA 319 Project in east central Kentucky, Tetra Tech produced **a riparian buffer assessment, an onsite wastewater system risk analysis, and a focused study of two selected tributaries** affected by livestock access to the stream corridor.

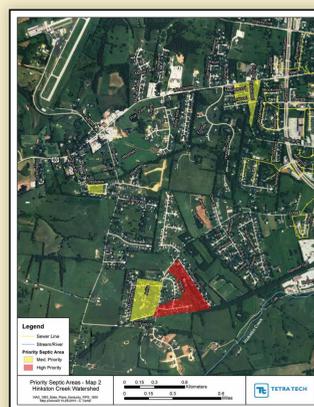
**Onsite wastewater treatment system potential risk** to water quality was assessed via mapping analyses that considered system densities (i.e., number per square mile), system age, and proximity to surface waters. Prioritization was based on level of household density, closeness to streams, and closeness to karst topography (to account for impacts to groundwater). Publicly serviced areas with centralized wastewater treatment were eliminated first; household density was calculated for areas outside of public sewer line boundaries in the areas surrounding the municipalities – within 2 miles of publicly serviced areas in Mount Sterling and within

1 mile of publicly serviced areas for all other municipalities. Household density was not calculated across the entire watershed because septic failure impacts to water quality were assumed to be low in agricultural areas where household density is less than 1 house per acre. Data for calculating household density was obtained from the U.S. Census Bureau's 2000 Census Block data. Closeness to streams was calculated using the high resolution streams data layer created by the United States Geological Survey (USGS) as part of the National Hydrography Dataset (NHD; USGS, 2007). Closeness to karst was calculated using a geologic data layer developed by the Kentucky Geological Survey. Only areas having a household density greater than one household per acre were considered and household density, closeness to streams, and closeness to karst geology received equal weights throughout the prioritization process. Eight census blocks within the Hinkston Creek watershed received prioritization ratings at levels of medium priority (7 blocks) and high priority (1 block). All other census blocks included in the prioritization analysis received ratings of low priority due to low levels of household density (<1 house per acre).
