Continuous Water-Quality Monitor Installation Example: An Air Purge System to Reduce Sediment Fouling and Improve Data Quality

Marshall Williams and Alexandra Etheridge

USGS Idaho Water Science Center

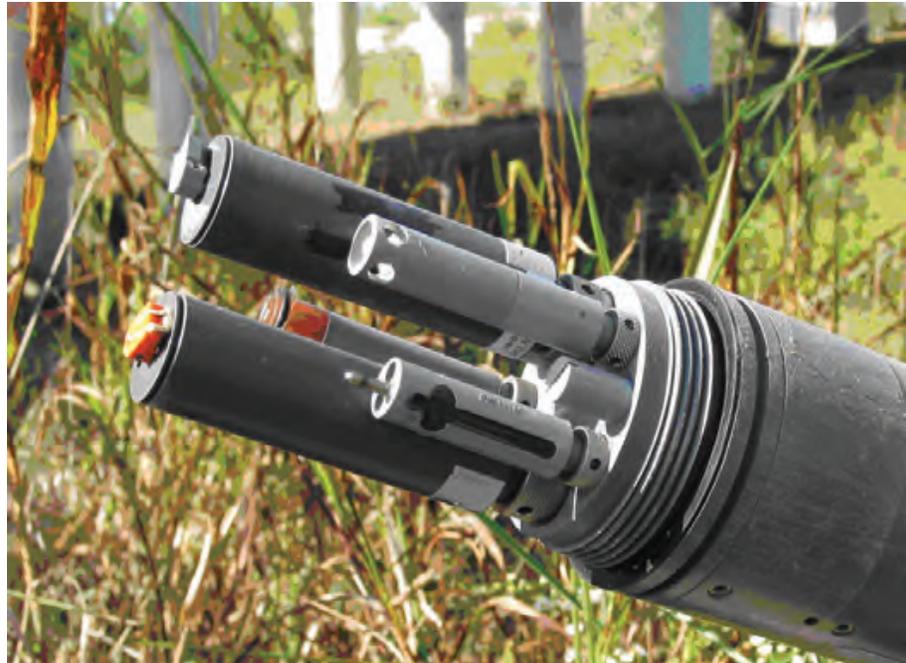
CWQ Monitor on the Boise River

- Bank mounted Continuous Water-Quality Monitor
 - Operational periods:
 - WY 2009 – 2010
 - WY 2014 – until present
 - Fouling became a problem in WY2014

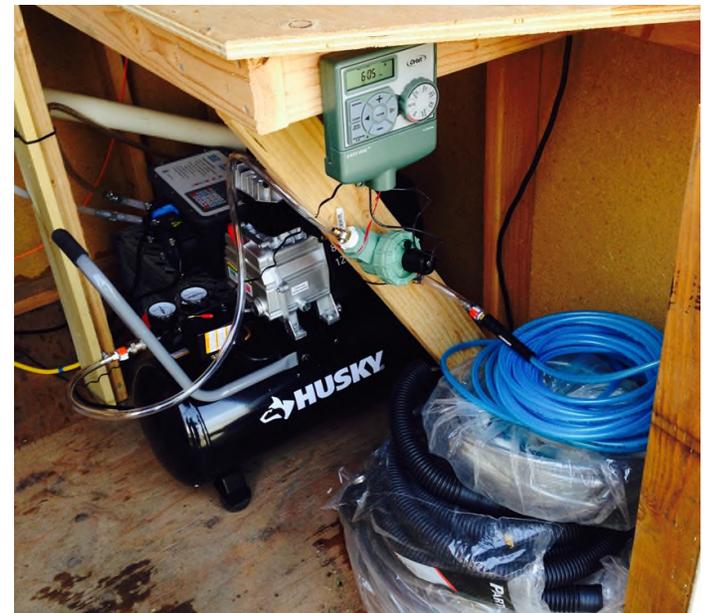
CWQ Monitor on the Boise River

- New air-purge system installed in March 2015 to combat fouling
 - \$300 in equipment and hardware
 - Est. \$10,000 in operational cost savings
 - Greatest improvements:
 - Turbidity and specific conductance
 - Most sensitive parameters to fouling

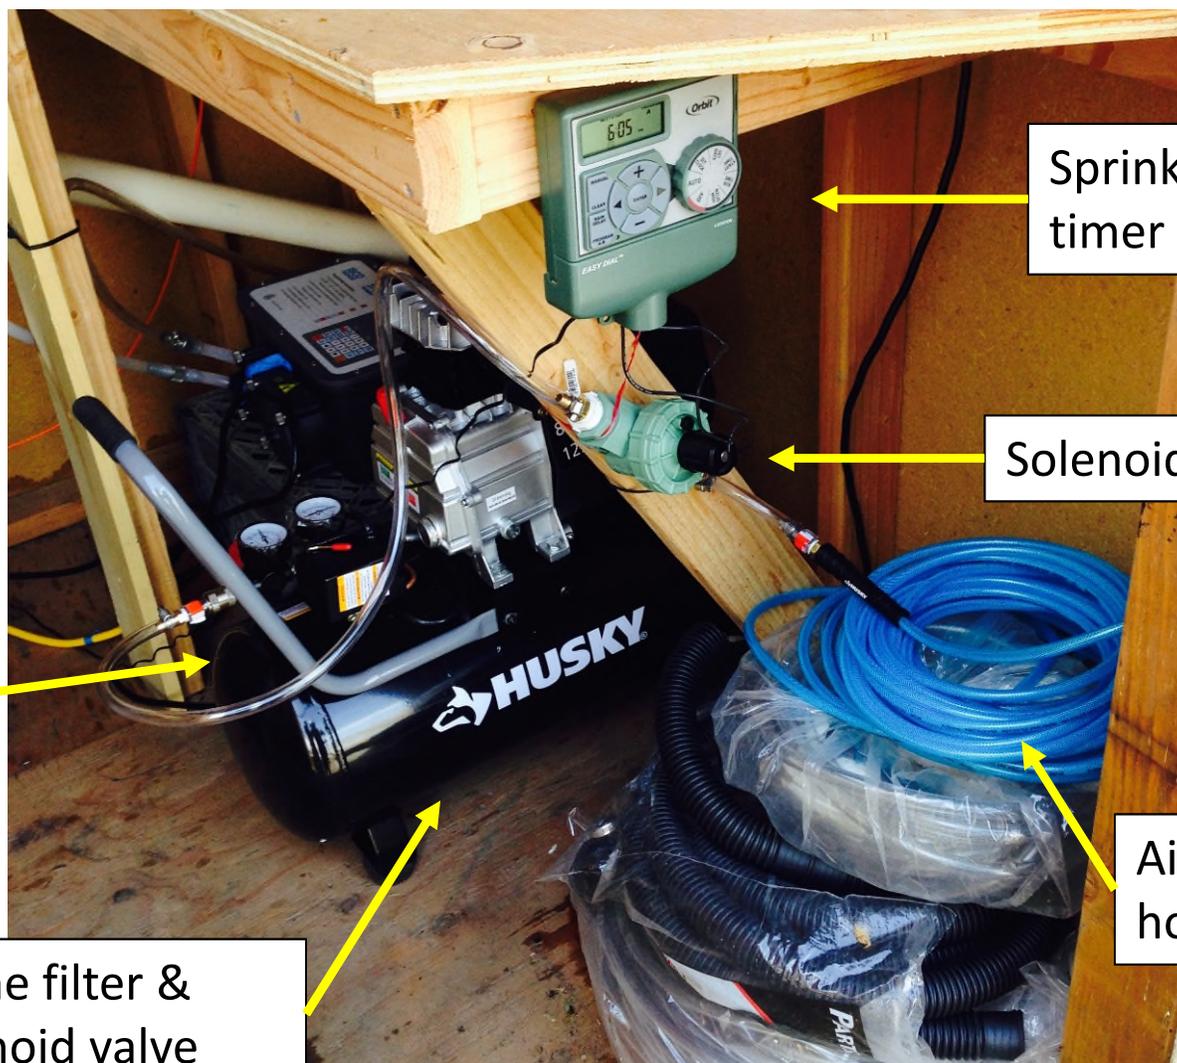
Air Purge System Components

Sprinkler irrigation timer

Solenoid valve

Air compressor

Air compressor hose

In-line filter & solenoid valve

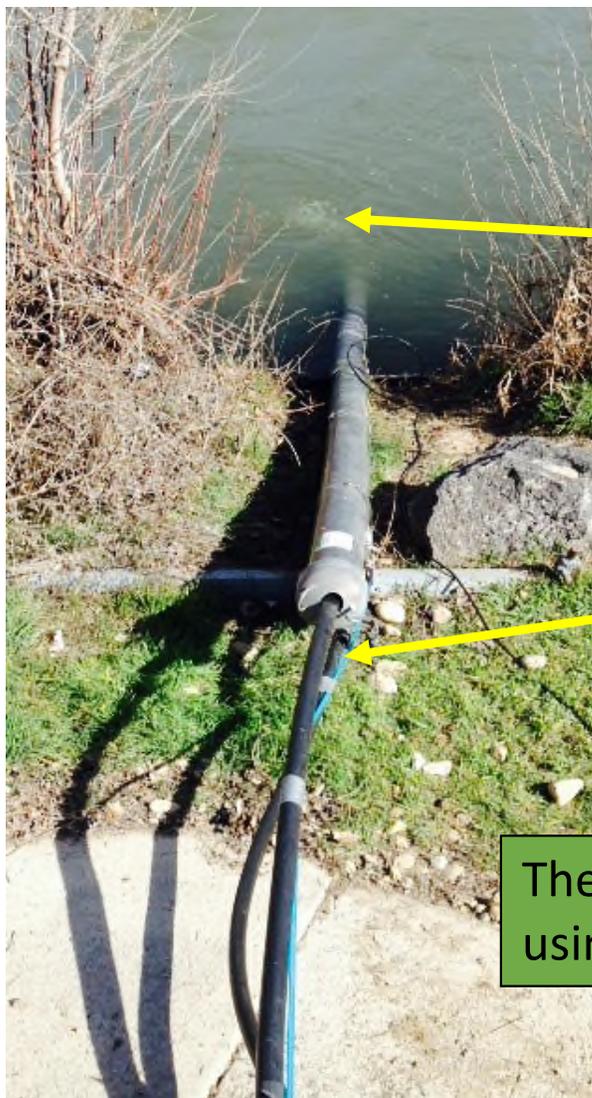
Air-Purge System Operation

Air compressor line has barbed fittings to direct air toward the bottom of the sonde guard, and probes

Air compressor line and moisture check-valve

The system purges for 2 minutes 2 X a day using ~ 25 PSI

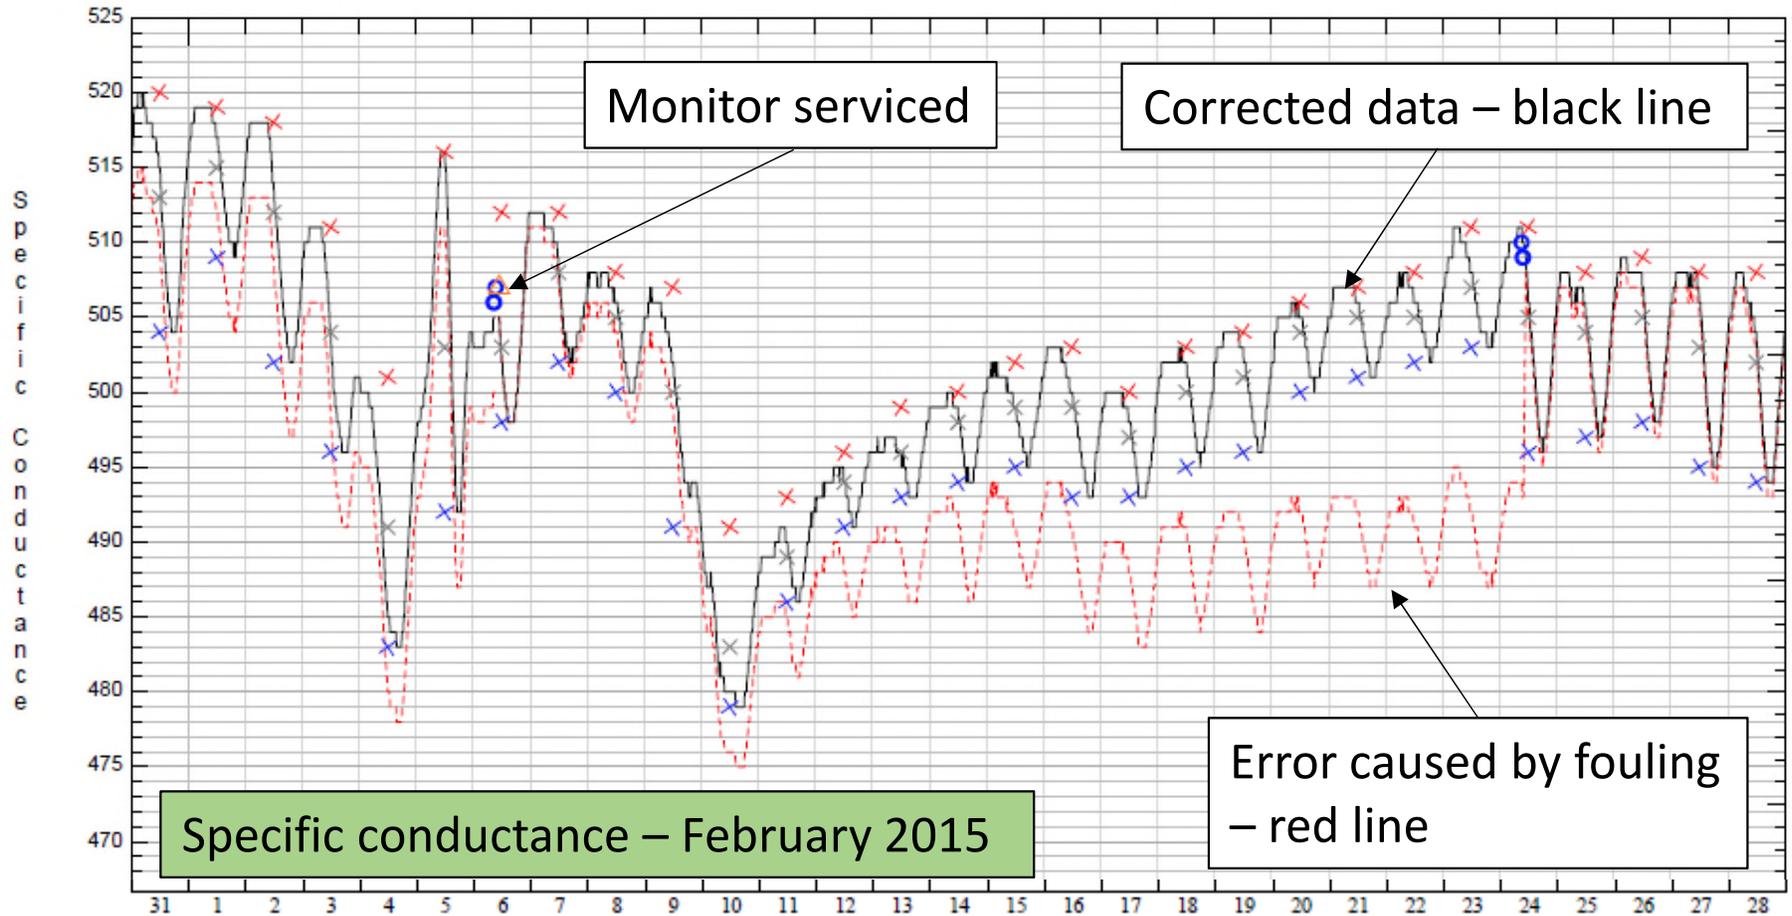
Before

13213000 – Boise River near Parma, ID

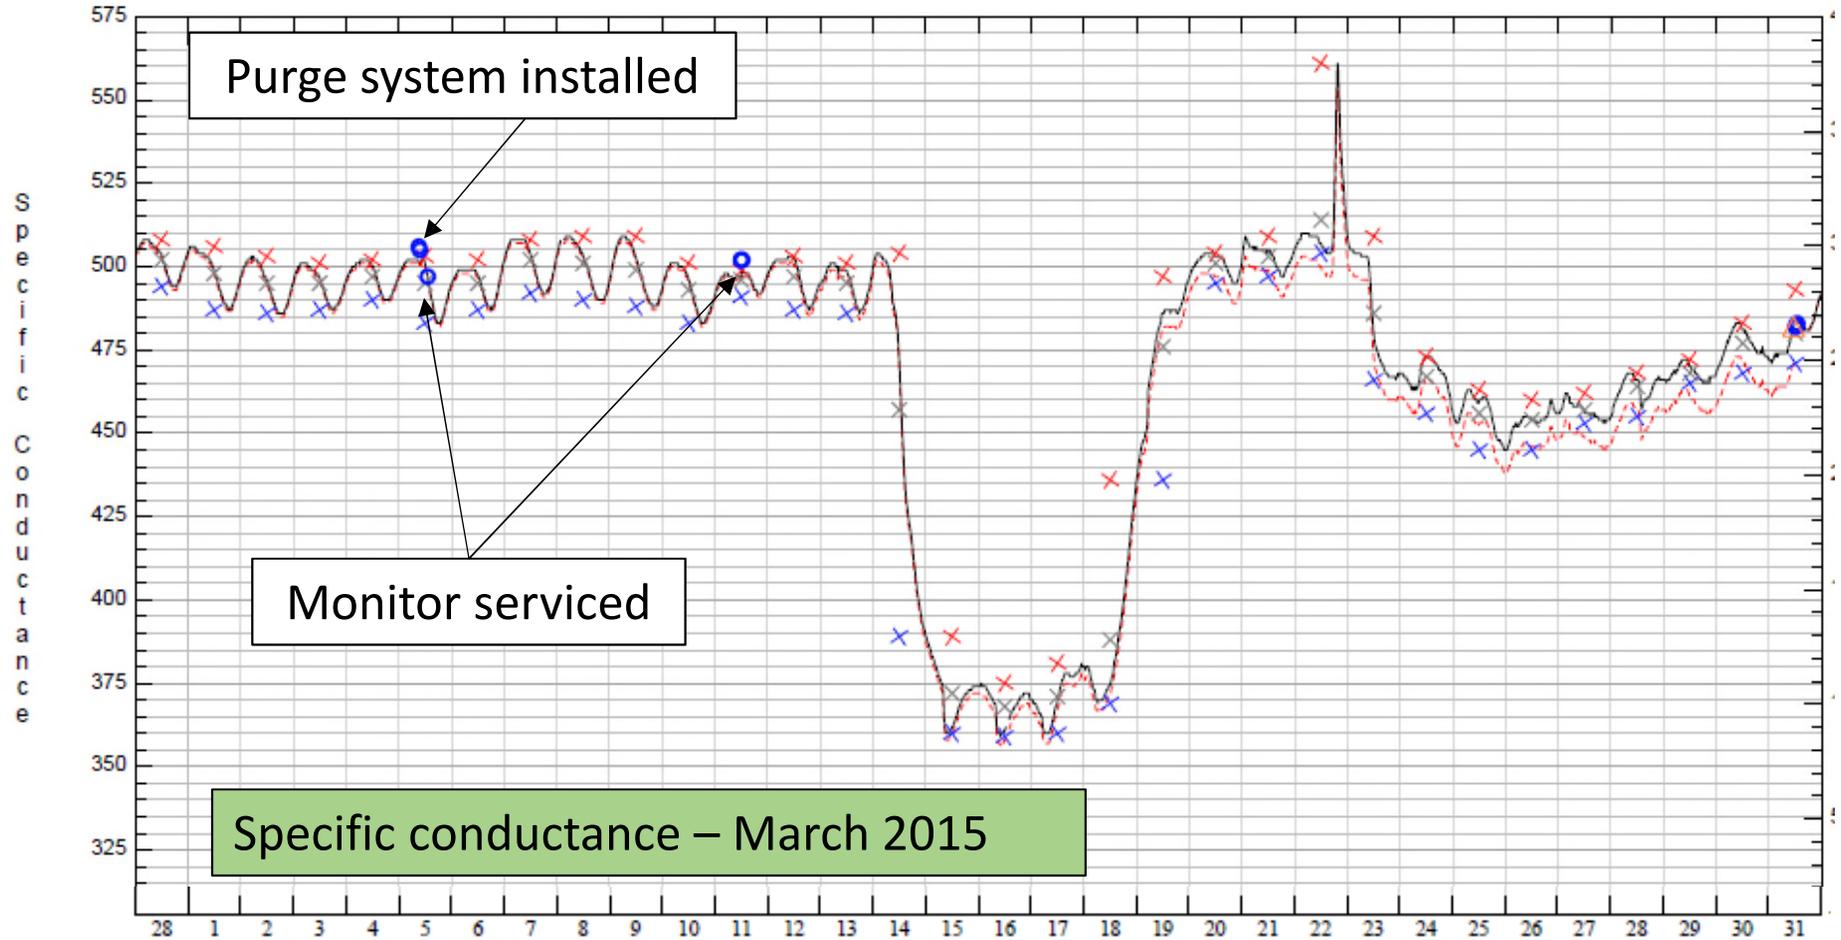
After

13213000 – Boise River near Parma, ID

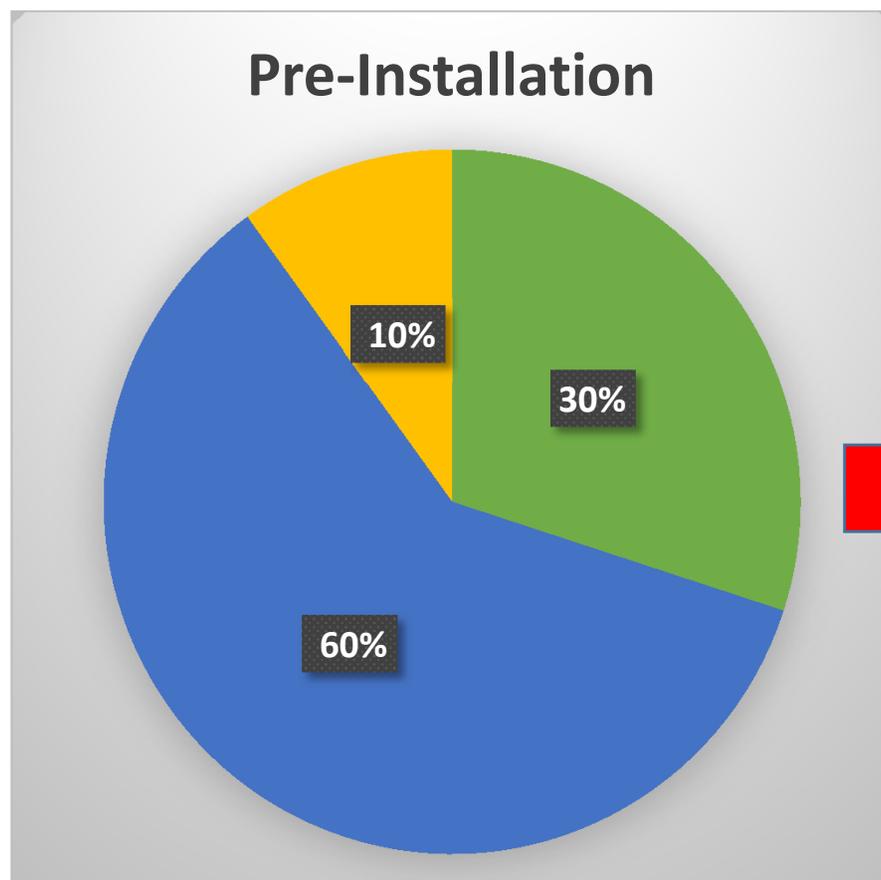
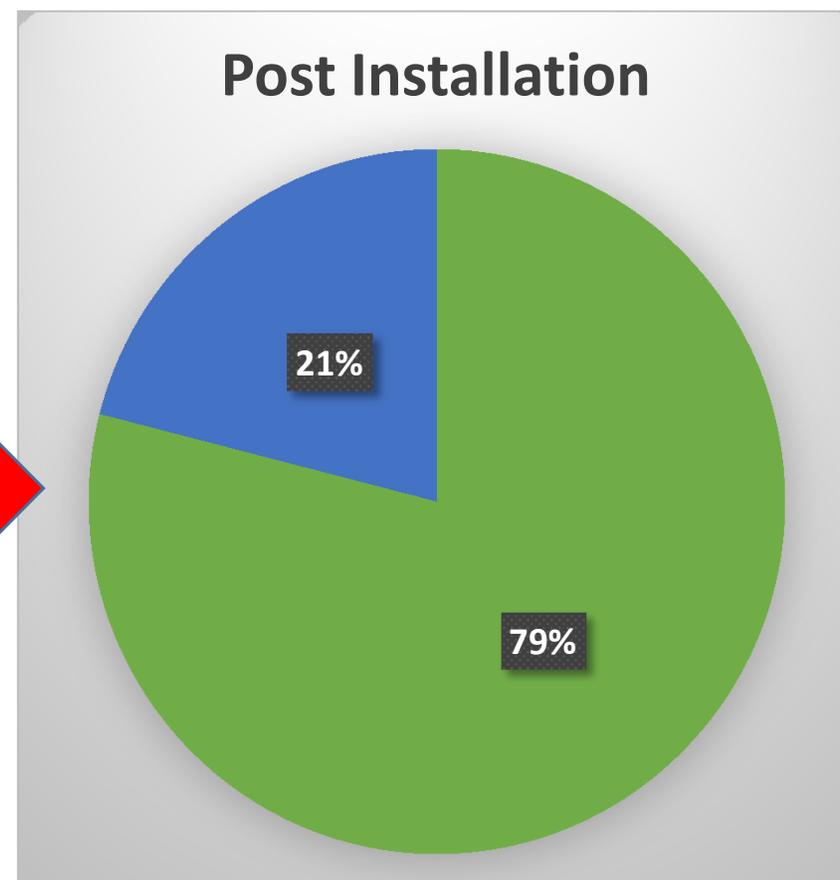
Comparison: Data Quality Rating

March – December 2014

March - December 2015

Excellent (<3% error)

Good (3-10% error)

Fair (10-15% error)

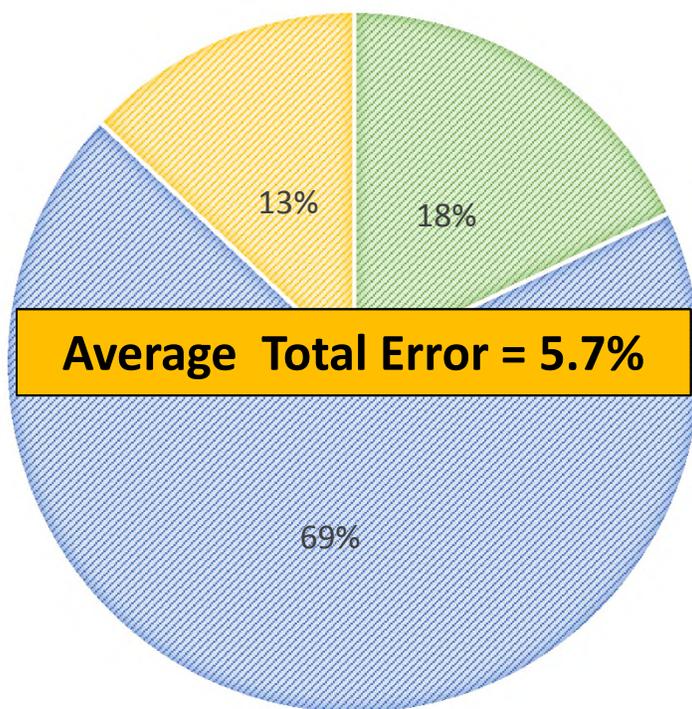
PRE-INSTALLATION

Comparison: Average Correction

■ Excellent (<3% error)

■ Good (3-10% error)

■ Fair (10-15% error)

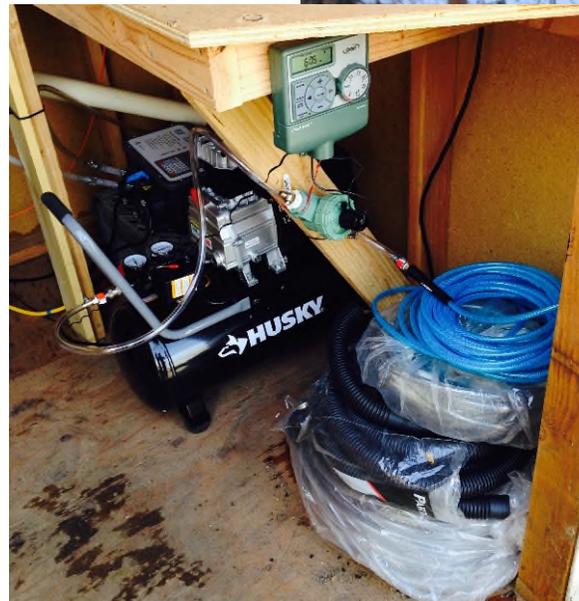
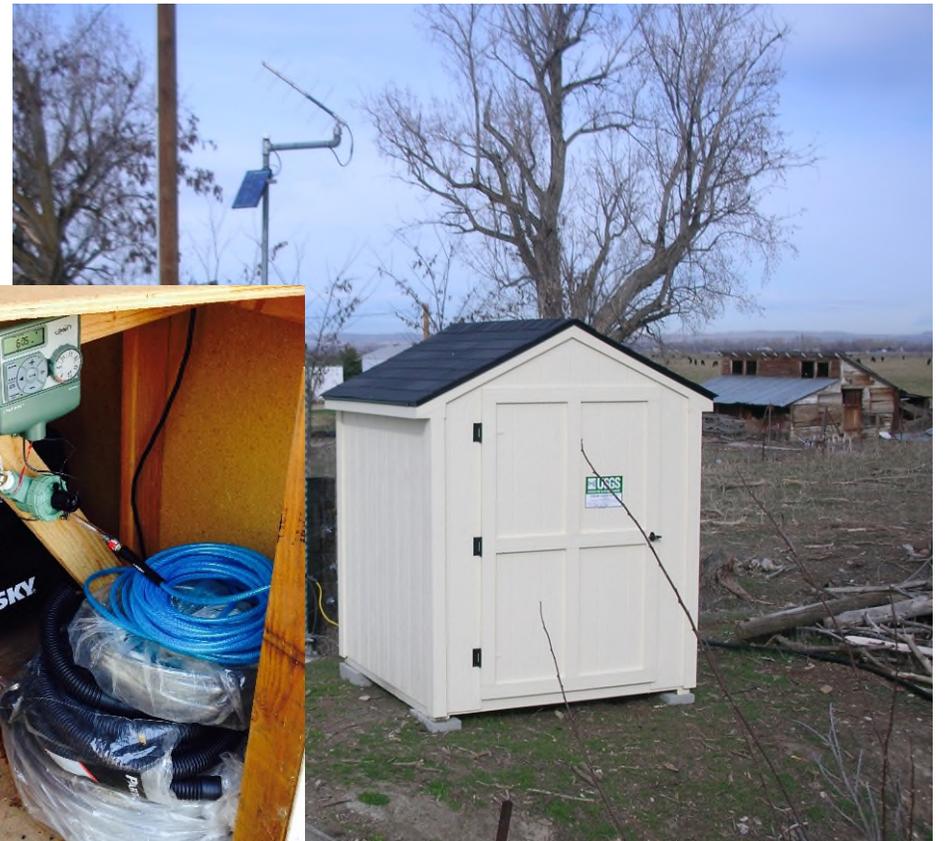
There are some limitations

- Bigger footprint
- 120 VAC power source
