# **Water Quality Monitoring to Assess a Regional Approach to Treat Agricultural Runoff**

**National Monitoring Conference 2016**

**Environmental Scientist  
St. Johns River Water Management District  
Palatka, Florida**

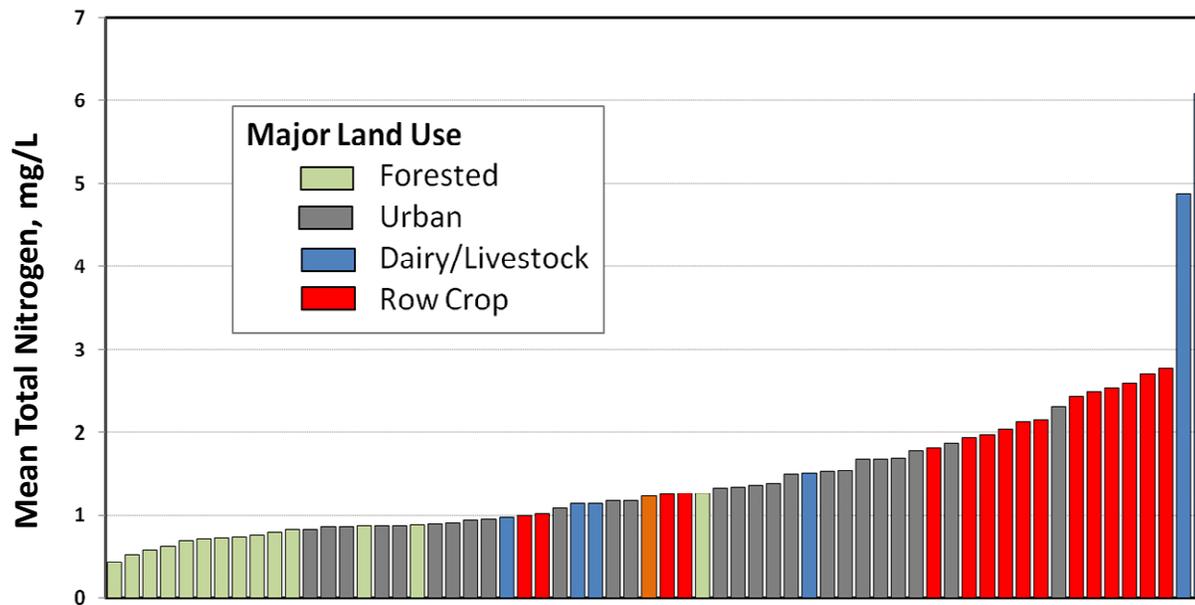
**Total Nitrogen for 61 streams in the Lower St. Johns River Basin**

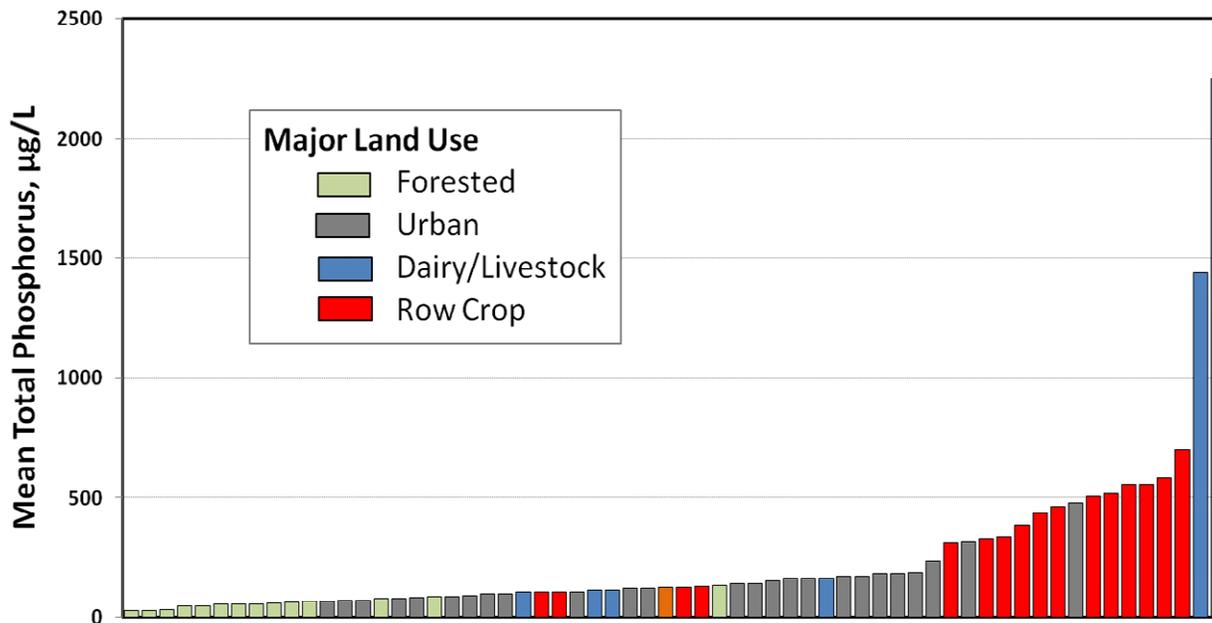
**Total Phosphorus for 61 Streams in the Lower St. Johns Basin**

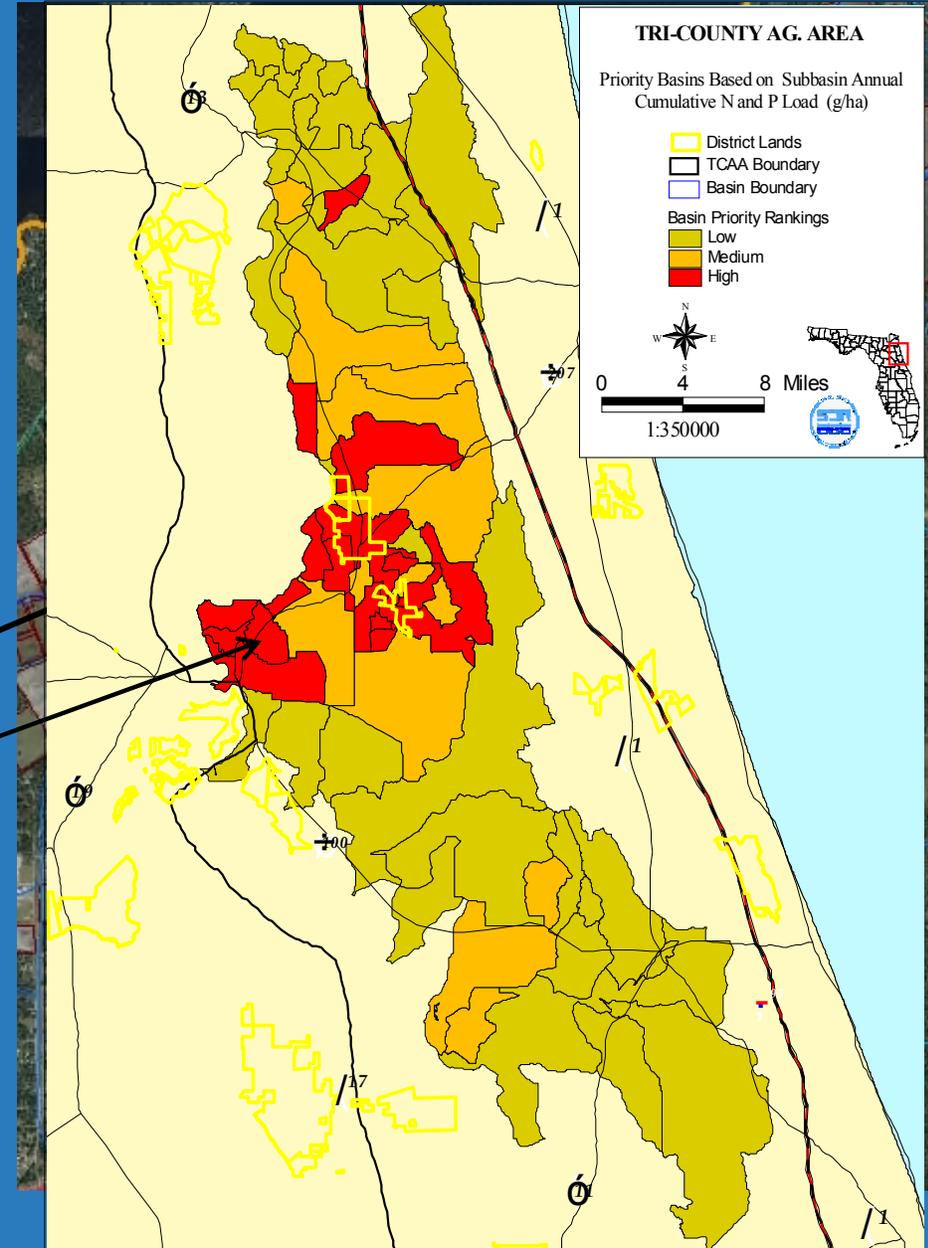
Figure 5. Priority Basins Based on Subbasin Annual Cumulative N & P Load (g/ha).

- Regional stormwater treatment implemented as secondary treatment for Dog Branch Basin
- Watershed modeling identified Dog Branch watershed as priority basin
- Basin area – 2000 acres - 65% agricultural
- Former agronomic field

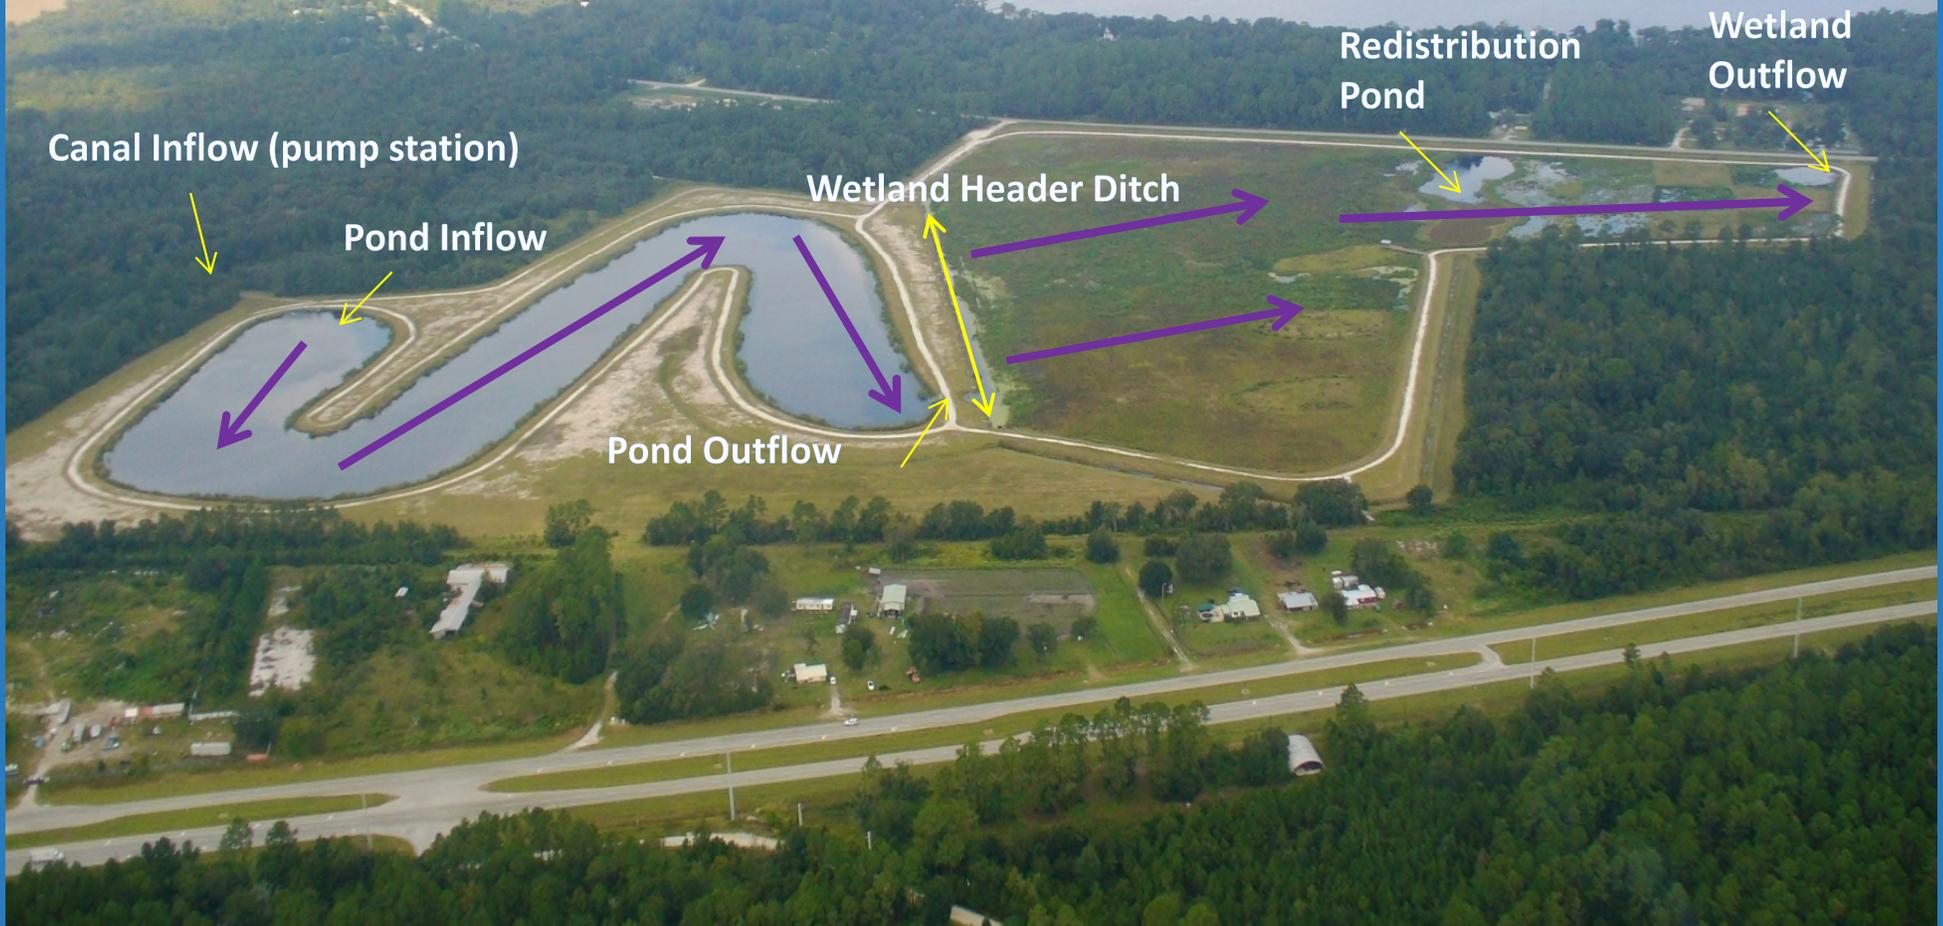
# Dog Branch RST – BMP Treatment Train

*11 hectare wet detention pond + 23 hectare constructed treatment wetland*

- *Performance monitoring is required to understand RST system delivery, behavior and performance.*
- *DBR BMP treatment train design is effective in treating both nitrogen (wetland) and phosphorus (pond) loads entering the system.*
- *RST treatment removal is greater during years with more rainfall compared to years with less rainfall.*

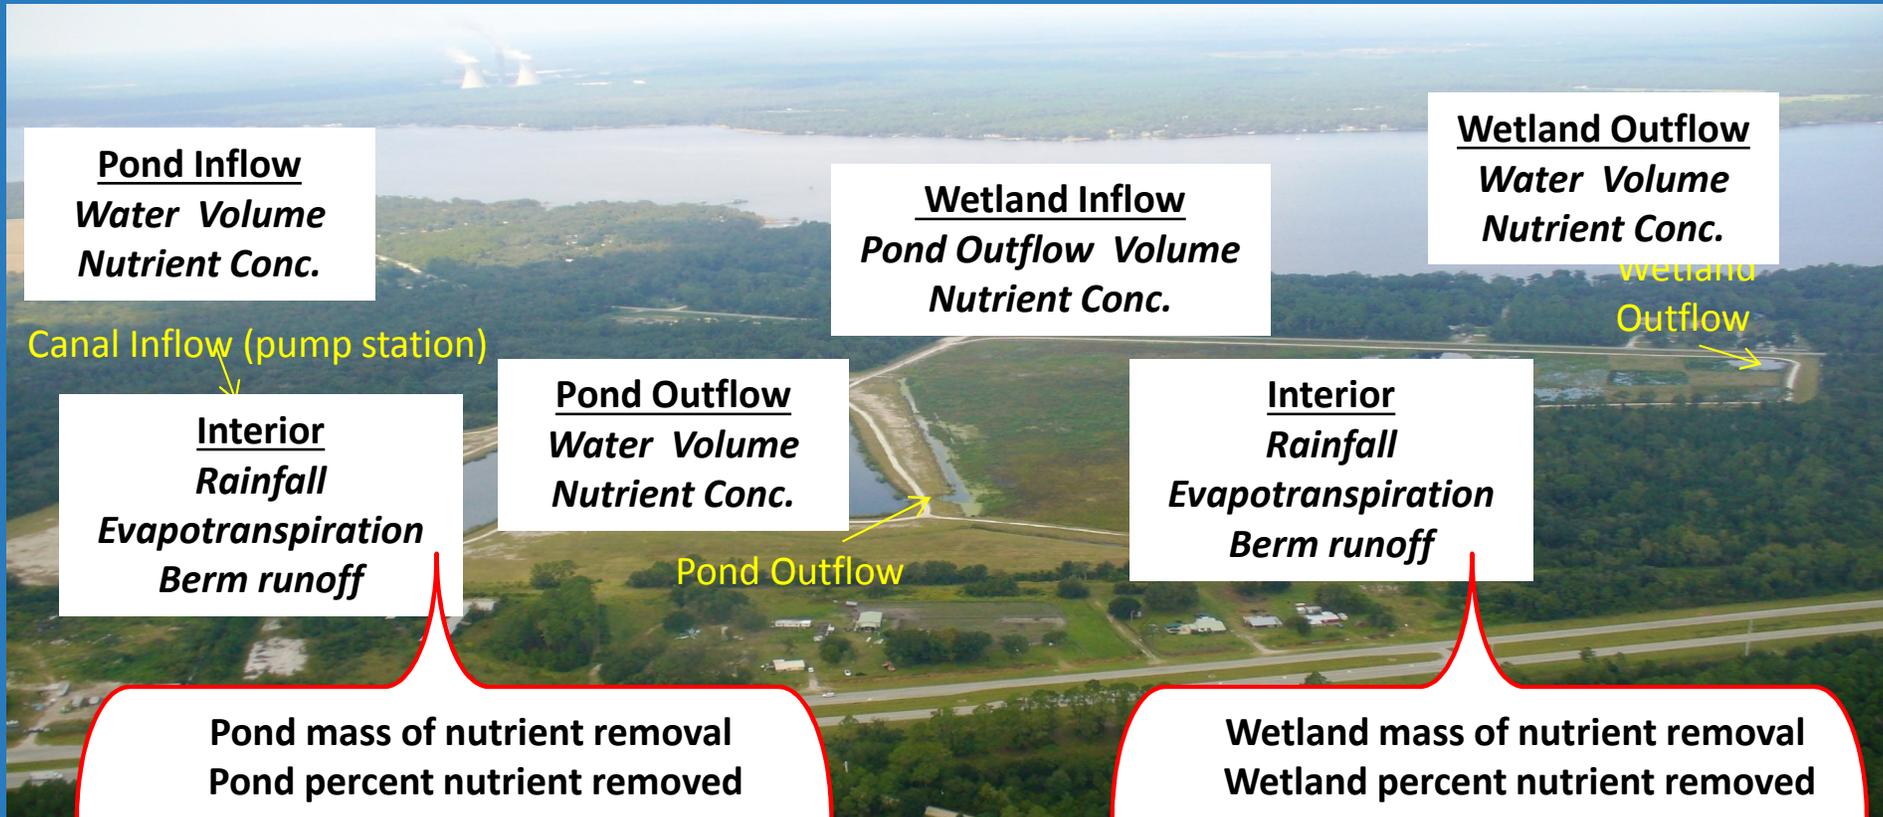
# System Performance Monitoring

- RST - Water Quality (base flow and storm water samples)
- RST - Water levels and pumped inflow (cfs) measured
- RST - Rainfall
- Analyze water samples for nitrate-nitrite, ammonium, total phosphorus, various

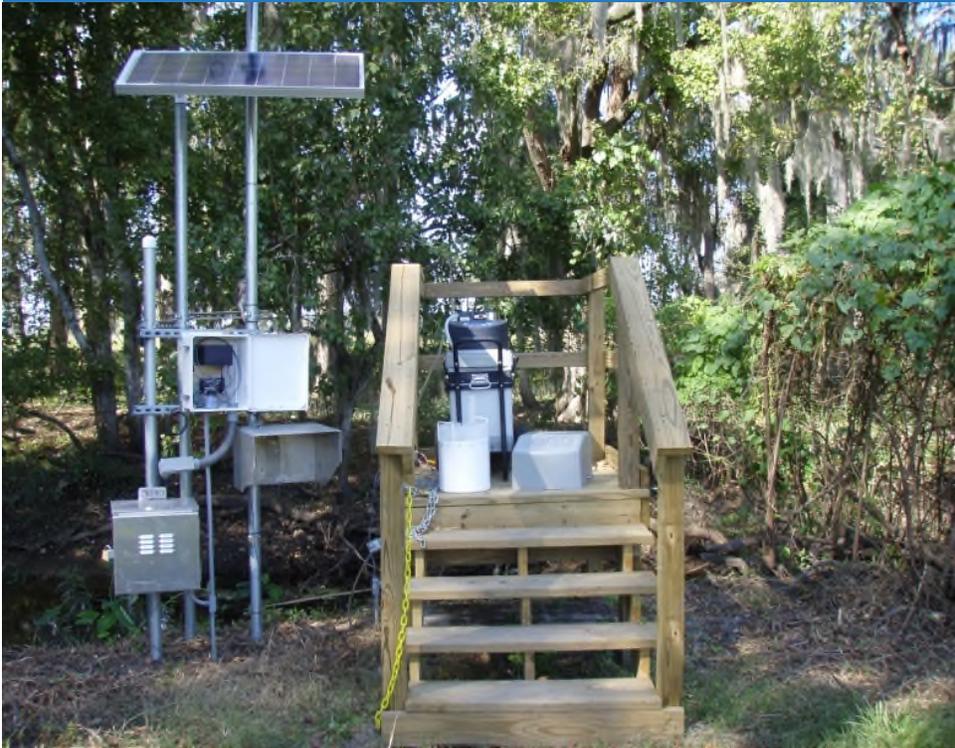
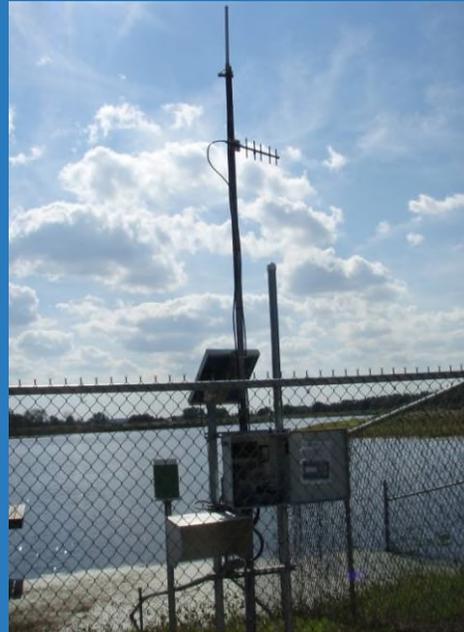
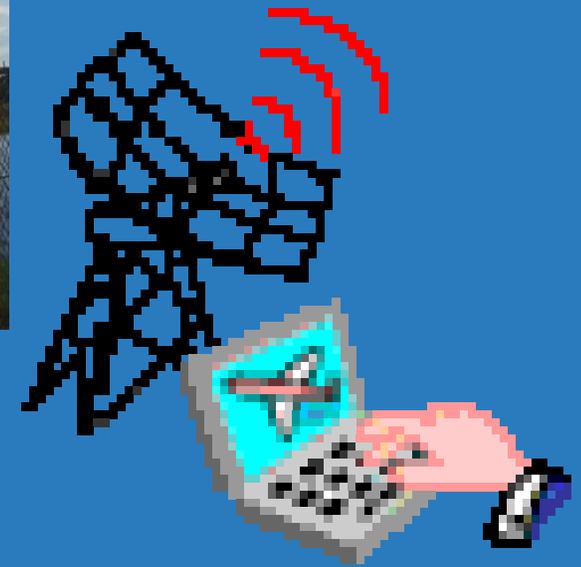
Cellular modem  
Telemetry data  
transmission

Data logger wireless communication

Perform long – term water quality analysis and hydrologic monitoring to assess performance of the treatment system.

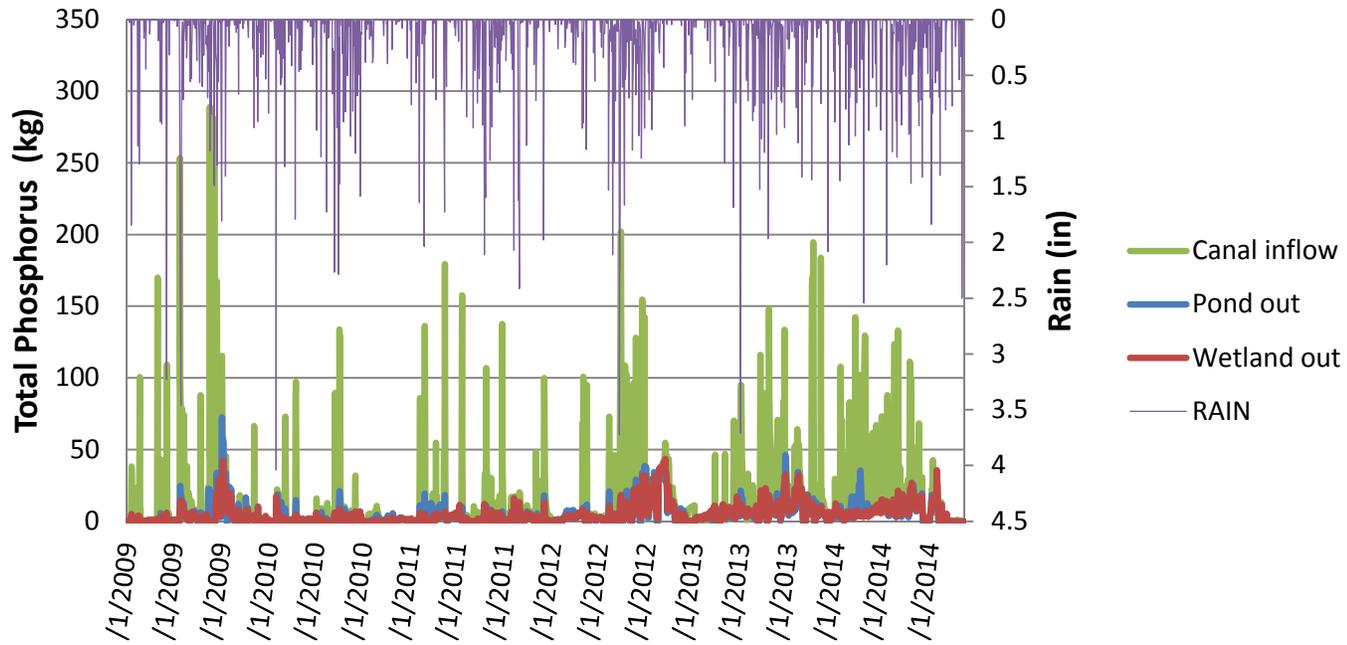
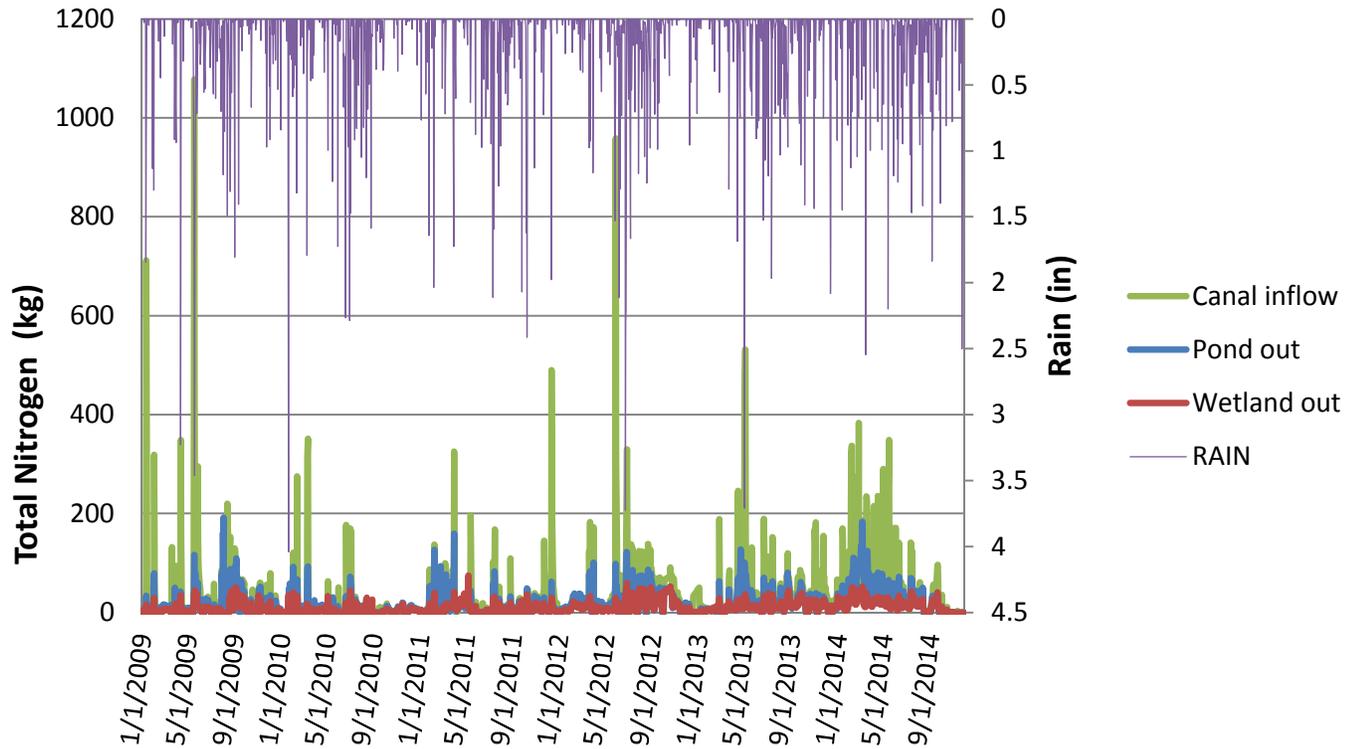
# Dog Branch System Performance

Year	TN IN (kg)	TN Out (kg)	TN Red (kg)	%Reduction TN	TP IN (kg)	TP Out (kg)	TP Red (kg)	%Reduction TP
2009	13227	2747	10479	79%	5771	1255	4515	78%
2010	3849	1722	2127	55%	1518	379	1138	75%
2011	7691	2966	4724	61%	3036	744	2291	75%
2012	13915	5063	8852	64%	6071	2760	3310	55%
2013	12555	4451	8103	65%	6278	2705	3572	57%
2014	16778	5012	11765	70%	6237	2206	4030	65%

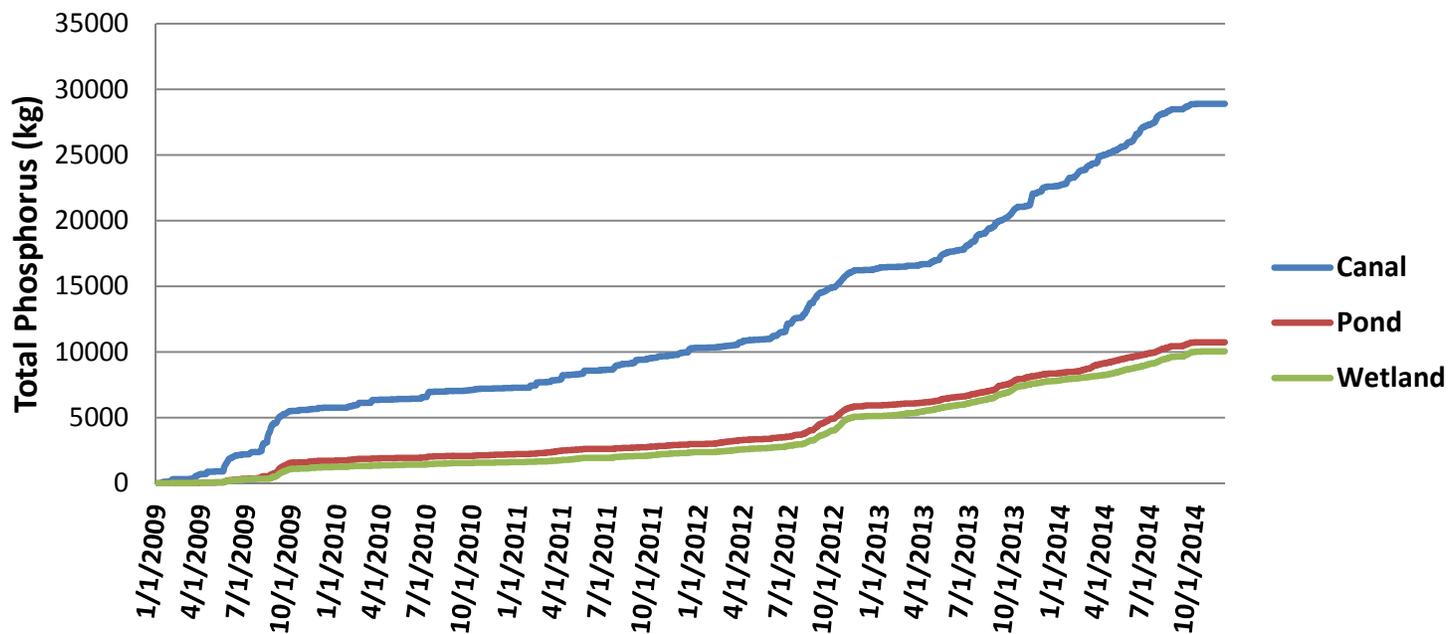
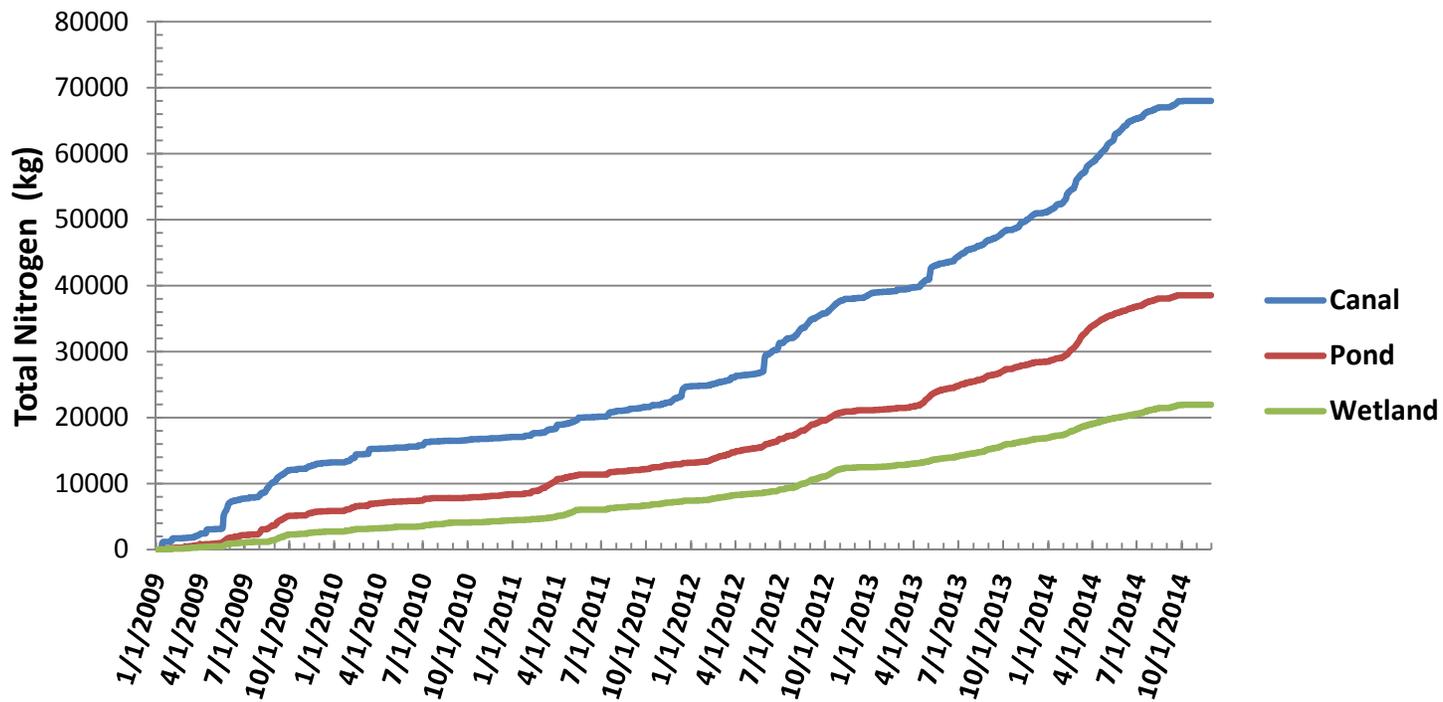
# DBR RST – Cumulative Load

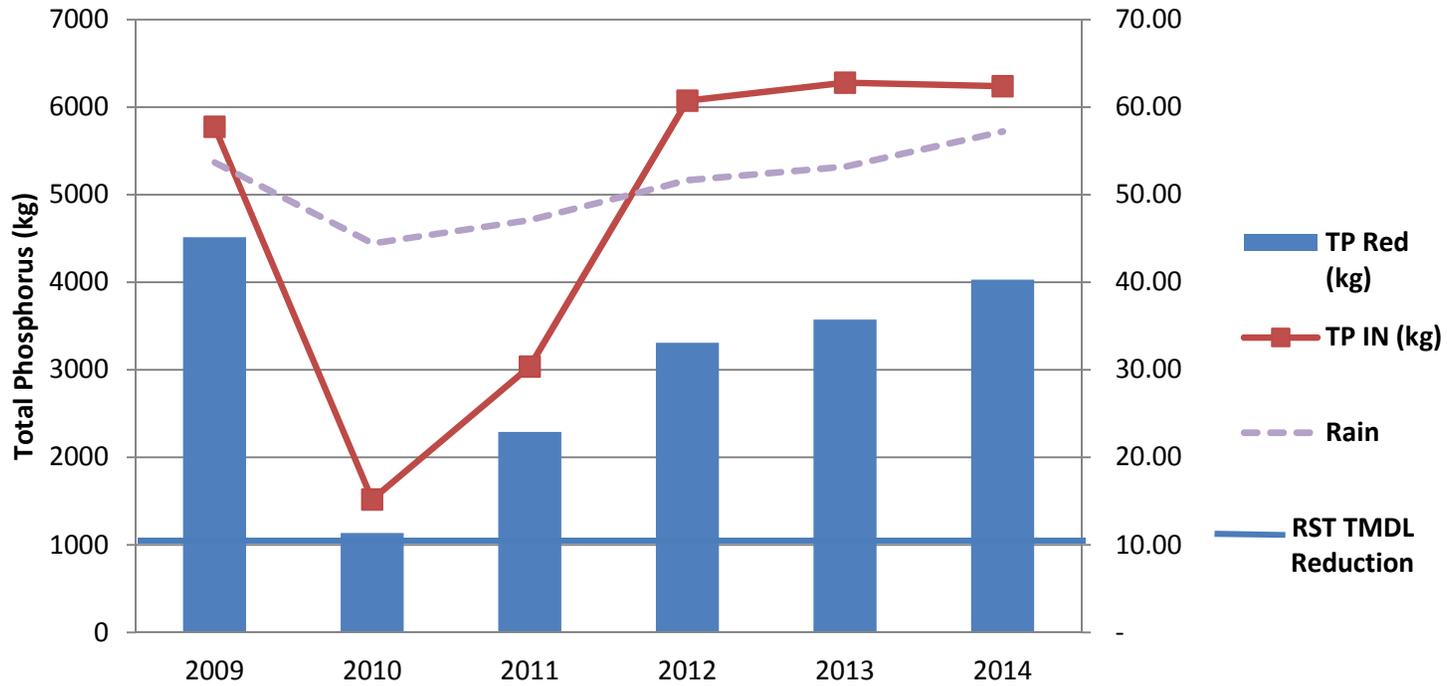
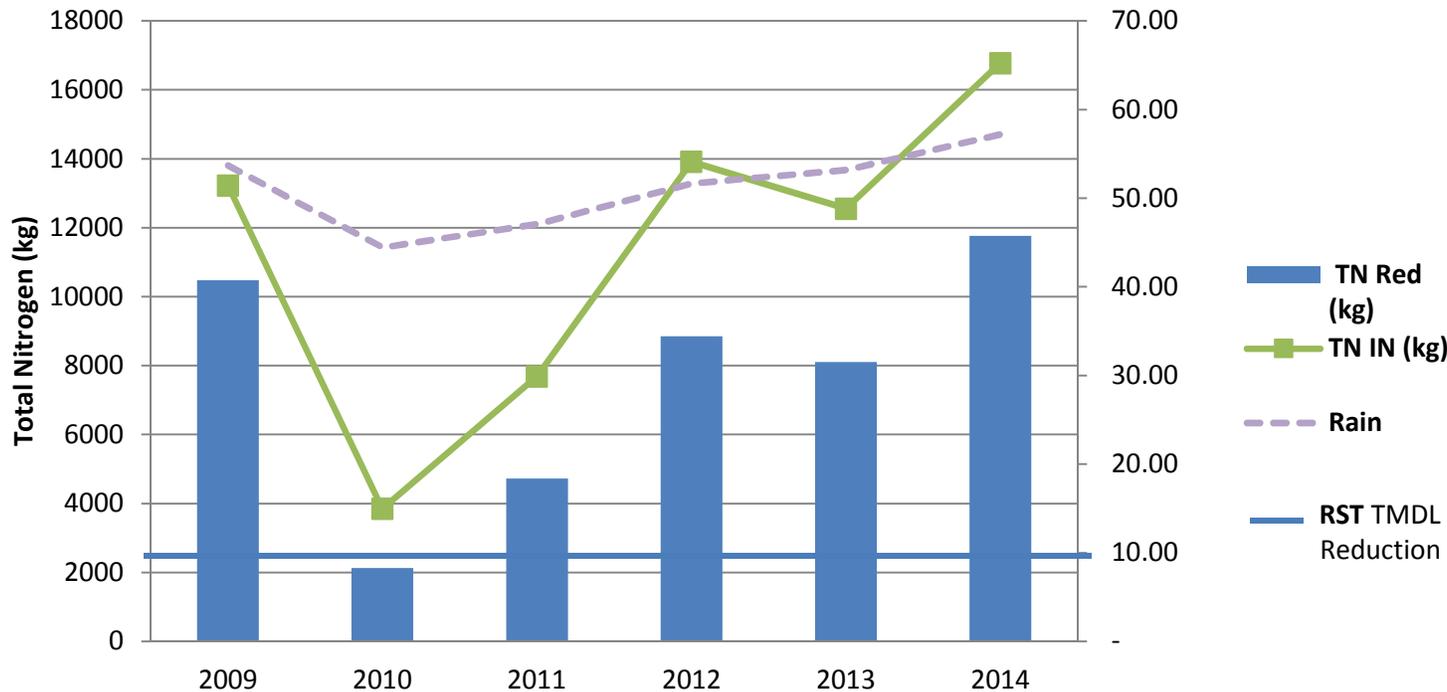
## Dog Branch RST - Annual Reduction

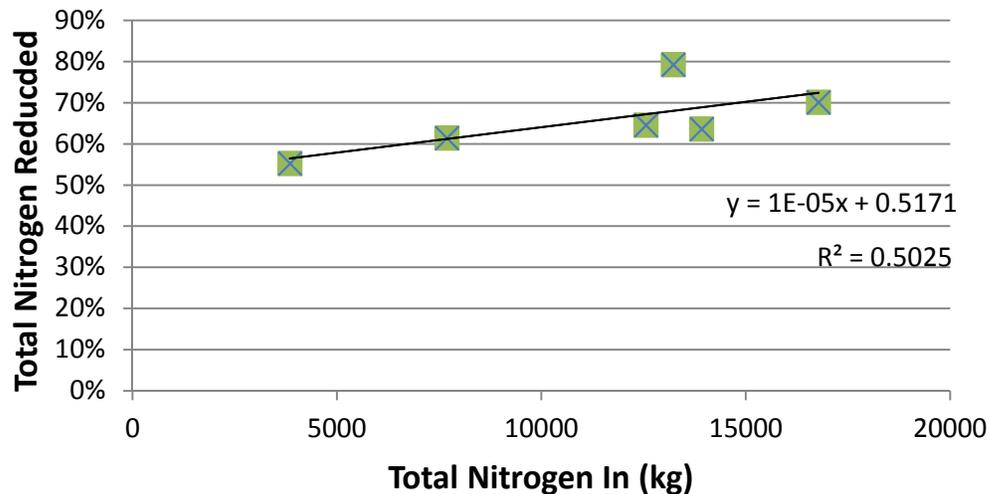
### Total Nitrogen In vs. TN Reduced

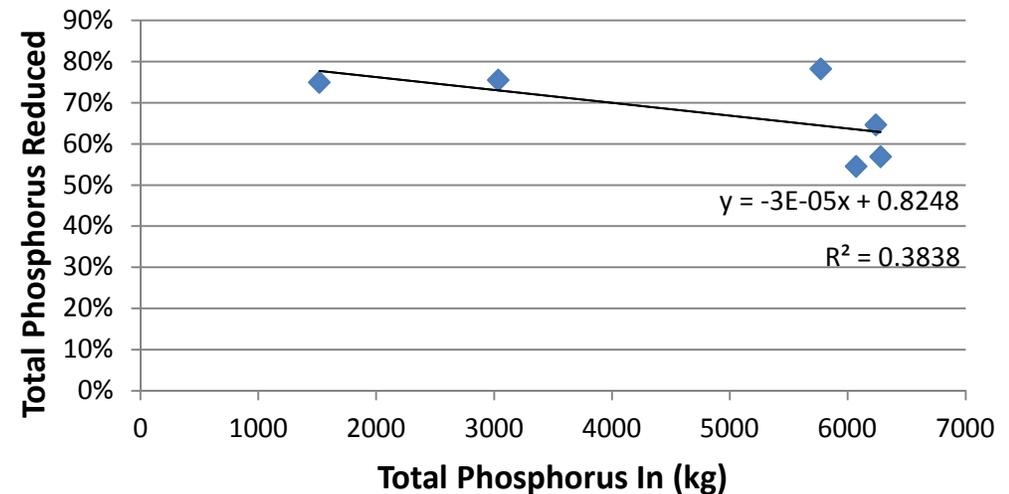
### Total Phosphorus In vs. TP Reduced
