BATTLE CREEK: LESSONS LEARNED FROM TINKERING AT A CONFLUENCE

Steven E. Yochum, Hydrologist, US Forest Service, National Stream & Aquatic Ecology Center, Fort Collins, CO, steveneyochum@fs.fed.us

prepared for the 10th Federal Interagency Sedimentation Conference
April 19-23, 2015, Peppermill Hotel, Reno, Nevada, USA

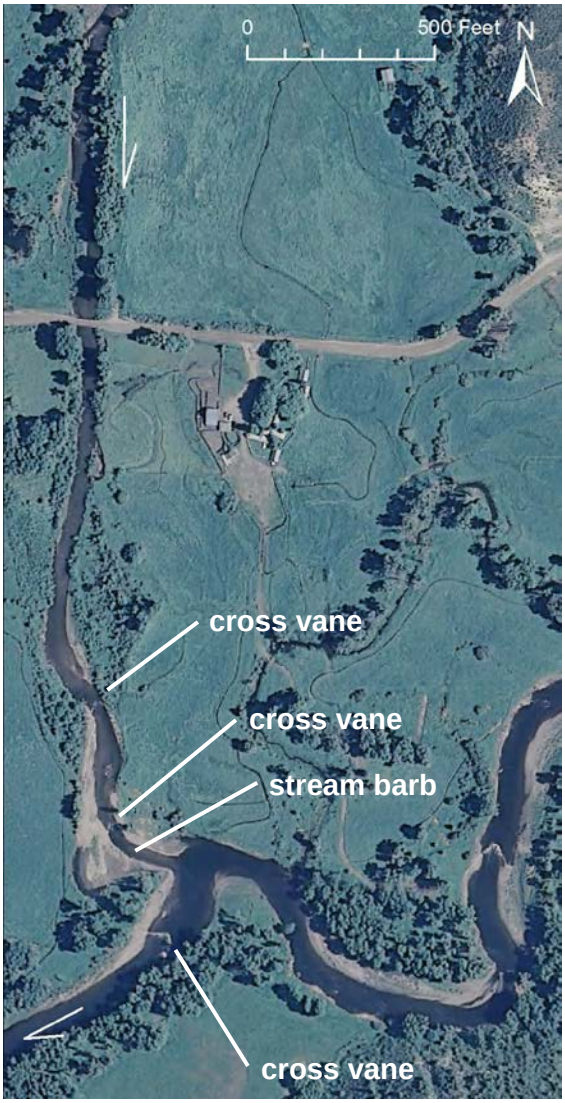
Figure 1: Battle Creek at the Little Snake River confluence (7/23/2009).

A substantial amount of sediment was deposited on and just upstream of the upper cross vane installed on Battle Creek (Figures 2 and 3). This local aggradation extends for a length of about 200 feet. This deposition forced an avulsion of the stream channel to the west of its previous location (Figure 1). The channel has a braided form within this short extent, with the preferential flow channel currently on the west edge of this depositional bar. A meander bend and point bar is forming to the east of this channel. In the vicinity of this depositional bar, both sides of the channel have willows along much of the banks, but coverage is patchy with grazing apparent on both banks, negatively impacting willow- and sedge-induced bank stability. The streambank on the west side of the depositional bar, adjacent to the principal flow channel, is actively eroding (Figure 4). A few of the patchy willows that were once present along this bank were laying in the channel. The fenceline and aerial imagery indicate rapid bank erosion rates.

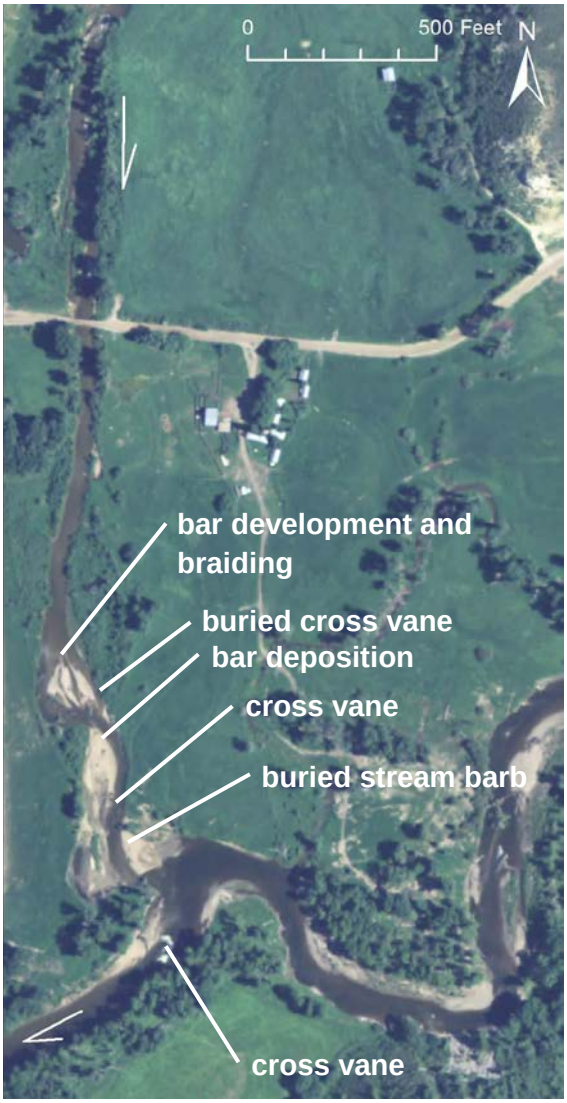
cottonwood gallery. Battle Creek enters the Little Snake with an atypical upstream orientation. Substantial sediment deposition is evident in Battle Creek just above the confluence (Figure 2). Combined with the impacts of grazing practices on riparian vegetation, this deposition resulted in rapid bank erosion rates that are problematic for the landowner.

Figure 2: Battle Creek at the Little Snake River confluence (7/23/2011).

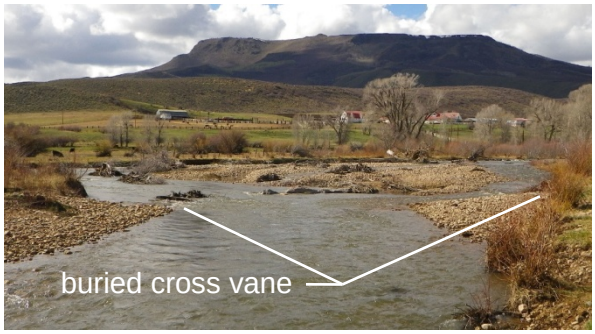
Figure 3: Upper cross vane, with sediment deposition and braiding just upstream.

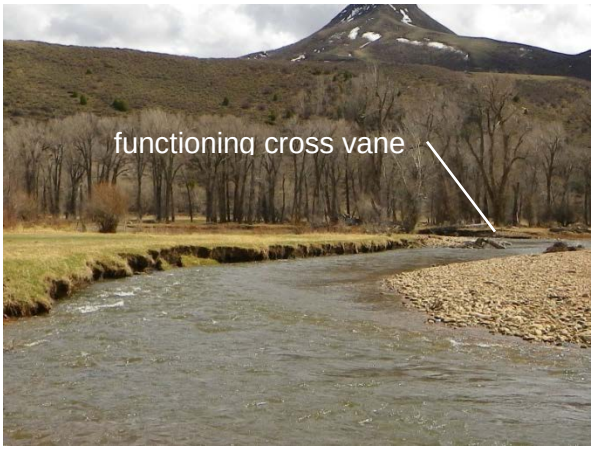
An additional bar has been deposited downstream of this location, on the west bank between the two cross canes (Figures 2 and 5). Opposite this point bar, a second rapidly-eroding bank is present (Figures 5) as the stream attempts to increase its meander planform. A cross vane that appears to be functioning properly is located just downstream of this eroding bank. No willows are present on this bank. The aerial imagery (Figures 1 and 2) indicate that this bank is not eroding as quickly as the upstream bank. Heavy grazing was apparent along this bank, along with indications of additional feeding in this pasture.

Figure 5: Rapidly-eroding streambank, opposite of an additional depositional bar.

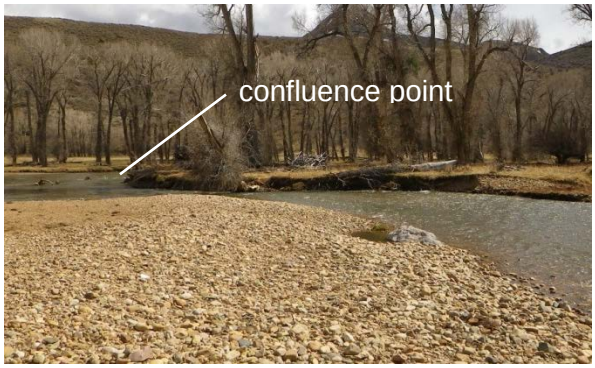
Figure 6: Confluence bar, with variable bed material size.

The third and final depositional bar is at the confluence (Figures 2 and 6), with the bar extending from north to south across the constructed channel location. This bar consists of multiple sediment sizes, with coarse material deposited on fines. A portion of a stream barb can be seen protruding from the bar (Figure 6). The growth of this bar mirrors the erosion of 20 to 30 feet of the confluence point between 2009 and 2011. Alongside this erosion the pool in the Little Snake just upstream of the confluence has been reported to have filled substantially. Additionally, flood debris is present on the fenceline on the west side of Battle Creek, showing the approximate high flow elevation for the Little Snake in 2011.
