Characterization of Water Quality in a Hydrothermally Altered and Historically Mined Watershed, Warden Gulch, Colorado

Erik Oerter
Colorado Geological Survey
Colorado Department of Natural Resources

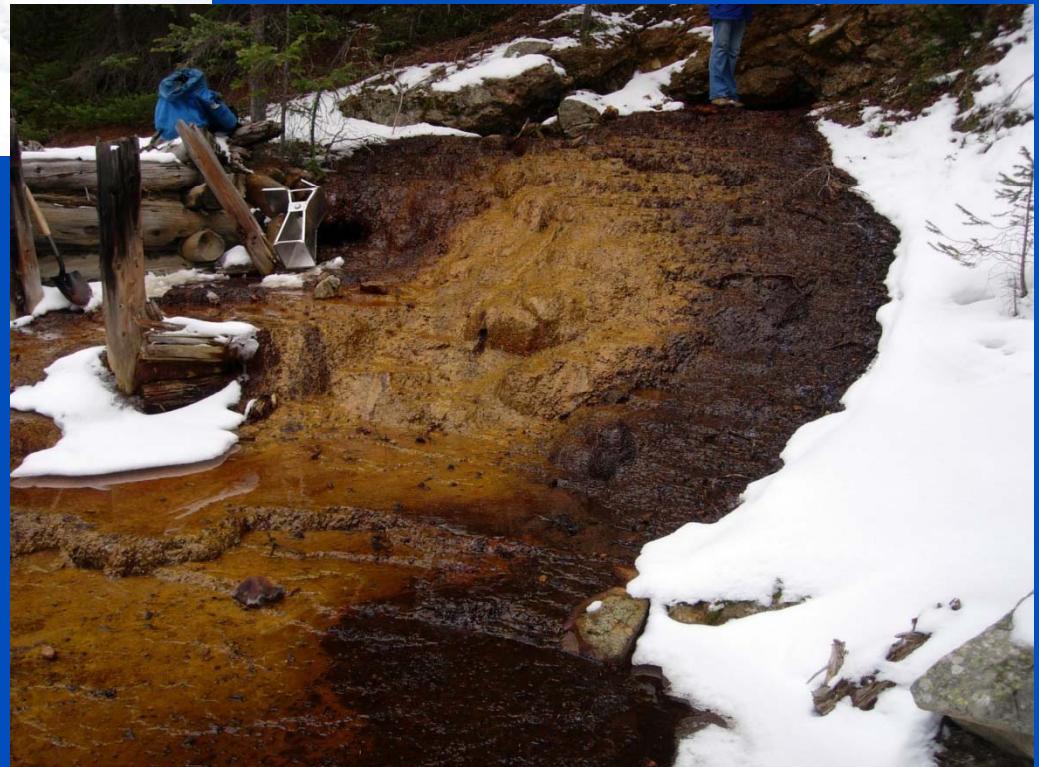
Adit #101

~6 gpm (June)

pH of 3.7

Al concentration: 82,000 µg/L

Fe concentration: 110,000 µg/L

Mn concentration: 30,700 µg/L

Zn concentration: 6,950 µg/L

SO₄ concentration: 1,100 µg/L

Draining adit in Lower Warden Gulch

Ferricrete deposits

Only flowing point source in watershed

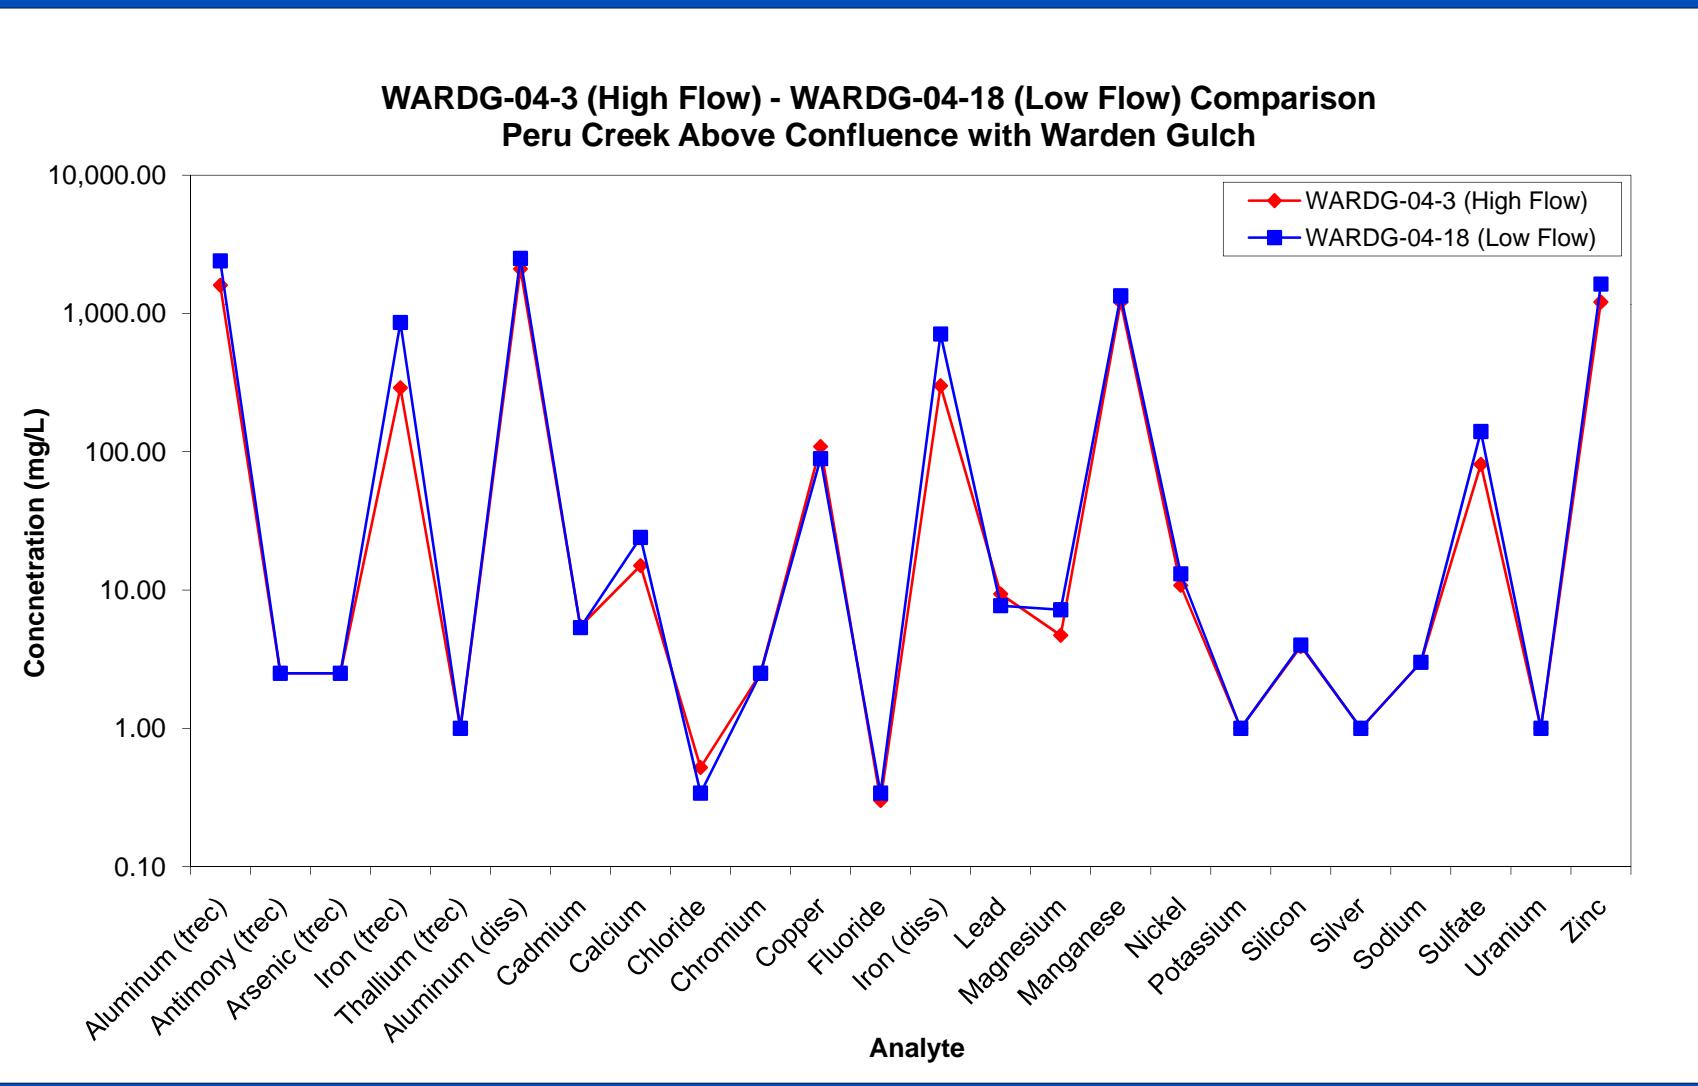
Expected (and observed in Peru Creek) results: Lower concentrations at high flow due to dilution by increased flow volumes

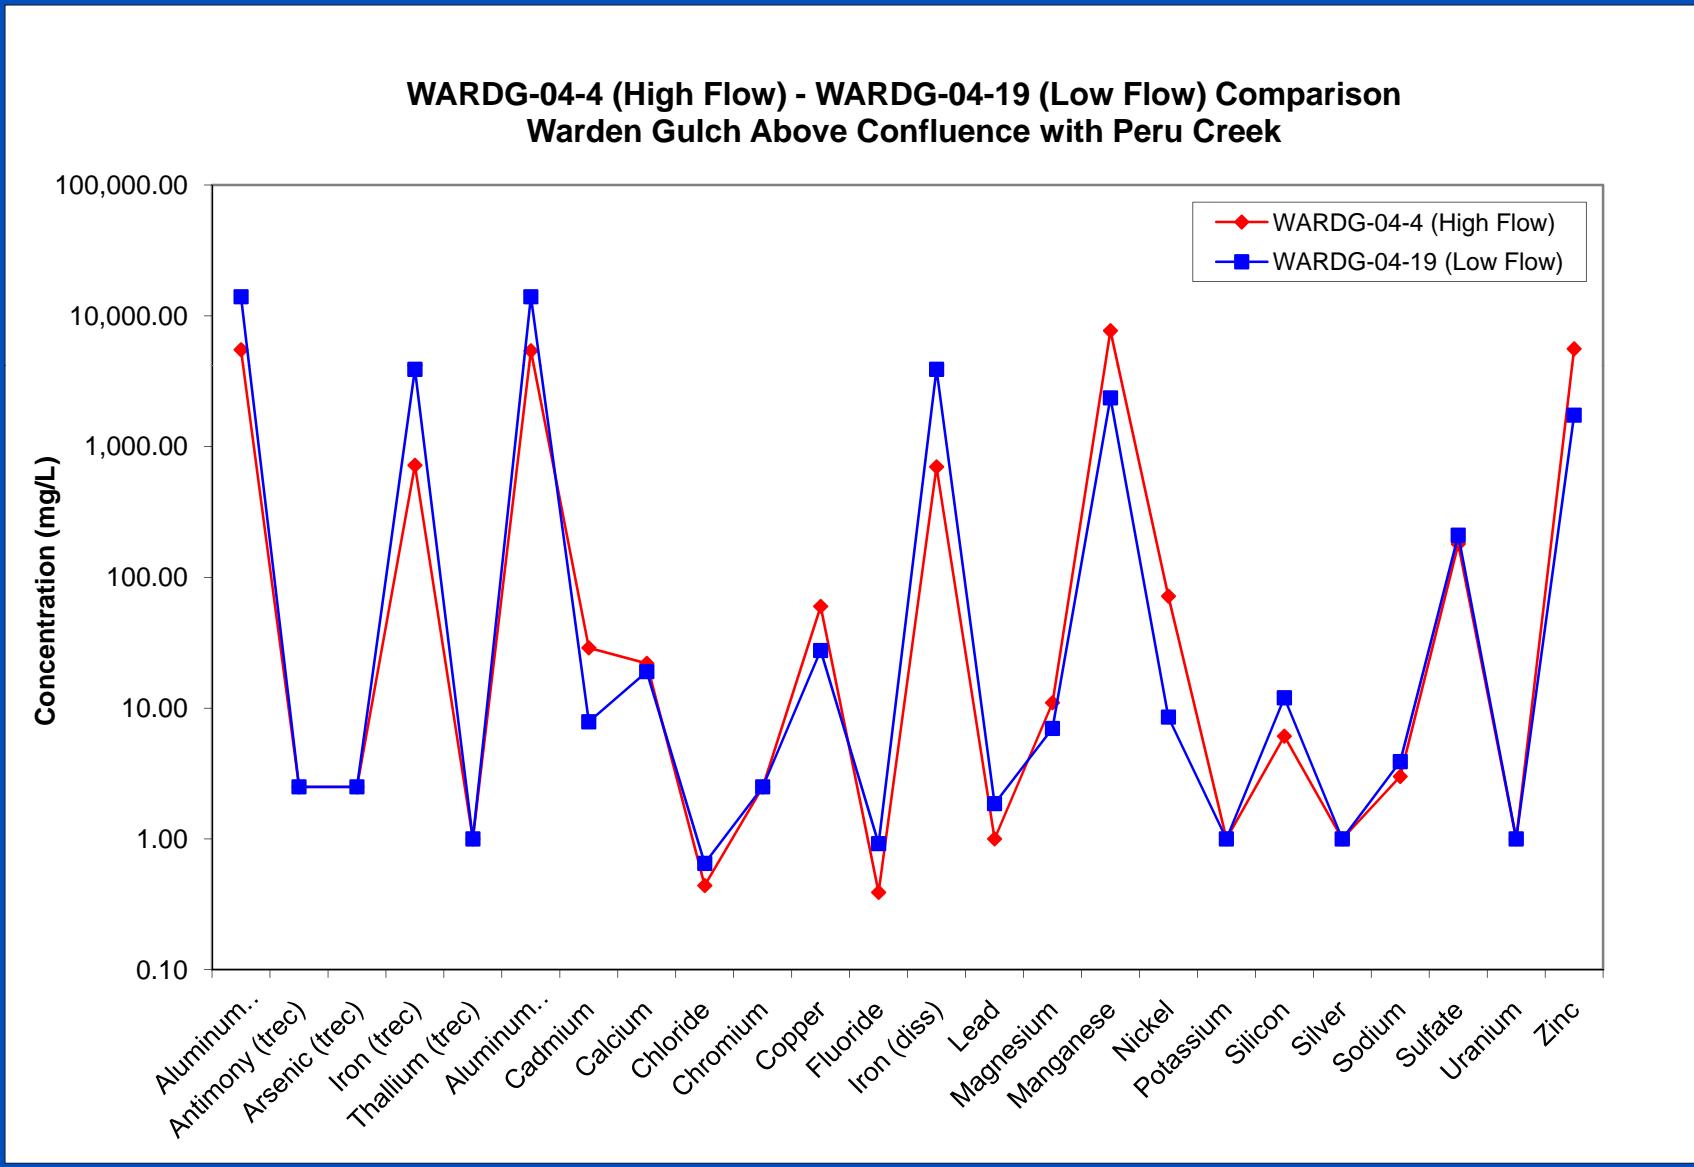
Observed results in Warden Gulch: Higher concentrations in some metals at high flow

- Likely Suspects:
 - Surface waters present during Spring snow melt infiltrating bedrock and colluvium (talus)
 - Surface waters infiltrating and draining waste rock piles
 - Similar materials (hydrothermally altered and mineralized bedrock)
 - Similar redox conditions in the unsaturated (vadose) zone
- Unlikely due to contribution from Adit #101
 - Adit Discharge: 1 – 6 gpm
 - vs
 - Warden Gulch: 200 – 1070 gpm
