EVALUATION OF THE LONG-TERM IMPACTS OF URBANIZATION ON A PIEDMONT HEADWATER STREAM:

A Comparison of Physical, Biological and Chemical Indicators of Response

Ted Mikalsen

Robert L. Bourne

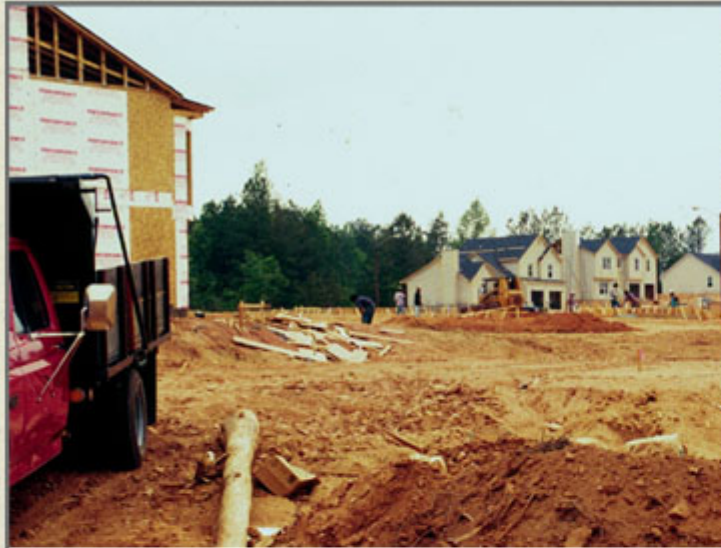
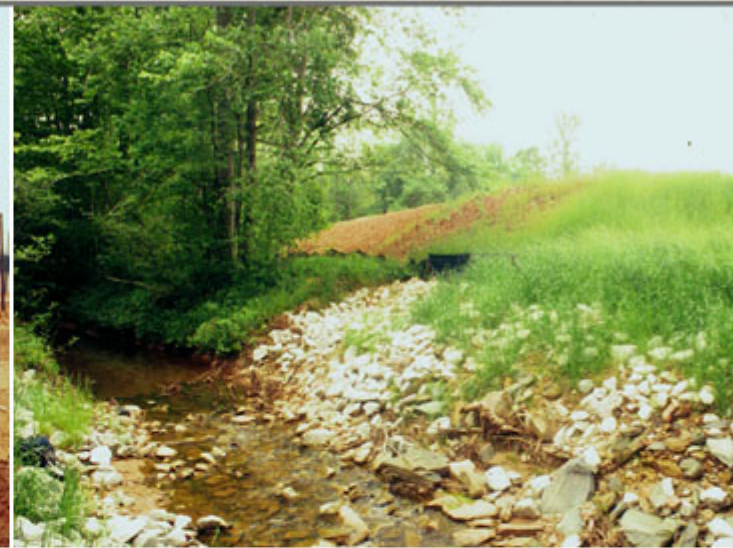
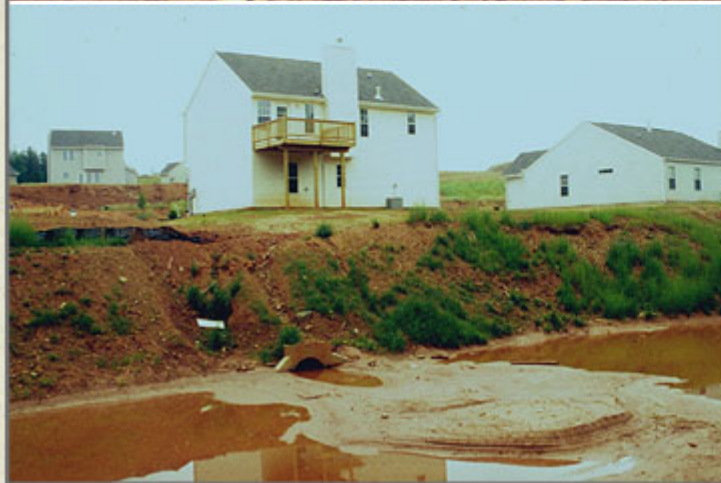
FIGURE 6: Proctor Creek Tributary

- Residential development immediately upstream of sampling reach.
- Inadequate erosion and sediment controls and spotty to inadequate enforcement actions.
- Heavy sediment loading to stream.
- Percent impervious increases from 14.6% in 1993 to 18.6% in 1995.
- Slightly below normal rainfall in 1996.

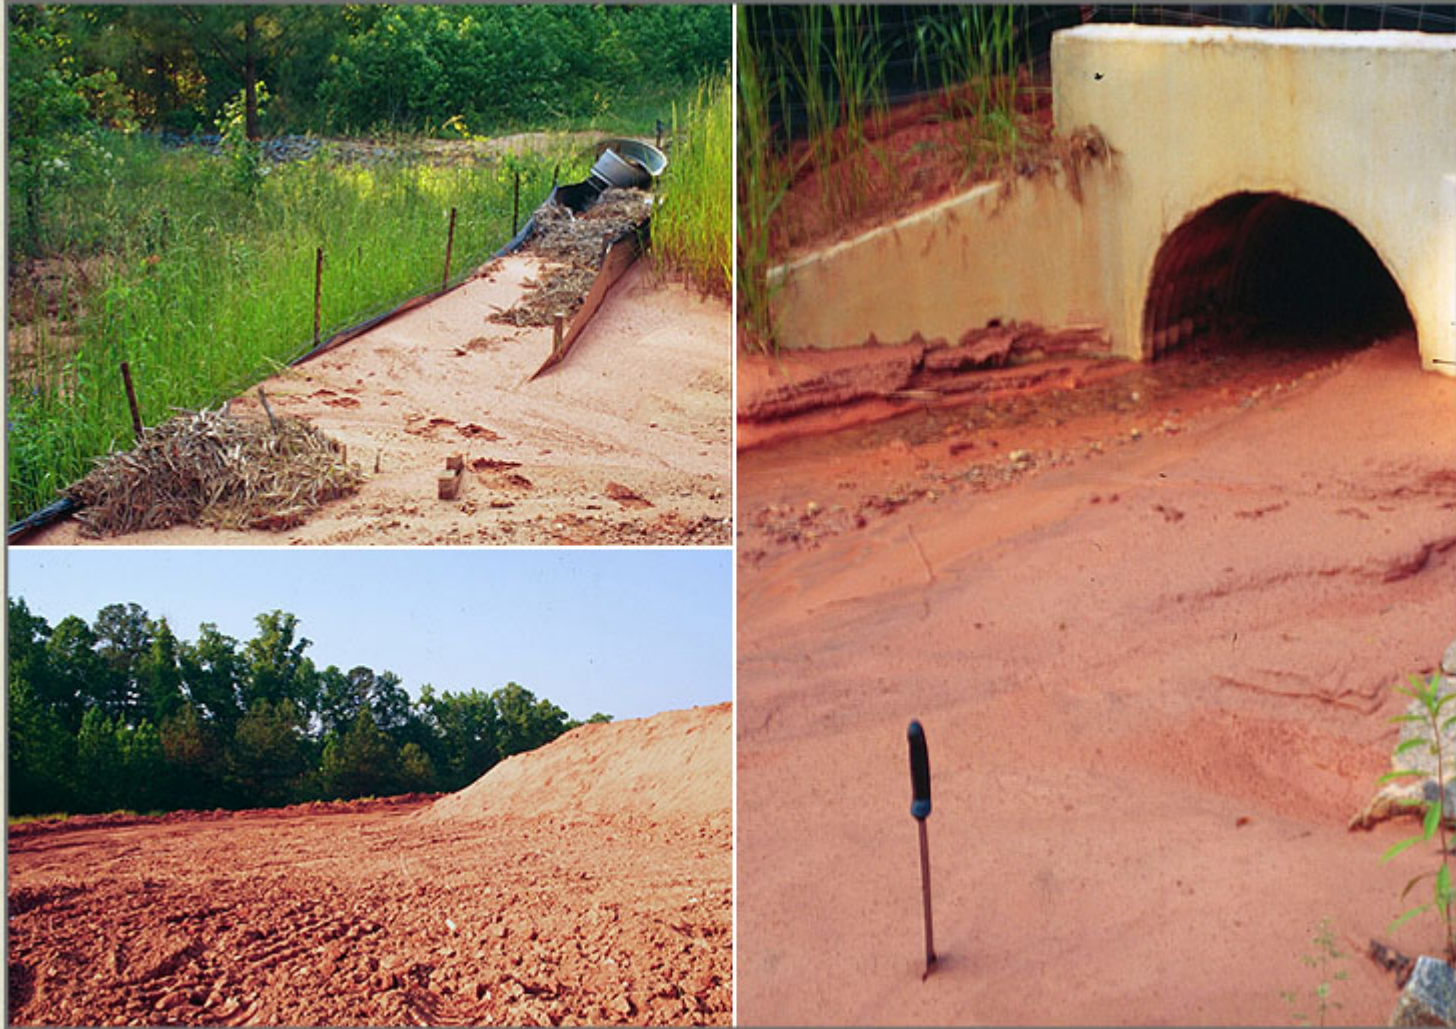
FIGURE 11: Proctor Creek Tributary

- While the construction of medium density residential development and the commercial-industrial park continued, Cobb County issued no new building permits during 1997.
- Heavy sediment delivery from immediately upstream residential construction continued despite reporting problems responsible jurisdiction. Cobb County took enforcement actions against a residential development in the middle of the watershed.
- The estimated impervious area approached 25% of the watershed.
- Normal rainfall in 1997 & 1998.

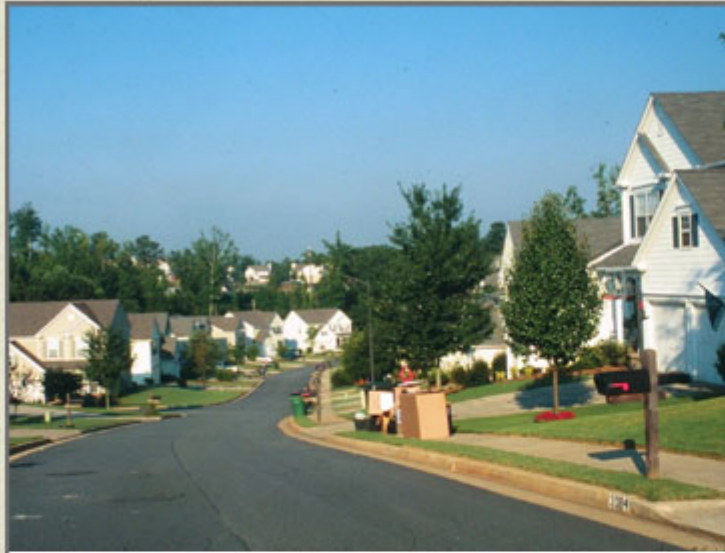
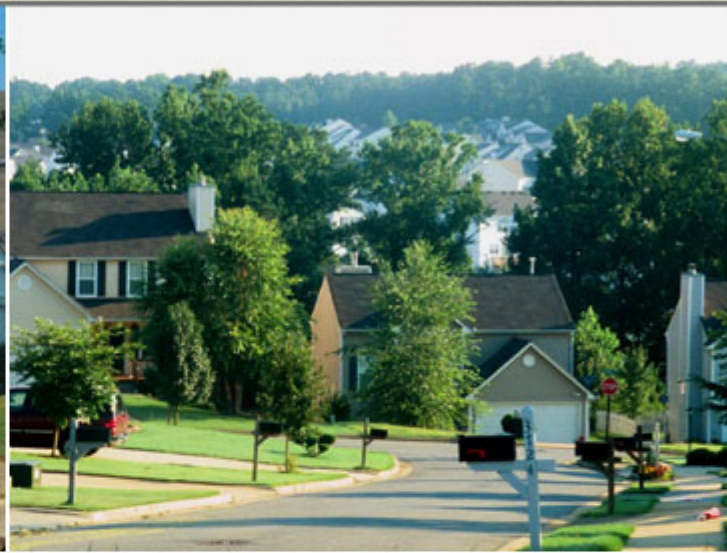
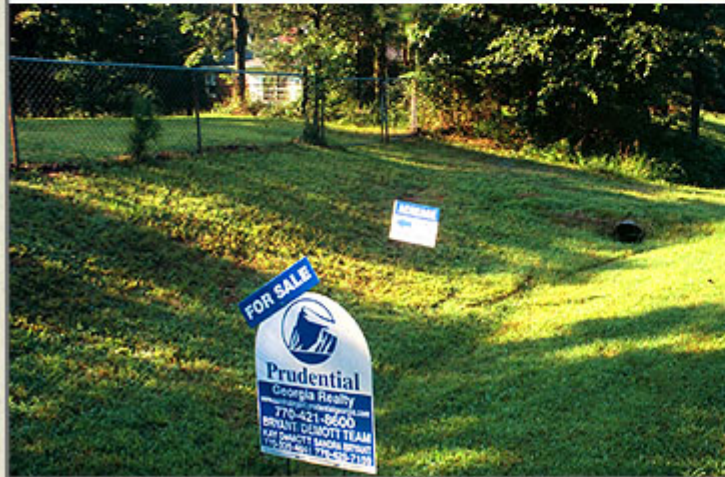
FIGURE 24: Proctor Creek Tributary

- By 2003, medium and high density residential development occupied over 53% of the watershed as compared to 23.3% remaining in forest.
- Estimated percent impervious increased from 14.6% in 1993 to 34% in 2003, vs the estimated 45.9% impervious for the fully developed Northwoods Branch watershed.

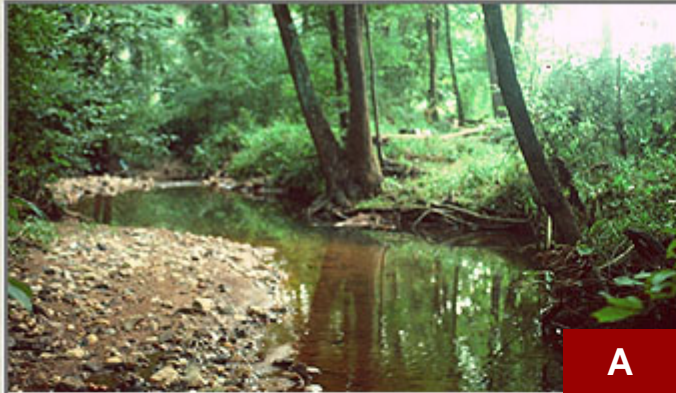
FIGURE 28: Proctor Creek Tributary 1996-2003

- “A” 1997 looking DS past TD.
- “B” 2003 looking US past TD toward X4.

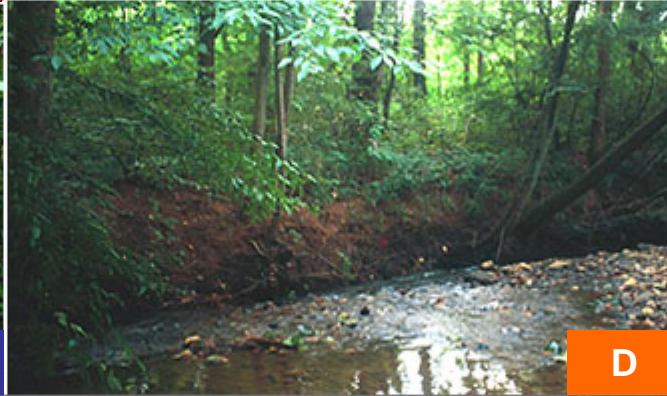
- “B” 2003 looking DS past TD. Note leaning trees.
- “D” 2003 Looking at LB above X3.

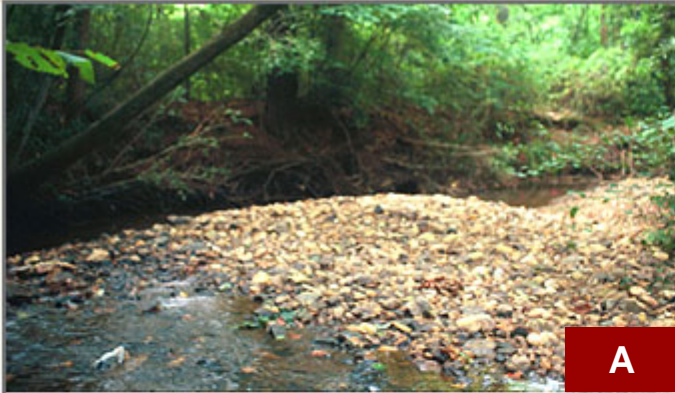
FIGURE 29: Proctor Creek Tributary 1996-2003

- “A” 2003 cobble, rock bed below X3.
- “B” 2003 looking DS @ LB above Sec. 23.
- “C” 2002 looking DS @ twin red maples & debris @ Sec 23.
- “D” 2003 looking US at former site of twin red maples shown in photo “C”.

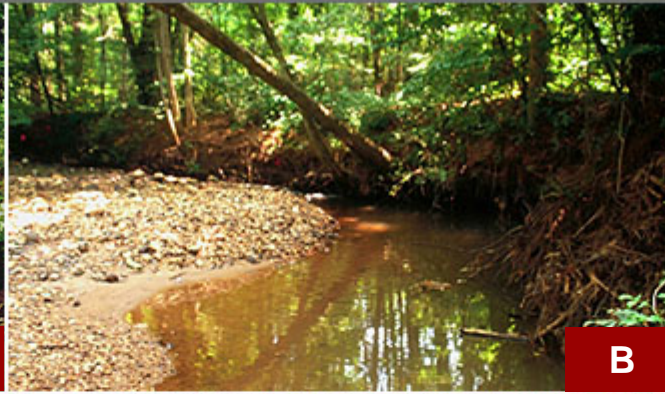
FIGURE 30: Proctor Creek Tributary 1996-2003

- “B” 2003 looking US at former site of traverse log shown in photo “A”.
- “D” 2003 looking US toward LB @ X2.

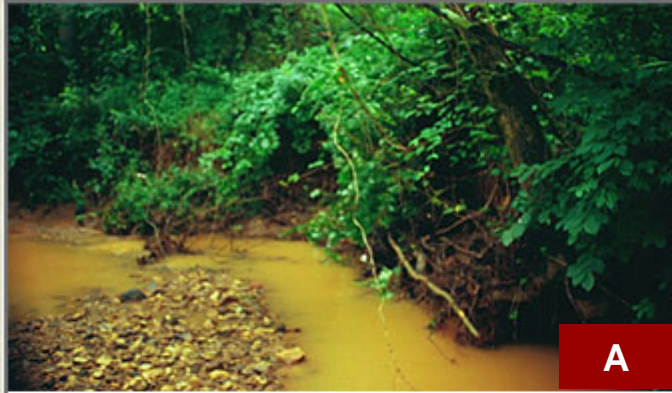
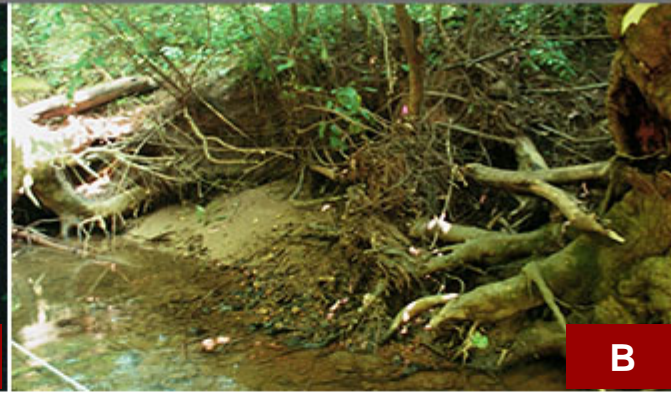
FIGURE 32: Proctor Creek Tributary 1996-2003

- Photo "A" 1996 looking US past Red Maple on LB.
- Photo "B" 2003 looking US past Red Maple on LB.
- Major changes in X3 were an up to 1.5' degradation of the right channel bed (left on the map) & 72% increase in bankfull area from 28.5 to 49.1ft².

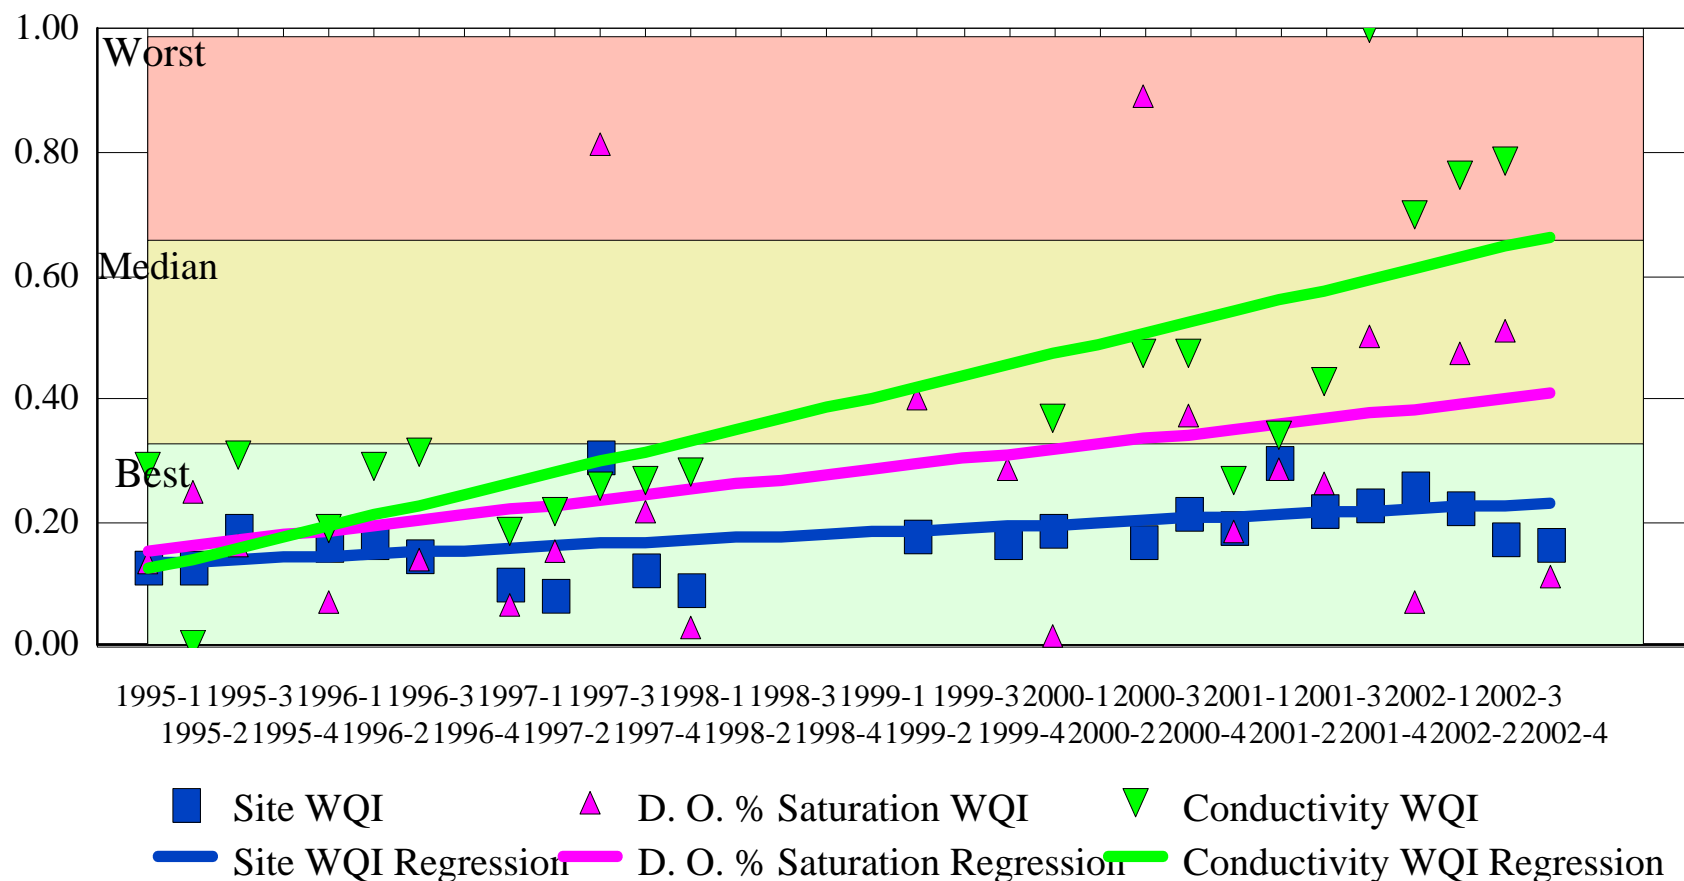
FIGURE 34: Water Quality Indices (WQI) Over Time

- The trend in the Water Quality Index developed for Georgia EPD by USGS/Atlanta Regional Commission (1994) closely tracks the increase in impervious area in the Proctor Creek watershed.
- Conductivity appears to be a promising and sensitive measure of the impacts of development on the Proctor Creek.
- M. J. Paul, et al. (2001) concluded that: “The strongest chemical response to urbanization was specific conductance”.

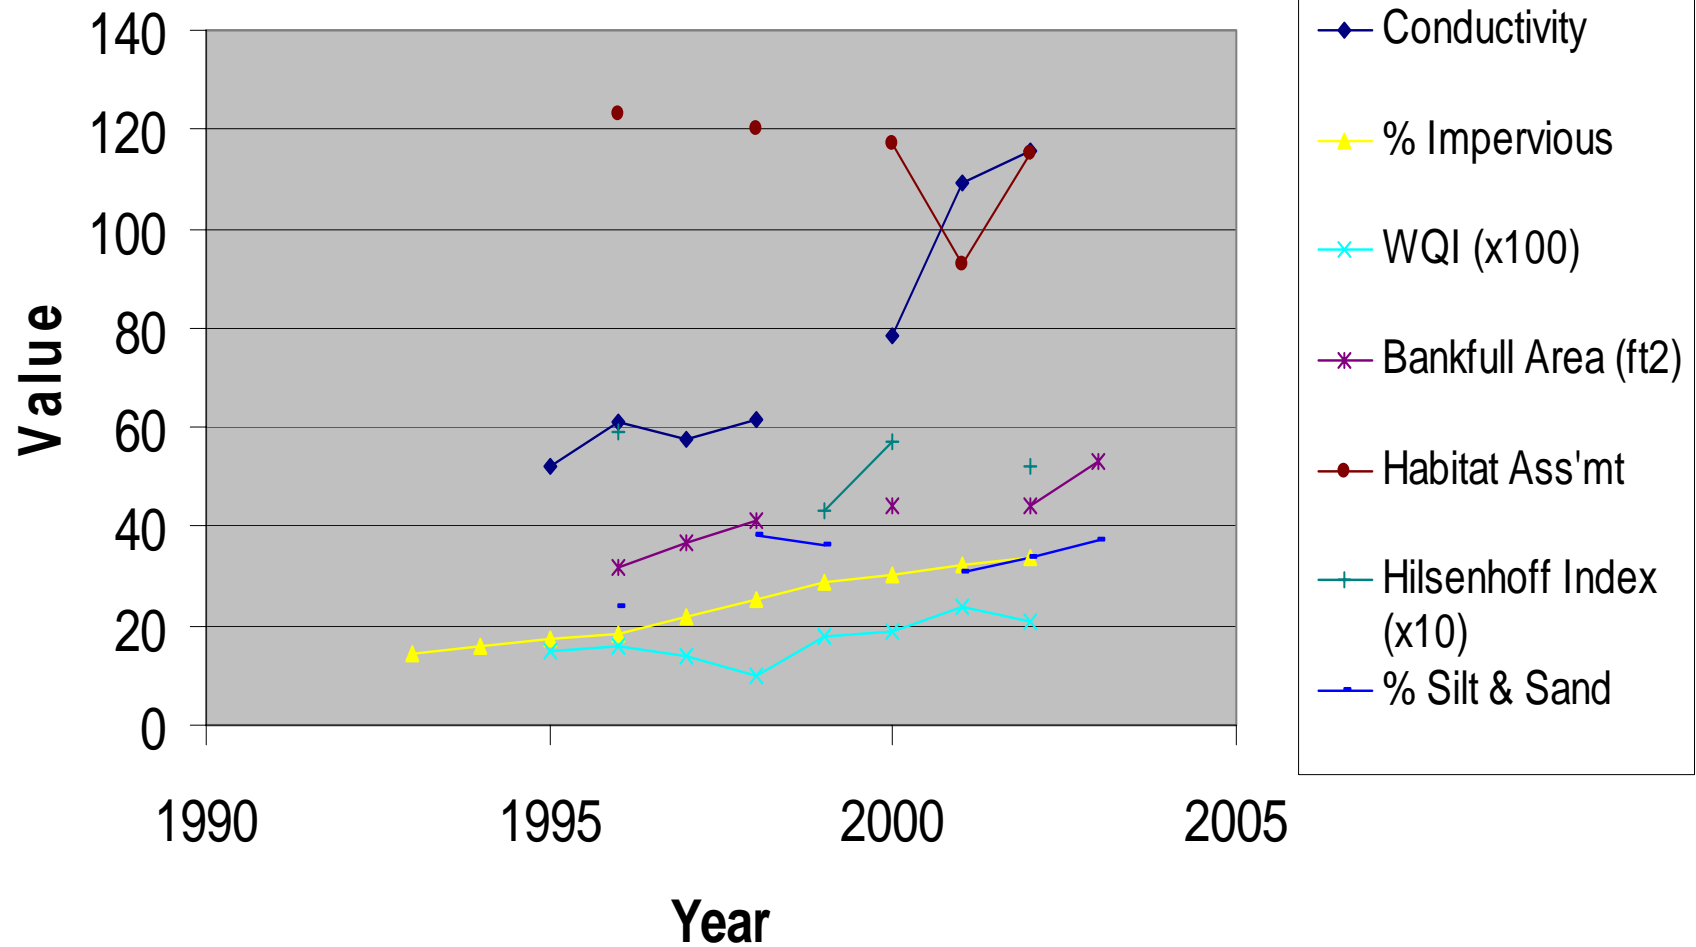
FIGURE 40: Comparison of Water Quality, Physical, and Biological Measurements Over Time

- Habitat assessment has not been adequately sensitive to declining conditions in the stream.
- Sand and silt bed composition probably more related to more direct influences than percent impervious.
- The mean increase in bankfull area follows increases in impervious areas, with largest increase between 2002-03, when rainfall was , exceptionally high.
- The Hilsenhoff index has not adequately reflected the loss of sensitive species and reduction of taxa and individuals in the creek.

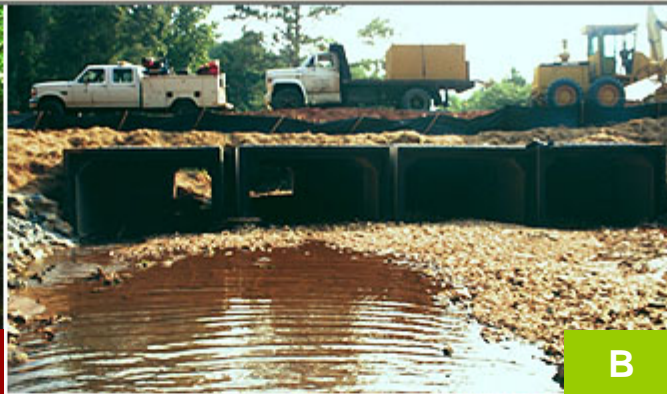
FIGURE 13: 1998 Plan View of Proctor Creek Tributary Sampling Reach

- "A" Looking US past X4 toward TR.
- "B" Construction of new bridge @ Baker Rd. Note ponding.
- "C" Silt deposition on LB opposite TD.
- "D" sycamore cluster @ TD leaning into stream, indicating undercutting.

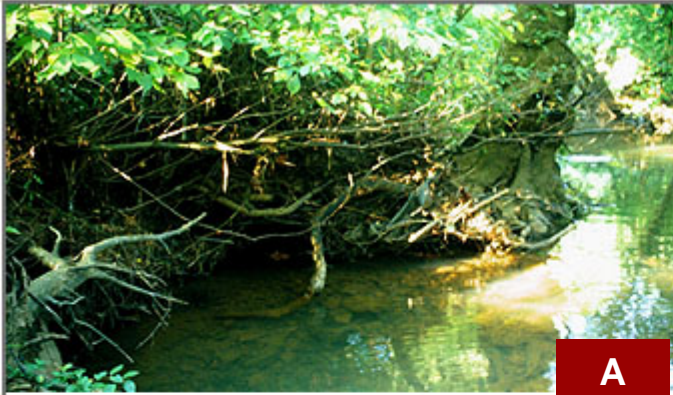
A

- Photos "A" & "B" show upstream ponding caused by new bridge @ Baker Rd.
- While the mean bankfull area of the four cross-sections increased but 7% from 1998 to 2000, X1 & X2 both increased by 17%.
- The increase in X2 above was due primarily to a gully in the rock & cobble bar on right side of the stream bed & an increase in the estimated bankfull stage elevation.

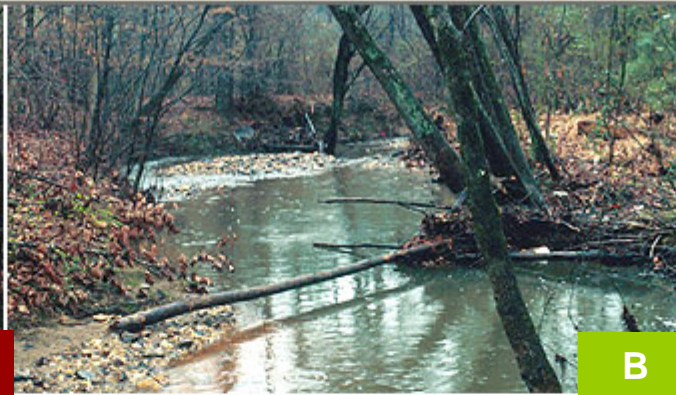
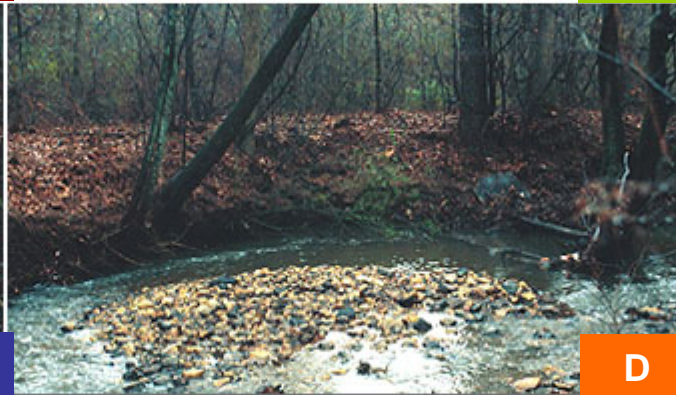
FIGURE 23: Proctor Creek Tributary 2000-2002

- “A” looking US at newly established X-5 & TR.
- “B” looking DS past TD & X3 toward cobble bar.
- “C” looking DS past twin red maples (@ Sec 23) toward bottom of reach (Sec. RM).
- Heavily scoured & undercut LB above twin red maples (on right side of photo).

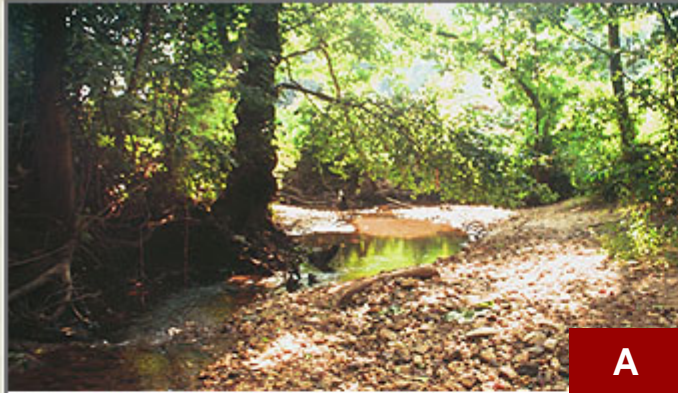
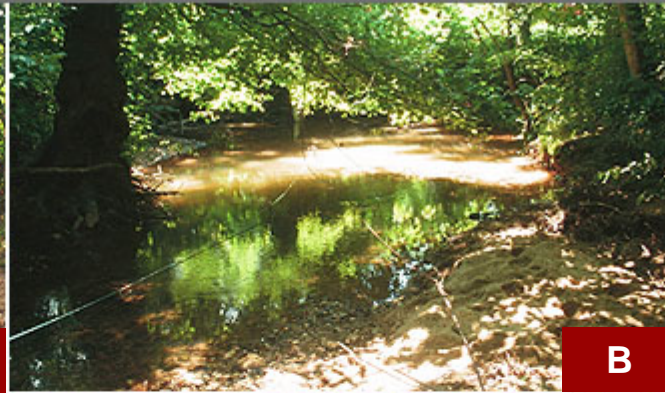
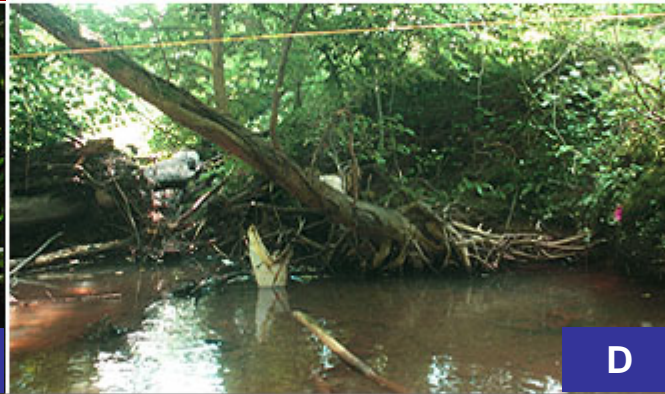
FIGURE 31: Proctor Creek Tributary 1996-2003

- “A” 1996 looking DS past Red maple on LB toward X1.
- “B” 1996 looking DS at X1.

- “B” 2003 looking DS past red maple on LB toward X1.
- “D” 2003 looking DS at X1. Note ponding.
