**STREAMBANK EROSION CAUSES,
AND
LARGE WOODY MATERIAL (LWM)
SOLUTIONS FOR
STREAMBANK EROSION AND SEDIMENT REDUCTION**

**Frank Reckendorf
Fluvial Geomorphologist
Reckendorf and Associates &
950 Market St. NE,
Salem, OR 97301
(503) 364-6681
frecken@mac.com**

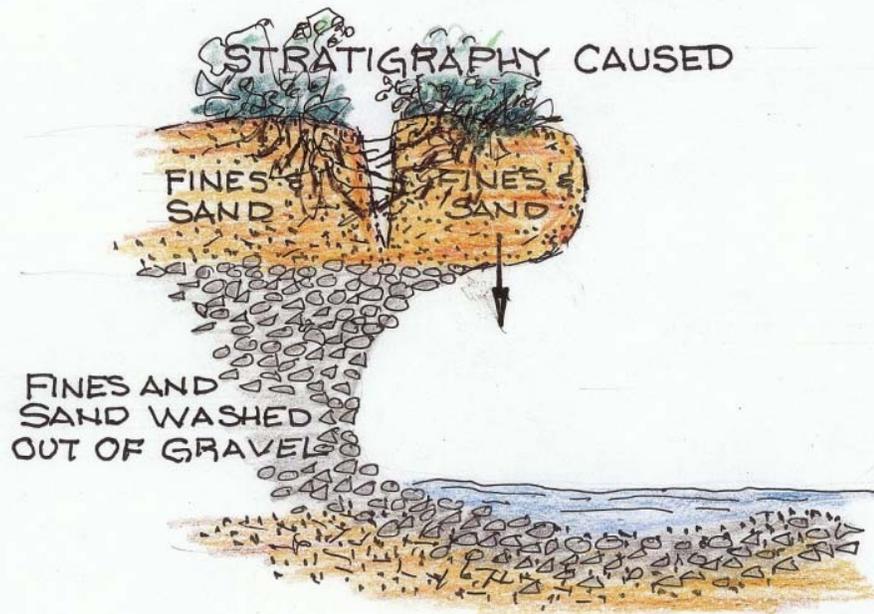
CANTILEVER FAILURE

Figure 1. Stratigraphy caused failure because sands and fines are washed out of gravel matrix, which causes gravel to sluff, and creating a cantilever that Falls.

One investigates whether bank instability is caused by mass failure such as cantilever failure (Figures 1 and 2), planer failure, rotational failure (Reckendorf, 2009a), preferential flow failure (Figure 3) including piping (Hagerty, 1991); high pore pressure, liquefaction and seepage forces especially during the falling stage of floods; popout failure; or because bank height exceeds some critical bank height (Schumm et al. 1984, Reckendorf and Tice, 2003, and 2001). Investigate if failure mechanisms are accelerated or modified by a stratigraphy caused cantilever (Reckendorf, 2010, 2009a, 2009b, 2008b, 2001, 1996, 1989). Is failure mechanism accelerated by R_c/W_{bkf} geometry as discussed in, Bagnold (1960), Thorne et al. (1997) Welch and Wright (2005), Southerland and Reckendorf (2008); flow condition (peak, duration, angle of attack parallel to perpendicular to location of failure); helicoidal flow, Wolman, 1959, Hooke, 1979, Thorne et al. 1997, Welch and Wright, 2005); pre-wetting (Knighton, 1995, and Thorne et al. (1997, Wolman, 1959); boundary shear stress; depth of bed scour along eroding bank; local sedimentation (Reckendorf, 2008b), and Rosgen 2006b); root density and depth (Reckendorf, 2001, and Rosgen 2006b); waves (Reckendorf, 1989); ice condition (freeze thaw, Knighton, 1995), and gouging); desiccation (Thorne et al. 1997), animal burrows (Reckendorf, 2008b); large woody debris jams or other mechanisms causing stream avulsion (Reckendorf 2010).

There are hundreds of miles of streambank, where the author has concluded that stratigraphy (especially washing fines and sand matrix out of gravel strata) is the principal cause of cantilever failure, along gravel bed river streambanks. For example in just one county (Clackamas County in Oregon) five rivers (Sandy, Salmon, Zigzag, Clackamas, Molalla), representing hundreds miles of river streambank have primarily cantilever failure that was caused by high water removal of sands and fines matrix material. In one study by the author on over 150 miles of streambanks in the Walla Walla and Columbia Counties in WA (Reckendorf and Tice, 2001, 2003), the majority of the streambank failures were from downcutting (Stage II, CEM) and widening (Stage III, CEM) associated with cantilever failure because of the removal of fines and sand matrix material from the gravel strata.

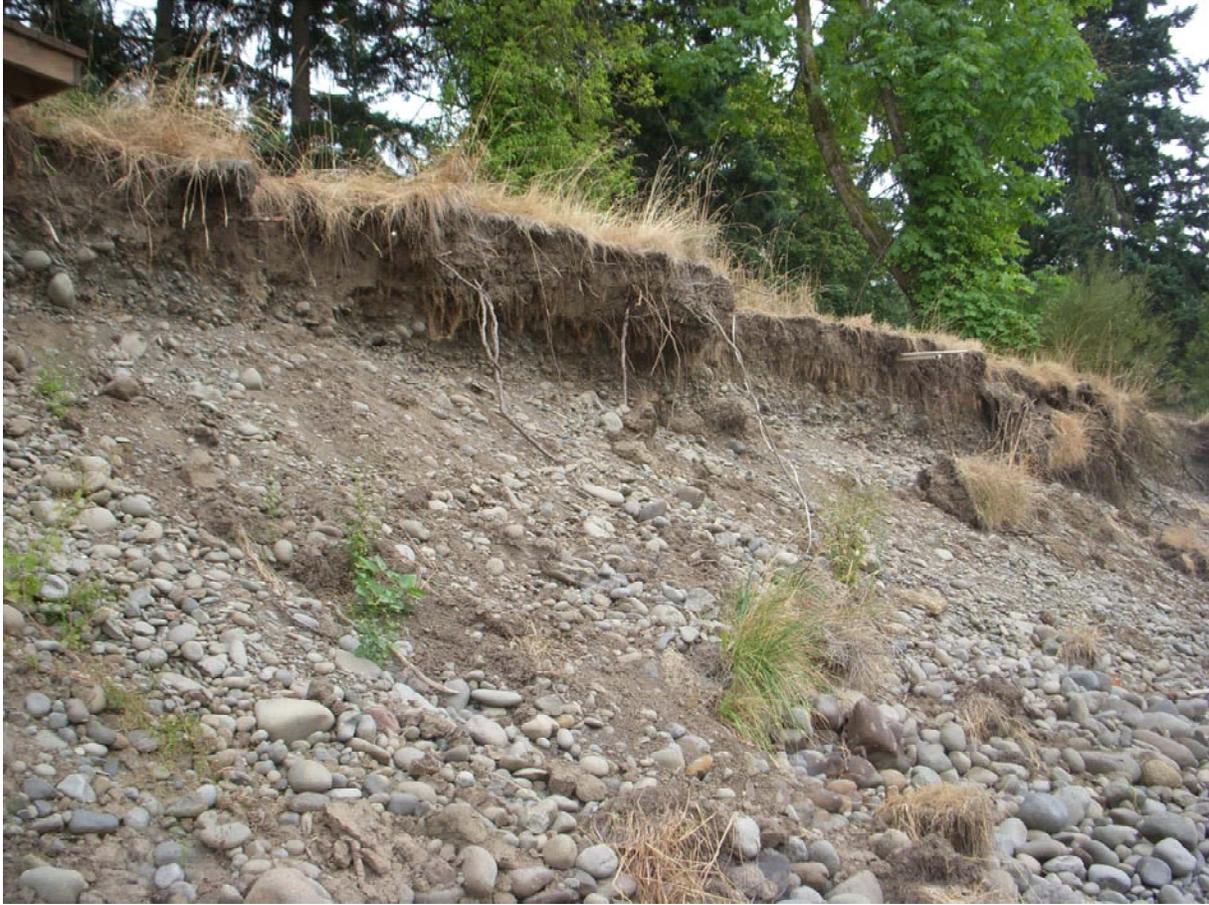
Figure 2. Upper slope cantilever of streambank along Molalla River, Clackamas, Co. OR. Small gravel, sands and fines are washed out of gravel matrix at bankfull flows causing gravel to sluff, and settle at the angle of repose of the slope.

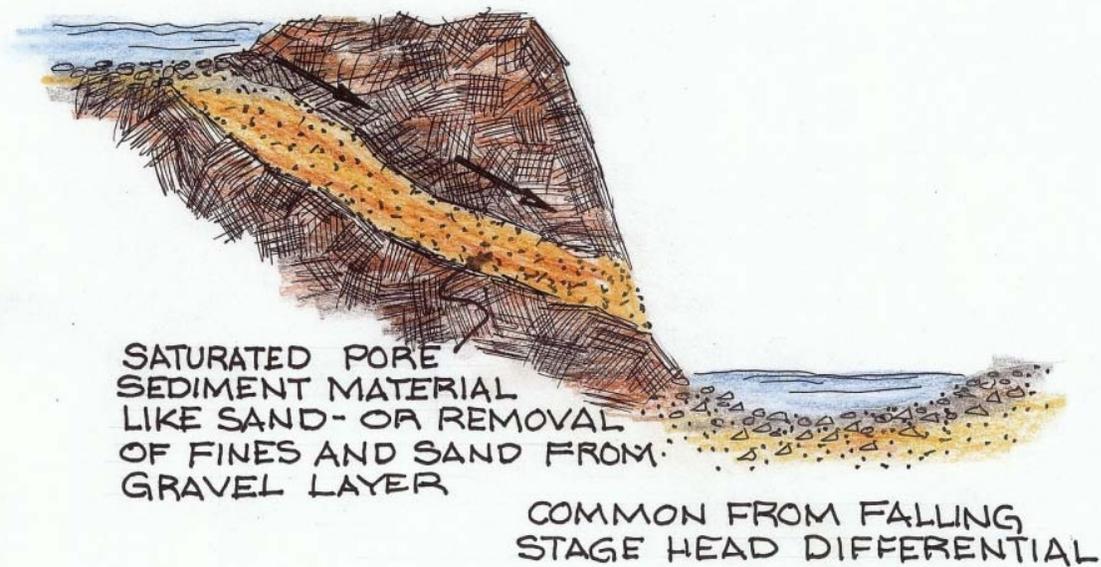
PREFERENTIAL FLOW-INDUCED FAILURE

Figure 3. Preferential flow induced failure is created by side hill or overbank flow creating an elevation head differential such that there is an increase in the materials pore pressure. For flood plains this is often associated with bank failure during the falling stage of floods creating liquefaction of sands and washing sands and fines out of gravel to create cantilever conditions. Landslides can create sag pond on the landscape that fill with water, which seeps downslope along some preferential strata. This can cause increased pore pressure of material that contributes to decreased material strength and rotational and plainer failure. Flow velocity from preferential flow failure can be so high as to cause piping of the lower bank where the seepage water daylights creating a void area in which the overlying material collapses into the void.
